Electron microscopy investigation of the Cr–Mo–V cast steel

Purpose: Investigation of low alloy Cr–Mo–V cast steel after long – term operation and regenerative heat treatment.

The material of research was G21CrMoV4 – 6 (L21HMF) low alloy cast steel taken from the internal turbine frame, serviced for over 186 000 hours at the temperature of 540 °C and the pressure of 13.5MPa. Chemical composition of the investigated cast steel is given in Table 1.

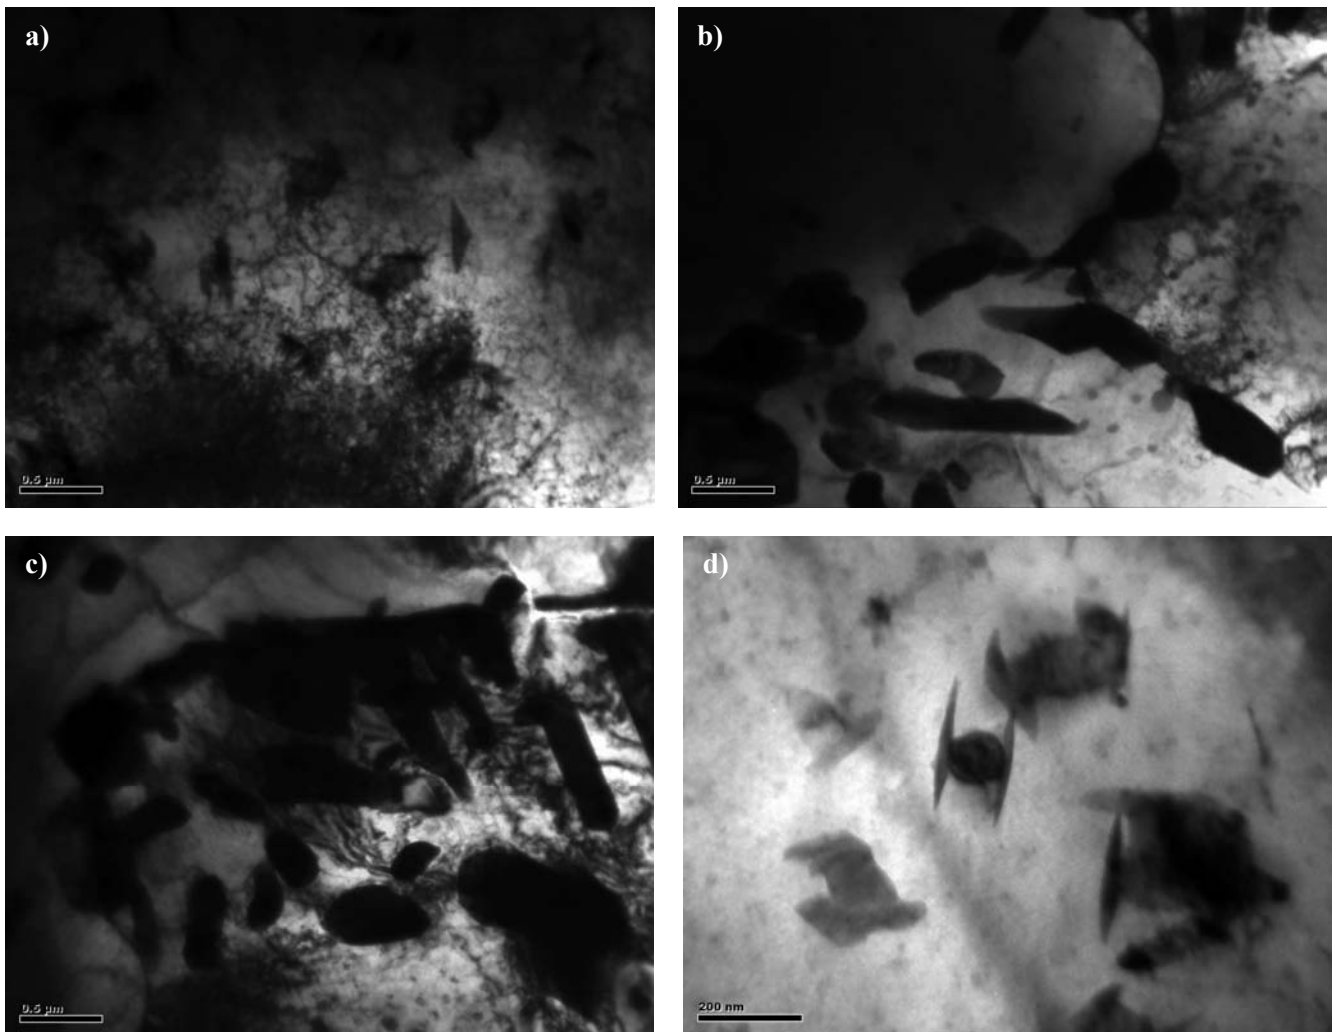
Fig. 1. Microstructure of Cr – Mo – V cast steel after long-term operation, TEM, thin foil

Investigated Cr – Mo – V cast steel after long-term operation was characterized by degraded ferritic – pearlitic structure.

- processes of ferrite recovery and recrystallization revealed by decrease of dislocation density and formation of polygonized ferrite; Apart from recrystallized grains of ferrite, also strongly polygonized grains with high dislocation density could be observed (Fig. 1a);
- privileged precipitation of carbides on ferrite grain boundaries. Occasionally the number of precipitated carbides was so large that they formed the so-called “continuous grid of precipitates” (Fig. 1b);
- process of pearlite colonies degradation consisting in fragmentation, spheroidization and coagulation of pearlitic carbides (Fig. 1c).

Performed research has shown that processes of recovery and recrystallization occur faster in border areas of ferrite grains, where compound precipitates could be noticed (Fig. 1d). Identification revealed that precipitates of such kind were formed by carbides of MC and M₂C grade, where MC carbide is a “horizontal” precipitate while M₂C carbides are “vertical” precipitates. In literature these compound precipitates are called „H - carbide” [13].

Identification of precipitates carried out by means of selective micro diffraction revealed in the structure of the cast steel after long-term operation: M_7C_3 and $M_{23}C_6$ carbides on grain boundaries, MC and M_2C carbides as well as compound complexes of „H – carbide” type inside the grains, while in the areas of degraded pearlite: M_3C and M_7C_3 carbides.

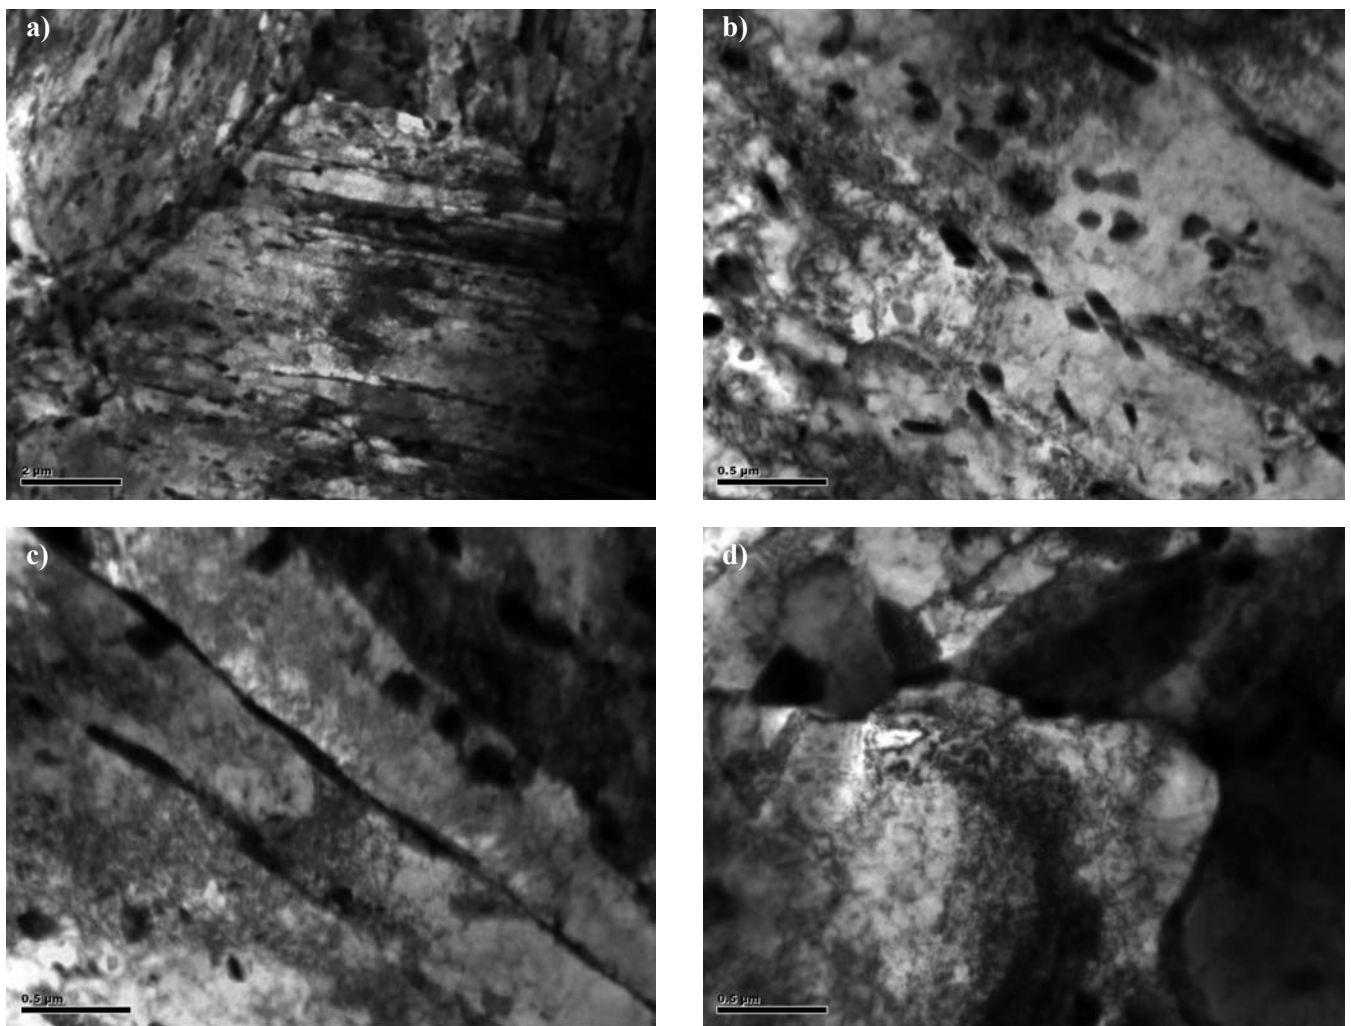
Fig. 2. Microstructure of the cast steel after regenerative heat treatment, TEM, thin foil

Applying of regenerative heat treatment (bainitic hardening combined with high-temperature tempering) caused obtaining of bainitic structure – Fig. 2a. Precipitates layout observed in the structure was characteristic of lower bainite – Fig. 2b. In the structure apart from precipitates of solid shape, as in Fig. 2b, there were also precipitates of elongated shape visible, which were located on packets boundaries – Fig. 2c. Identification proved presence of M_7C_3 and $M_{23}C_6$ carbides on packets boundaries, as well as MC and M_3C grade carbides inside bainite packets. A sample of calculated diffractogram is presented in Fig. 3. Average width of bainite packet was about $0.5\mu\text{m}$. Matrix of the investigated cast steel after regenerative heat treatment was characterized by high dislocation density, however, few polygonized areas with lower dislocation density were also observed (Fig. 2d). Presence of polygonized areas in the cast steel after heat treatment may be caused by the difference in chemical composition of particular grains, resulting from dendritic micro

segregation. Differences of chemical composition bring about local decrease of recrystallization temperature.

Regenerative heat treatment, carried out at assumed temperature and time parameters, resulted in obtaining of high-tempered lower bainite structure in the investigated cast steel, which ensures obtaining of optimum combination of high mechanical properties and high impact energy.
