FAILURE MECHANISMS THAT CAUSE HIGH ELECTRICAL LEAKAGE IN MULTILAYER CERAMIC CAPACITORS

HIROFUMI IKEO, SANPEI SAKAMOTO, KEN SATO[†], HISAKAZU NISHIURA[†], and KATSUHIRO OHNO[‡]

Kita-Itami Works, Mitsubishi Electric Corporation, Itami, Japan 664

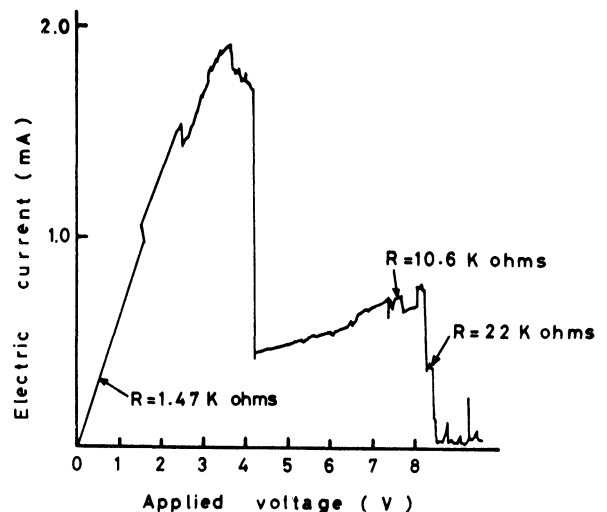
1) Voltage-current characteristic at low voltages was ohmic as shown in Figure 1.

FIGURE 1 Voltage-current characteristic of failed capacitor.

2) Most of the leaky capacitors recovered as the voltage was increased beyond several volts (they change discontinuously, with irreversible change, to the higher resistance level) as shown in Figure 1.

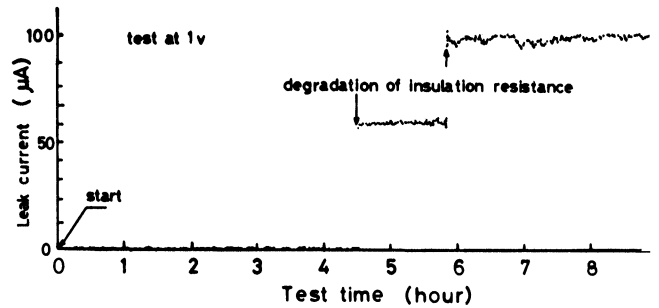
Every capacitor was subjected to dc voltage stresses from 0.25 V to 10 V in an atmosphere of 85% RH and at $+85^{\circ}\text{C}$ in a thermo-hygrostat. Under voltage stresses, some of the capacitors failed at less than 10^4 ohms for applied voltage between 0.5 V and 3 V as shown in Figures 3 and 4. Acceptable capacitors after boiling did not fail at any voltage. The electrical properties of failed capacitors in this reappearance test were the same as those of the failed capacitors in the reliability test. This reappearance test method was evolved by taking account of the electrical properties and the environment of the failed capacitor.

FIGURE 3 Abrupt degradation of insulation resistance at 1 V, at $+85^{\circ}\text{C}$ and in 85% RH.

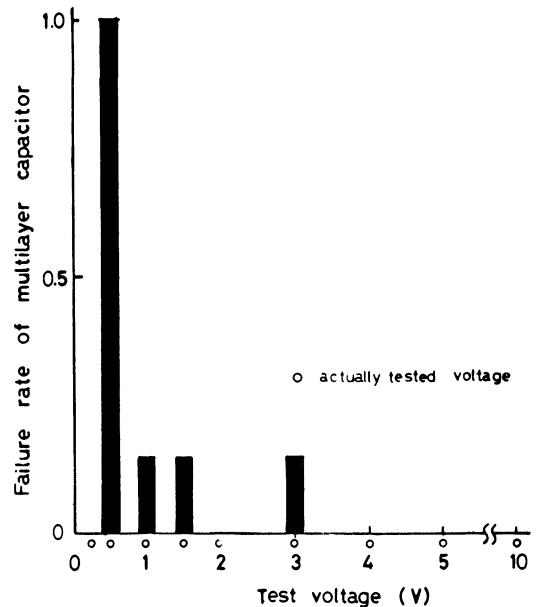
FIGURE 4 Failure rate at dc voltage stresses from 0.25 V to 10 V under high temperature and humidity

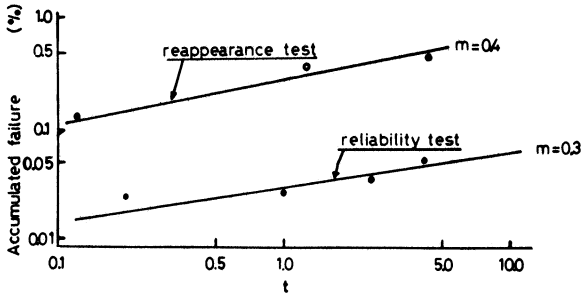
Weibull distributions were plotted for the failed capacitors in two cases. The first was for the failures in the reappearance test, and the second was for the failures in the device reliability test. From Figure 5, the shape parameter m of the Weibull distribution can be seen to be 0.3 to 0.4 in both cases. It is therefore possible to detect failed capacitors because every failed capacitor belongs to a decreasing failure rate group.

FIGURE 5 Weibull distribution analysis of failed capacitors.

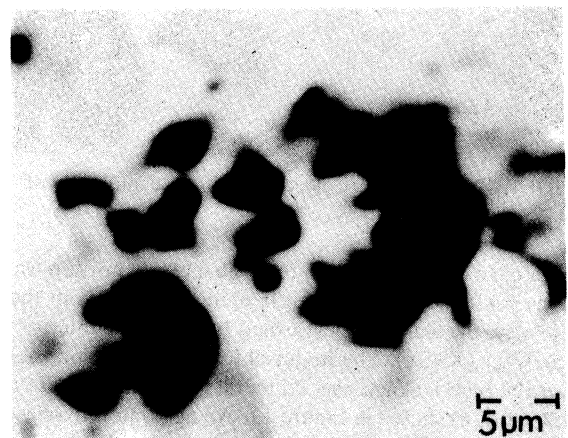
Third step: When the electron beam of a Scanning-Electron Microscope (SEM) is allowed to impinge on the insulator, a charging phenomenon occurs. However the charging phenomenon does not occur if the dielectric exhibits high leakage (see Figure 8). It is thus possible to determine the exact position of the high leakage portion of the dielectric exposed in step 2.

FIGURE 8 Charging image by SEM (insulation resistance of sample is 80 ohms).

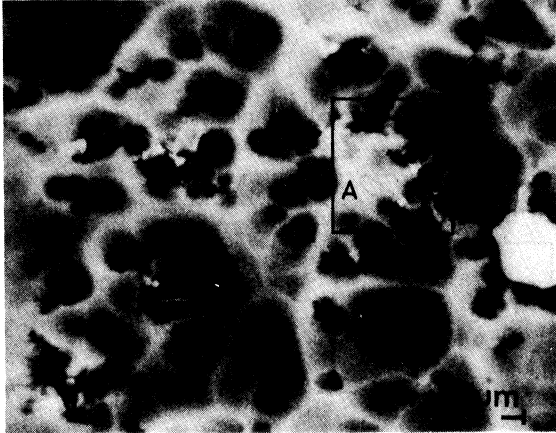
FIGURE 9 Secondary electron image of Figure 8.

existence of small voids in the high leakage portion was thus confirmed. Subsequently element analysis in the vicinity of voids was performed by an X-ray micro analyzer (XMA). The material found to be responsible for the high leakage was Pd metal together with Cl^- in the voids as shown in Figure 11. An agglomerate phase containing Ca was also found near the voids. After bombarding the high leakage portion with Ar^+ ions step by step, it was also confirmed by SEM-XMA that

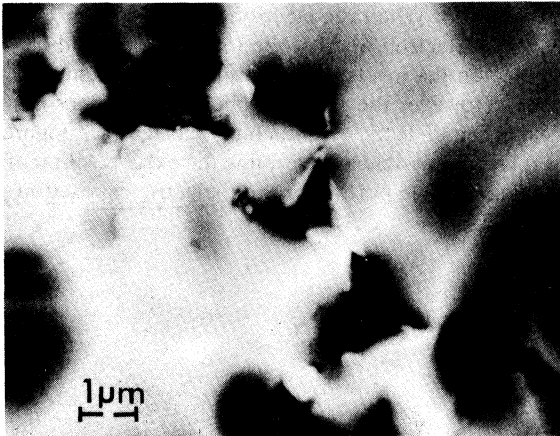
FIGURE 10 Secondary electron image (magnification of portion A in Figure 9).

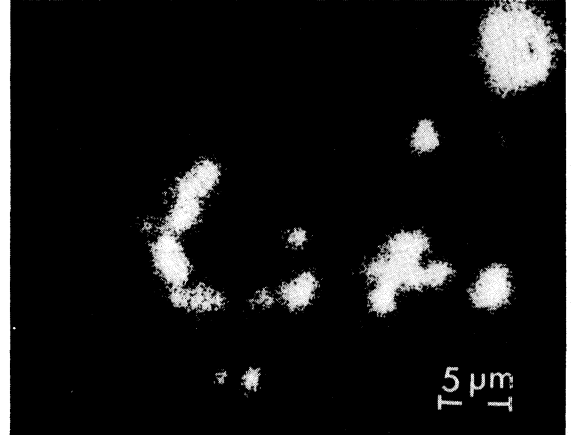
FIGURE 11 Characteristic Pd $L\alpha$ X-ray image.

the leakage path branched and penetrated more than one dielectric layer. The concentration of Cl^- ions together with Pd metal was found to be about 0.1 wt%. A failed capacitor having relatively high insulation resistance contained smaller quantities of Pd than failed capacitors having low insulation resistance.

It has been shown that the most important defects leading to the degradation of insulation resistance are small voids and microcracks leading from the outside of the capacitor through the inner electrodes. The causes of these defects are very complicated. It is suggested that the appearance of agglomerate phases in the ceramics, as found by XMA analysis must be avoided, since the difference in thermal expansion between the two phases may cause microcracking. Contamination

by Cl^- ions must also be eliminated because Pd dissolution at low dc voltage is increased in the presence of Cl^- ions.

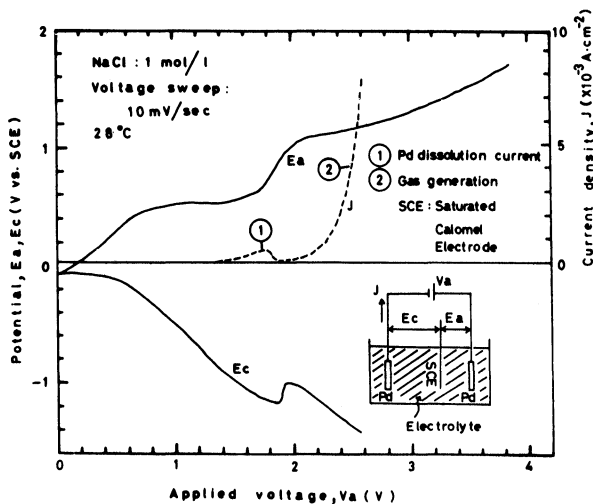
In order to study Pd migration, the dissolution of palladium was measured as a function of electrochemical electrode potential in water and in aqueous solutions of Na₂SO₄, NaNO₃, and NaCl. The relationships between the applied voltage V_a , the current density J , the anode potential E_a and the cathode potential E_c , are shown in Figure 12 for the case of aqueous NaCl solution. To measure the minimum dissolution voltage for Pd, the current (1) in Figure 12 is shown in Figure 13 on an enlarged scale. The beginning of the current increase appears around 0.3 V. This anode potential is equivalent to the applied voltage of about 0.5 V given in Figure 12.

As an attempt to observe Pd dissolution directly, two sheets of filter paper containing 1N NaCl solution were sandwiched between Pd metal plates, and a low dc voltage was applied to the Pd plates. As expected, one could observe directly the Pd migration from the colour change (black) on the paper at the cathode. Pd migration was observed at 1.5 V, but applied voltages above 3 V no longer gave Pd dissolution. Pd migration in the region of 0.5 V to 3 V coincided with the voltage region in which capacitors failed.

FIGURE 12 Electrochemical reaction test in an aqueous NaCl solution.

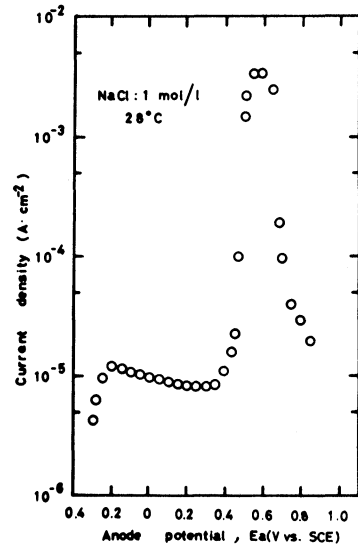
FIGURE 13 Enlargement of current (1) in Figure 12.

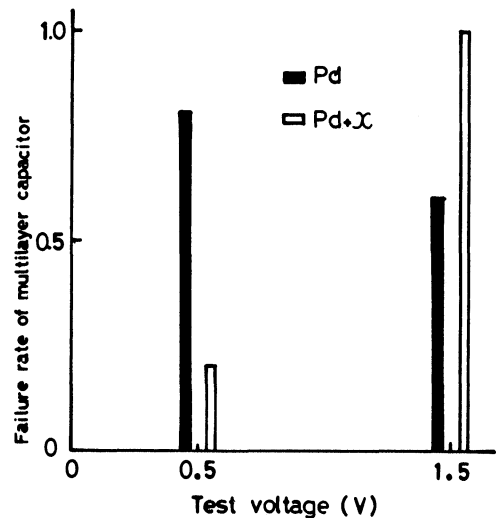
FIGURE 14 Dependence on test voltage of failure rate (for two cases: Pd inner electrode, Pd + x inner electrode).

groups: those associated with capacitors having electrodes of pure Pd metal and those associated with capacitors having electrodes in which the Pd is contaminated by a small amount of another unknown metal represented by x in Figure 14.

The fact that the failure rate of the Pd electrodes contaminated with small amounts of another metal is much higher at 1.5 V than 0.5 V is interpreted as showing that the voltage migration depends on the electrode material. Furthermore measurements of the time taken to arrive at failure gave figures of between one minute to 45 minutes for capacitors boiled in NaCl solution and 10 minutes to 10 hours for those boiled in water.
