Siemens Esprit 型 CT 机探测器传感器单元故障的应急维修

牟强善 朱继军 牟宗峰

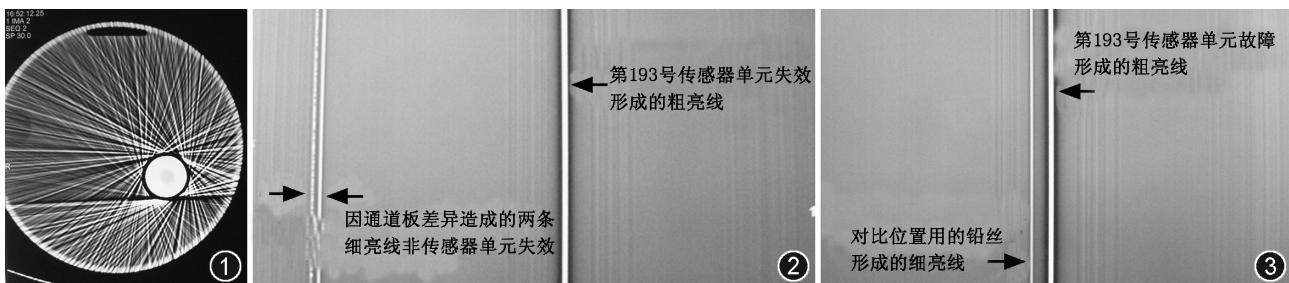
故障现象:Siemens Esprit 单排螺旋 CT 长时间停用后扫描标准水模时所得图像有偏离中心的环状伪影(图 1),而行 TOP 扫描所得图像中间稍偏右有一条垂直粗亮线。该垂直粗亮线左侧亮度稍暗、宽度稍窄的 2 条细线后被证实属通道板差异,运行空气校准后即可去除(图 2)。

图 1 显示 CT 长时间停用后扫描标准水模时所得图像有偏离中心的环状伪影
图 2 示通道板差异造成的亮线(左图箭)和第 193 号传感器单元(右图箭)
图 3 显示铅丝(左图箭)和坏的第 193 号传感器单元(右图箭)间相互位置

维修过程:将探测器模块后级的 14 块探测器通道板按板号 1-7、2-6、3-5、4-11、8-14、9-13、10-12 相互交换位置后故障不能排除,说明故障点在探测器通道板前级的传感器单元部分。在输入密码进入维修模式下,查得第 193 号传感器单元失效,且使用维修软件屏蔽该传感器单元故障仍不能排除。原生产厂家只提供整个探测器阵列而非单个探测器模块,而每个探测器模块又包含多个传感器单元,更换整个探测器阵列费用极其昂贵。我院维修人员经第三方维修公司技术指导,自行调换第 193 号传感器单元所在探测器模块。

具体操作过程:首先把直径 2 mm 铅丝按垂直方向放在探测器射线输入口处行 TOP 扫描,比对所得图像中铅丝和坏的第 193 号传感器单元间相互位置(图 3),待铅丝与坏的第 193 号传感器单元位置完全重合时,随即标记出坏的第 193 号传感器单元所在位置。将整机断电后维修人员佩带防静电腕带进行更换;首先极度小心取下坏的第 193 号传感器单元所在的探测器模块,然后取出探测器阵列中左侧第 2 个探测器模块,与第 193 号传感器单元所在的探测器模块交换位置后,将 2 个探测器模块的电插接件紧固好,开机做空气校准后所得图像质量符合临床需要。
