Regulation of Brahmaputra-Jamuna River around Jamuna Bridge Site, Bangladesh: Geoenvironmental Impacts

This study is conducted to evaluate the ongoing geoenvironmental impacts of Brahmaputra-Jamuna (BJ) River around the Jamuna Bridge (JB) site which was modified prior to the construction of Jamuna Bridge in 1996. Remote sensing and GIS techniques are adopted to evaluate the temporal and spatial geohazards. This study shows that the intensity of channel shifting has been increased due to regulation of river width at Siraganj–Bhuiyapur section from 11 km to 4.8 km. Planform analysis shows that the major channel has been stressed to migrate (315 m/year) eastwards. The phenomena of channel changes are predicted to be the consequences of interaction of water flow, sedimentation and channel corridor. The erosion and deposition have complicated variations over time and space due to the abrupt changes of flow and sedimentation around the regulated section. Due to width reduction, the bridge site in the braided system acts as sluice gate which can not accommodate the entire flow to release downstream properly. The helical flow developed with the interaction of guide bund creates local scou

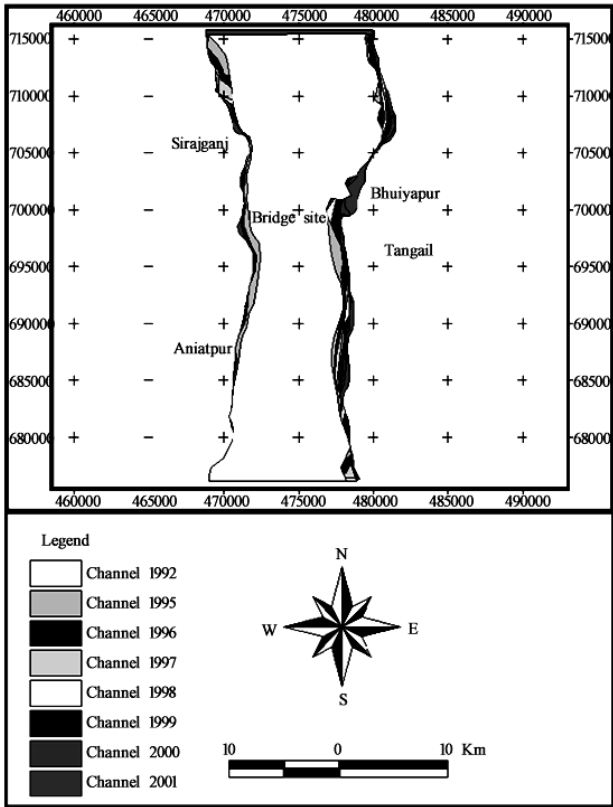
Figure 3. Trend of bank line shifting of Jamuna River around Jamuna bridge site.

of post bridge adjustment. In Figure 3, it is shown that the erosion is predominantly eastwards (Bhuiyapur) around the bridge sites and downstream part, whereas the west bank shows deposition tendency (from bridge to Aniatpur). In fact, the temporal and spatial migration is prominent in three different points of the studied sections, though the entire river is considerably migrated eastwards (Table 2). The rate of bank line migration at Bhuiyapur site was calculated to be 315 m/year and the maximum bank line migration (2.5 km) was also observed near the bridge abutment of Bhuiyapur from 1992 to 2001 (Figure 3).

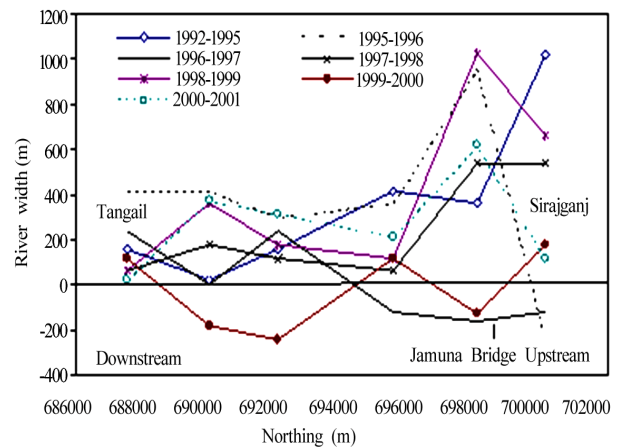
**Figure 4. Changes of bank line from 1992 to 2001 around bridge site (calculated from raster images).**

tional phenomenon in most of the points except the upstream part of Sirajganj town and downstream part of Aniatpur, where up to 3.5 km of erosion were observed. Hence, the net erosional phenomena between 2001 and 2008 was about one and half times higher than that of the previous phase (1992–2001) in both banks of the studied river section. The point to point measurement of river width, calculated from raster data (Landsat TM image) shows that the maximum bank line shifting is observed between northing N69600 and N702000 which covers the immediate upstream and downstream parts of the bridge site (Figure 4).

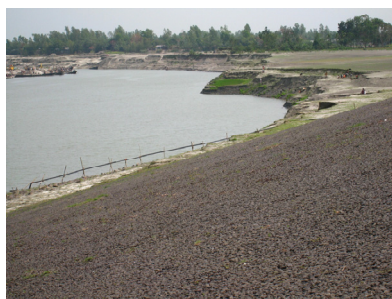
(a) Erosional point at Bhuiyapur (bend scour developed around the bridge abutment).

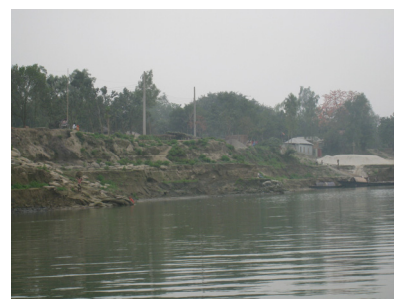
(b) Erosional point at Sirajganj (bank sliding occurred for downcutting of river bed).

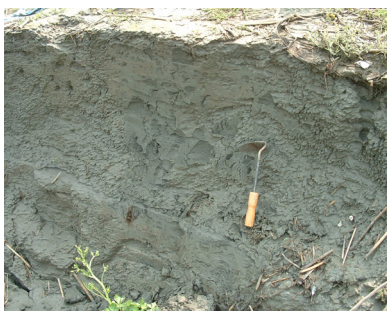
(c) Sediment signature in east bank, mostly composed of silt clay and mud.

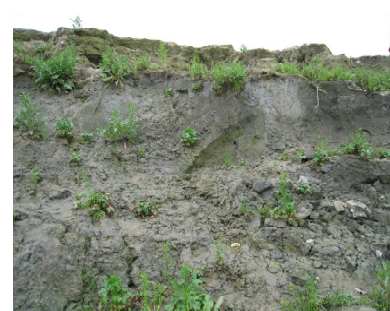
(d) Sediment signature in west bank, mostly composed of dark clay.

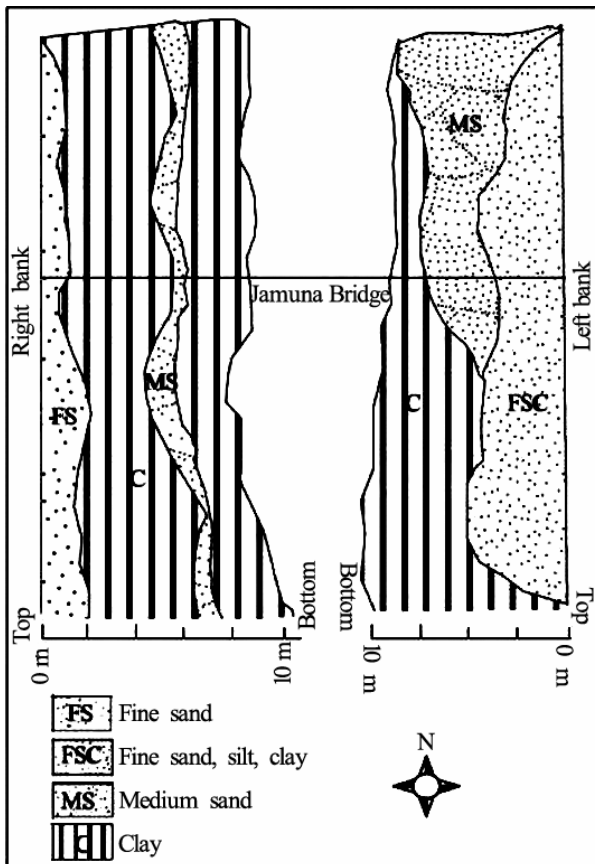
Figure 8. Sediment signature of the erosional bank of Jamuna River at Jamuna Bridge site.

Natural levee is almost absent in most of the meander bends along upstream site of Sirajganj town due to rapid erosion. In lieu of well-developed levee, there is a thick sheet of fine sand layer (around 2.0 m thick) which is underlain clayey materials (Figure 8). In contrast, channel bed scouring and concave benches are observed in the eroded bank morphology due to the presence of resisting (clayey) bank materials at bottom of eroded bank (4.0 m thick) (Figures 7(b) and 8). As a result of intensive downcutting, rapid river-bed degradation is induced, and the longitudinal training structures have gradually been destroyed. Therefore, none of the groyne constructed in one year in this channel has survived to next year. Groynes and many bank reinforcements are seriously damaged every year in this section. This aggradations and deposition phenomenon in the vector projection, show very similar fashion (Figures 2 and 4). Due to river training works, the present bridge section becomes a funnel-shape passage (sluice gate) across the river reach. Within this regulated section, it is hard to pass the entire flow regime during the flood season; accordingly, a flow gradient is developed between the upstream and downstream sites.

the confined channel. Hence, deposition occurs at the immediate upstream of the bridge and raises the river bed level. Furthermore, the shallow channel can not accommodate the floodwater as before. Thus, the flood stage has become extremely high and the phenomenon known as the “little flood with high flooding disasters” has occurred in the river basin, thereby widening the channel corridor. The change of the channel area from 1992 to 2001 is plotted in Figure 5. Attributable to the existing pressure gradient between the upstream and downstream sites, the down-channel suffered excessive bank erosion (Tangail site) (Figures 3 and 7). The results show that the active channel corridor has been increasing with time. The maximum increment is observed in 2000, though the value is extremely reduced in 2001 (Figure 5). Due to excessive flooding in the upstream site, the agriculture land is covered by a thin sheet of fluvial sand (about 1.0 m thick) (Figure 8).
