**Ponding Test Results
Seepage Losses
Laterals 8E and 2A-C**

Maverick County Water Control and Improvement District No. 1

**Texas Water Resources Institute Technical Report
November 2008**

March 30, 2004

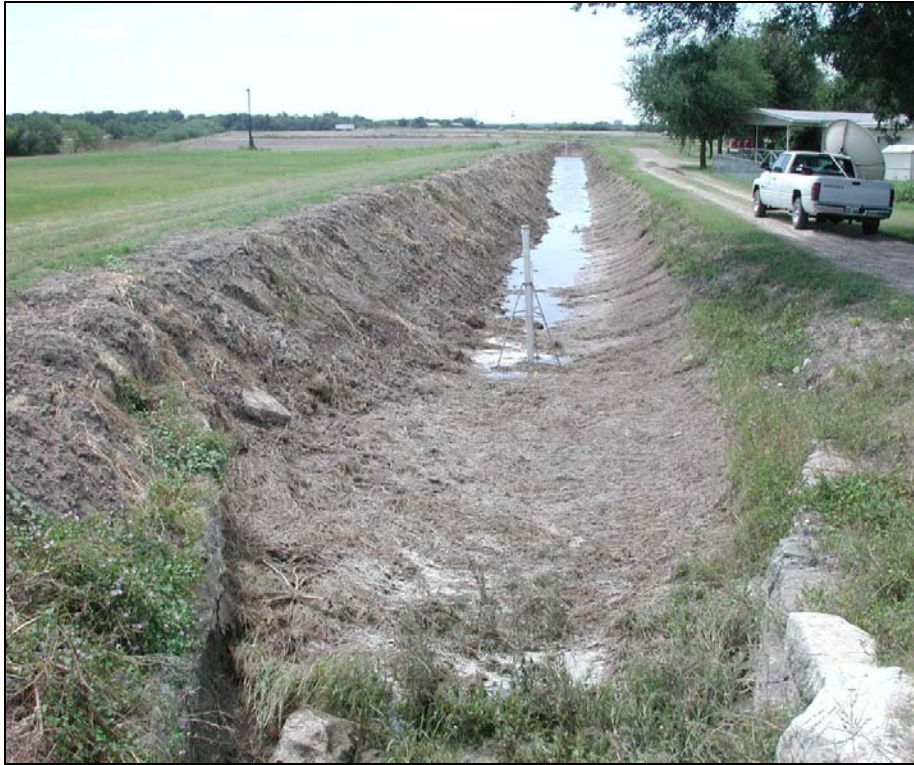
Ponding test results are summarized in Tables 1 and 2 and were high for both types of canals. Test Segment MA3 (lined) had been dredged and cleaned two weeks prior to testing which is likely to have contributed the relative have seepage loss rate of 13.85 gal/ft²/day. The lining of MA4 was in poor shape as shown in (Fig. 7 – 8), resulting in a loss rate of 8.82 gal/ft²/day.

Figure 1. Test MA3, a segment of the unlined canal Lat. 8E.

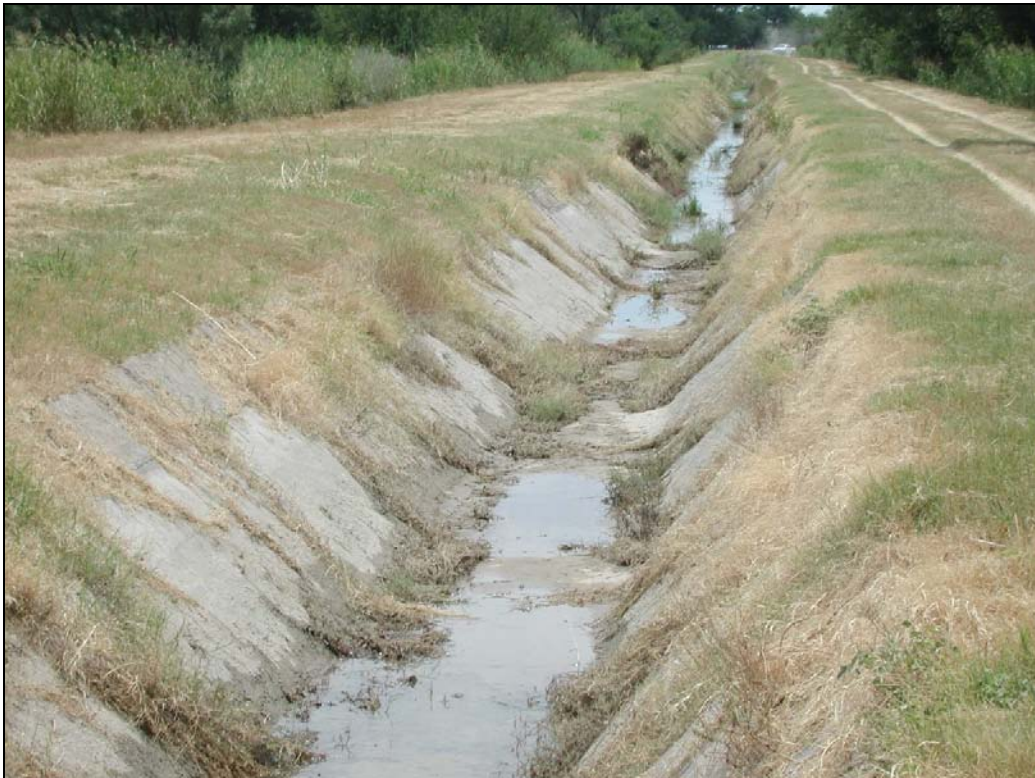
Figure 2. Test MA4, a segment of the lined canal Lat. 2Ac.

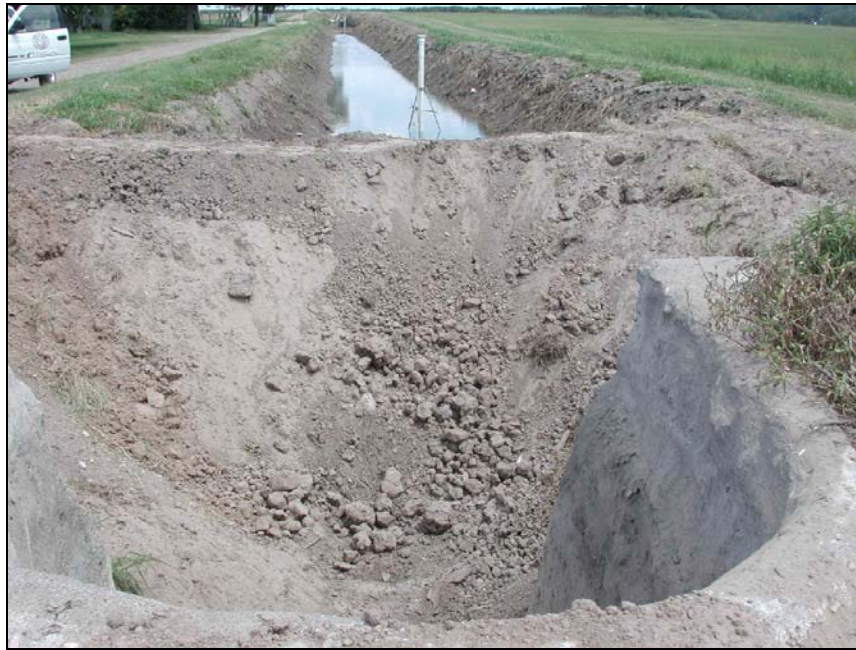
Figure 4. Downstream dam of Test Segment MA3.

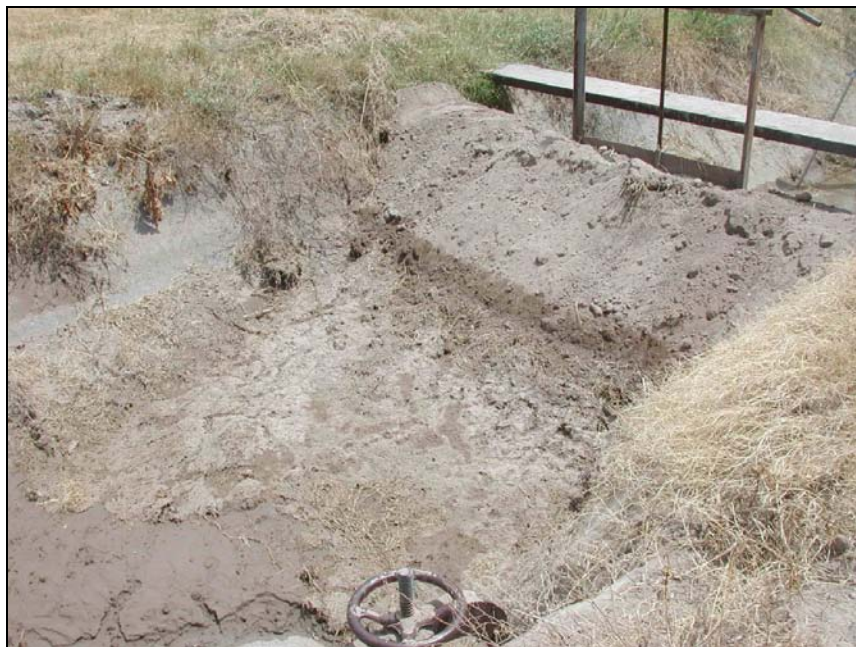
Seepage loss rates were measured using the ponding method. In this method, the two ends of a canal segment are closed or sealed with earthen dams as shown in Figure 4 and 5. As can be seen in Figure 5, the dam was built on the upstream side of the check gate allowing for better containment and to reduce fill needed for the dam.

Figure 5. Upstream dam of Test Segment MA4.

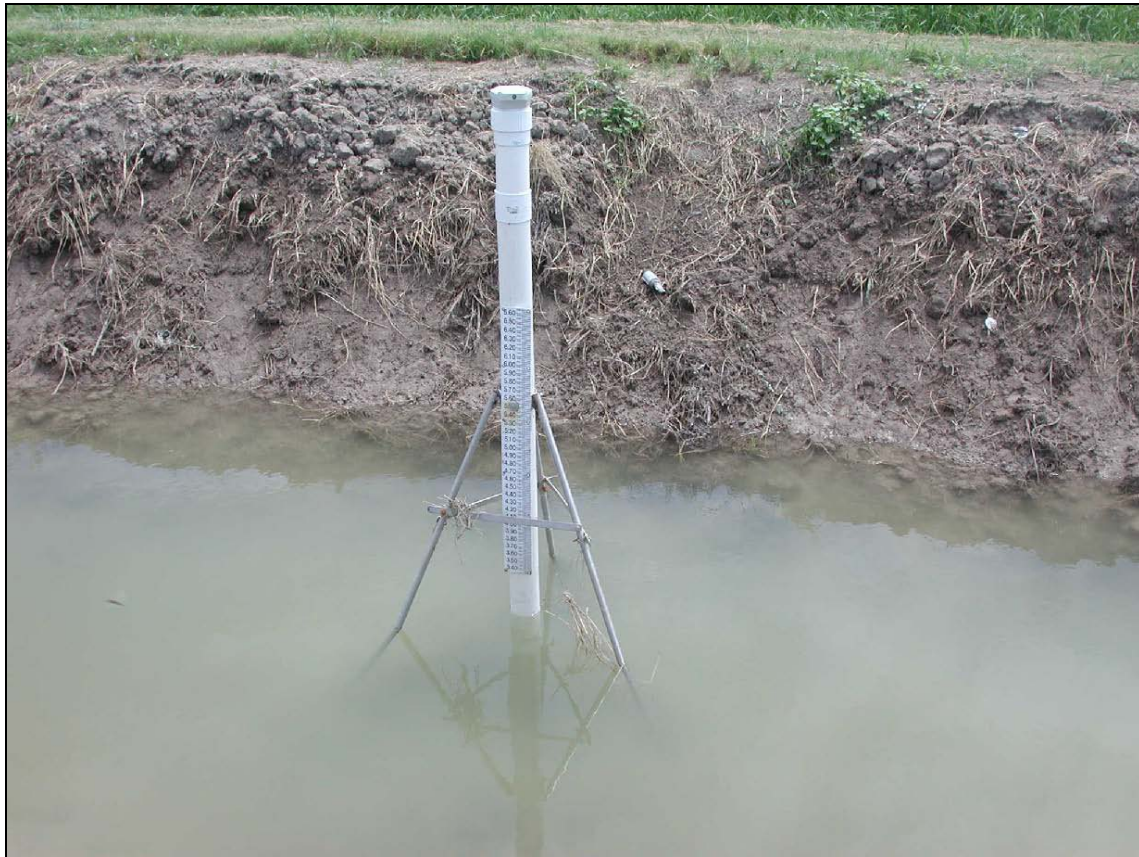
Figure 6. Staff gauge use to manual measure water levels.

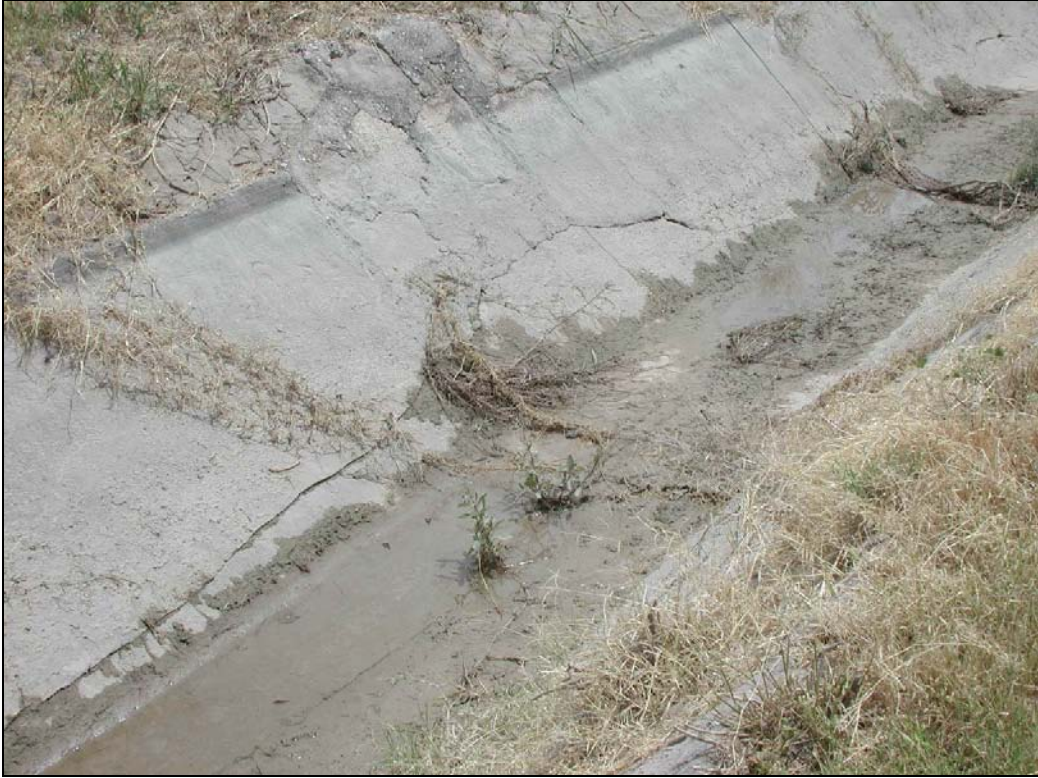
- Test segment MA3 did not contain valves or gates within the canal; thus, the seepage rate was measured.
- Test segment MA4 did not contain valves or gates within the canal; thus, the seepage rate was measured. High loss rates can be attributed to the canal lining condition shown in Figures 7 and 8.

Figure 7. Horizontal cracks in the sidewall of MA4.

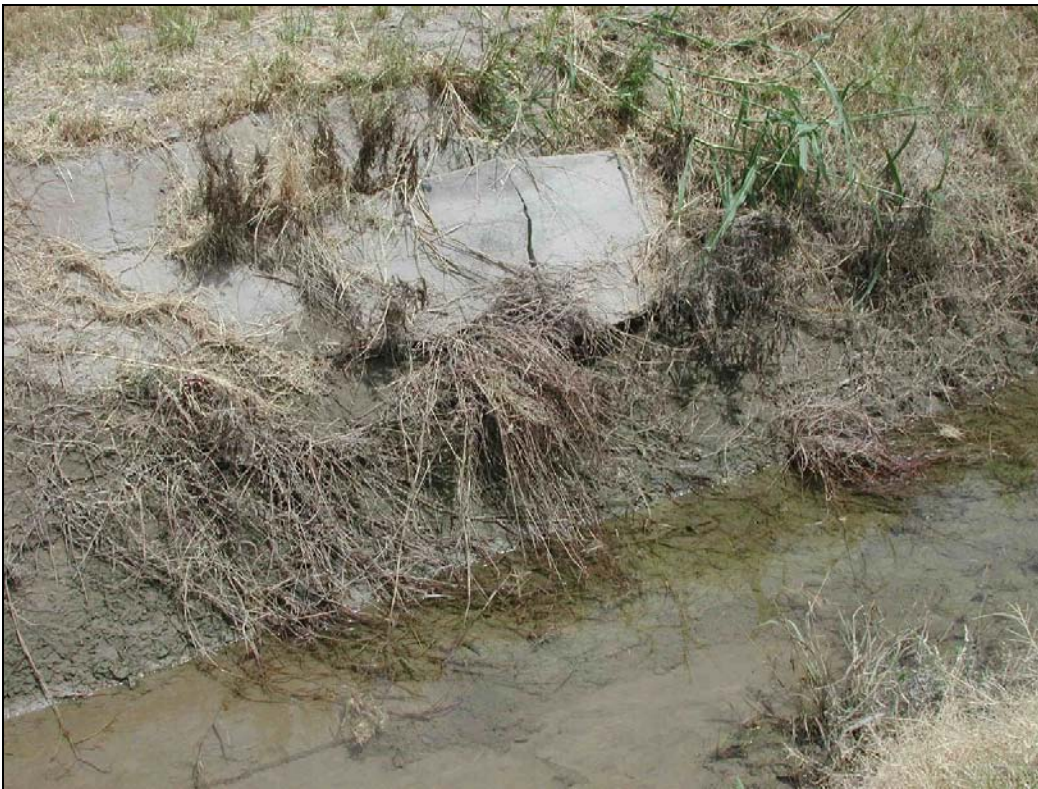
Figure 8. Large break in the sidewall of MA4.

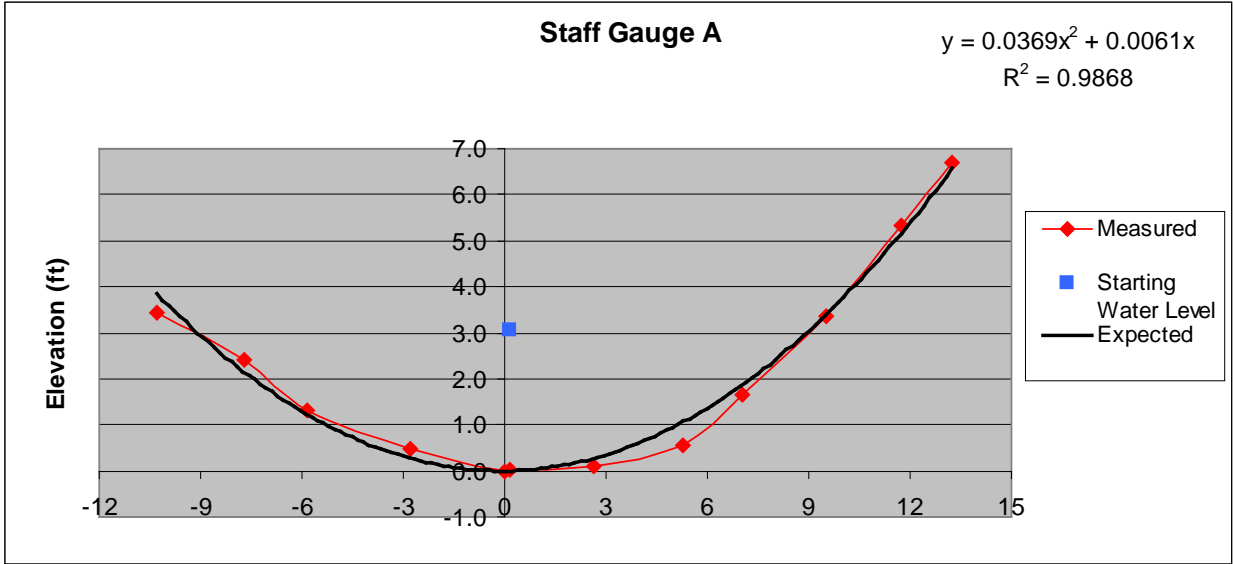
Figure 9. Cross-section at Staff Gauge A, MA3.

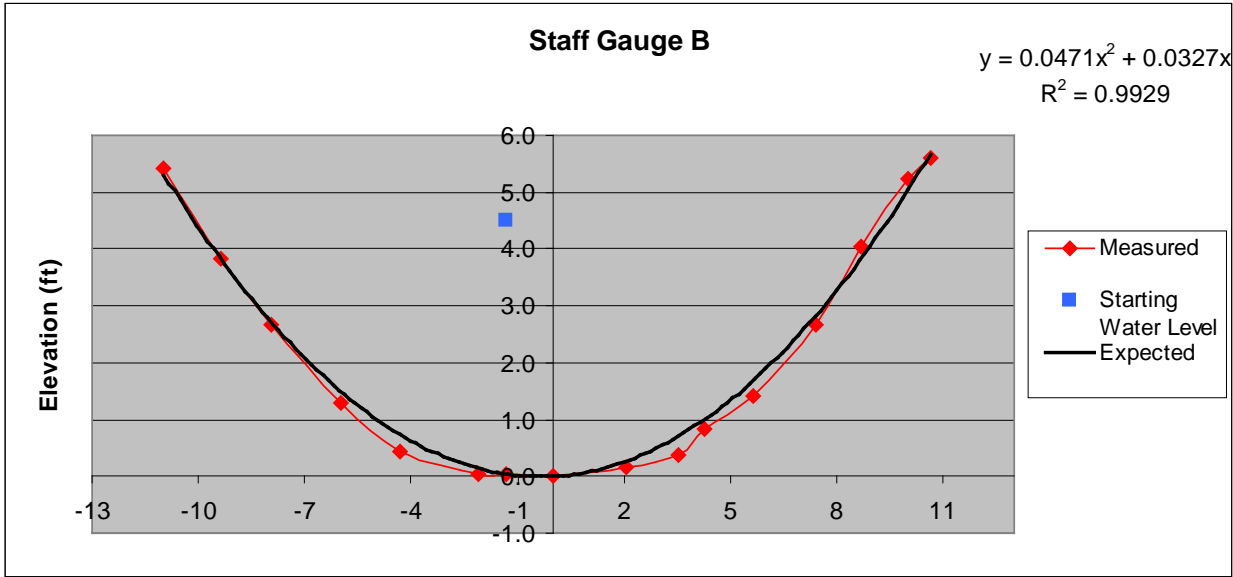
Figure 10. Cross-section at Staff Gauge B, MA3.

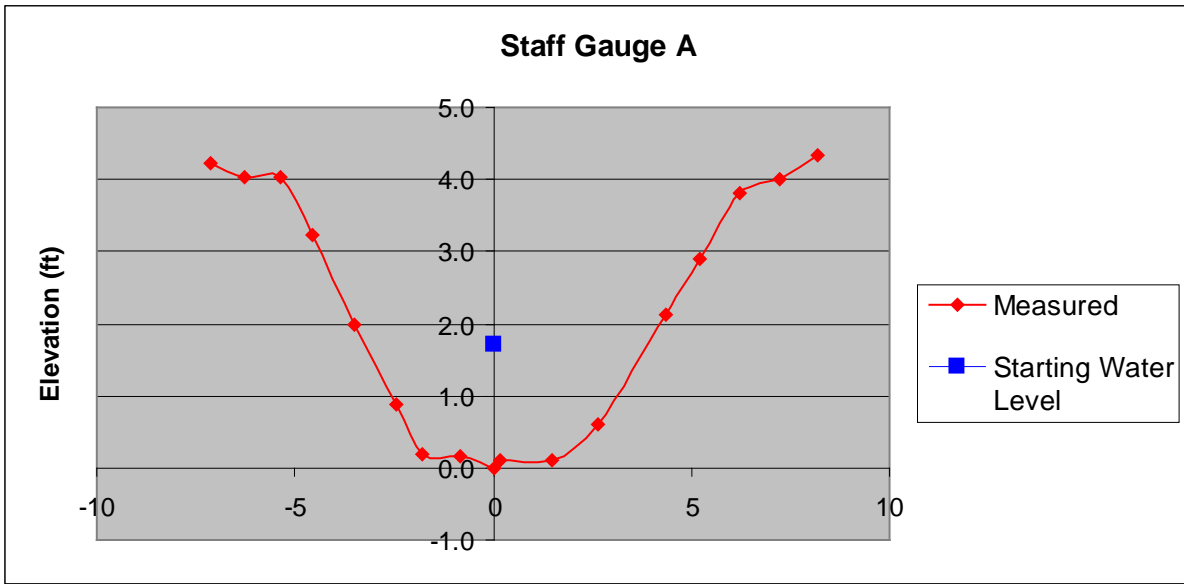
Figure 11. Cross-section of Staff Gauge A, MA4.

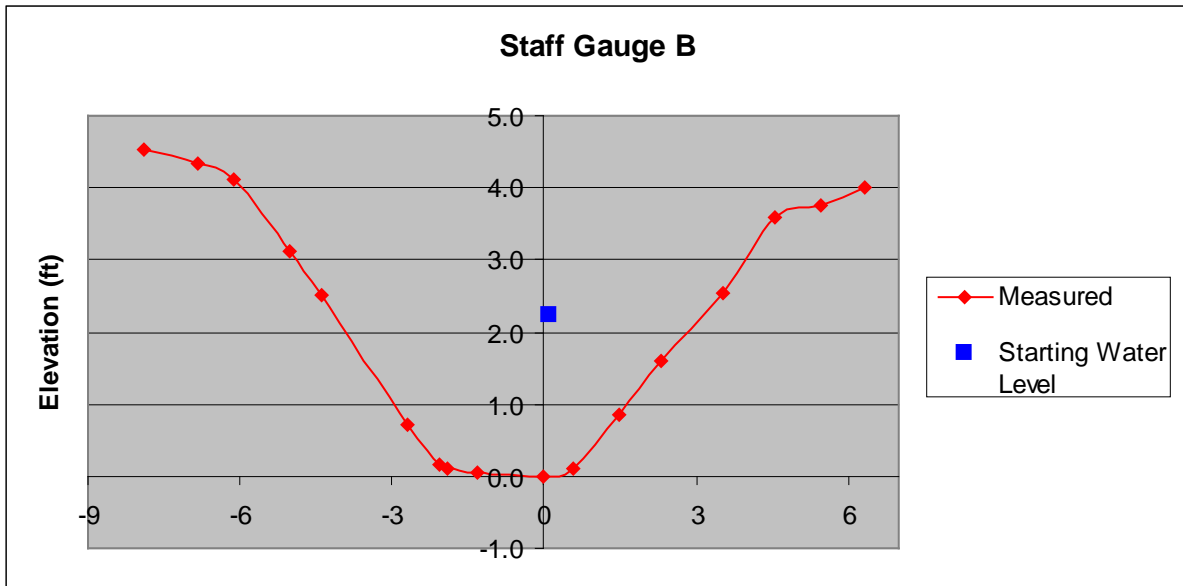
Figure 12. Cross-section of Staff Gauge B, MA4.

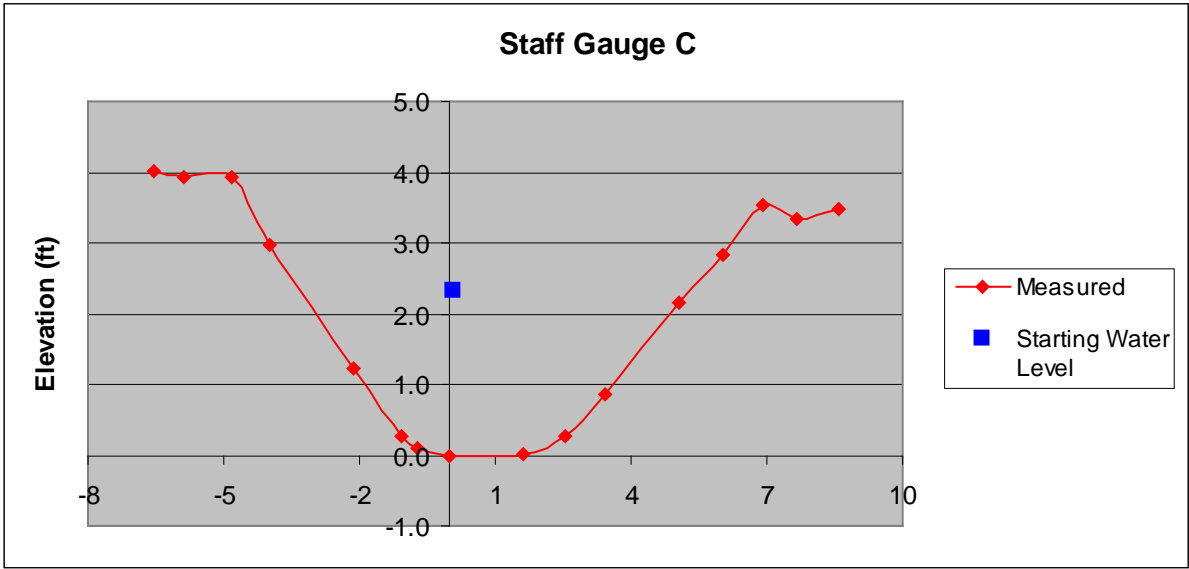
Figure 13. Cross-section of Staff Gauge C, MA4.
