Case Report

Face and Neck Dermatitis from a Stainless Steel Orthodontic Appliance

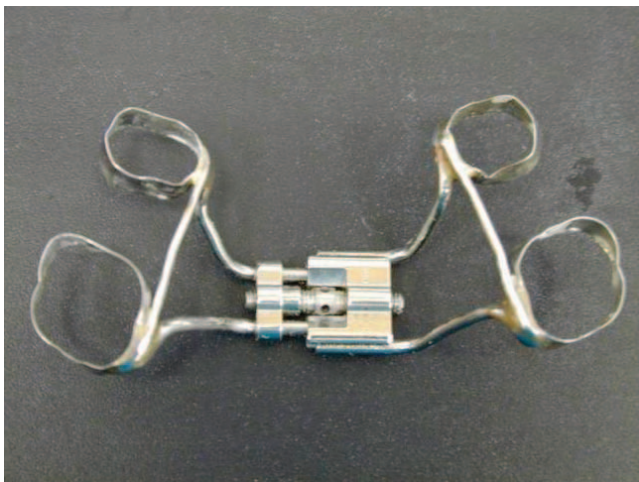
Figure 1. Rapid maxillary expansion appliance (RME).

The treatment plan consisted of rapid maxillary expansion followed by combined surgical and orthodontic treatment with the use of fixed appliances. Orthodontic treatment was started in January with surgically assisted rapid maxillary expansion (RME). The RME appliance consisted of a stainless steel expansion screw Hyrax II (Dentaurum 1.000 SS; 1.003 SS/remanium; 1.002 SS, nickel content 8% to 10%; Dentaurum, Ispringen, Germany) and four bands (Trimline 18/8 SS; Ormco Corp, Orange, Calif), which were soldered to the arms of the screw in the laboratory (Figure 1). Before the appliance was inserted, the patient's eventual allergic response to the appliance material was tested by fixing four identical stainless steel orthodontic bands to the patient's upper molars and premolars for 7 days. No adverse reactions were detected during the test period.

When two metals come in contact, corrosion of the less precious metal is increased. Silver soldering has been shown to increase nickel release from stainless steel arch wires.¹³ The RME appliance, because it is made of stainless steel and includes several silver-soldering seams, may have leaked nickel to an extent that exceeded the individual threshold of our patient. Whether the allergic reaction would have occurred similarly to that seen with standard fixed appliances can only be speculated upon. As to orthodontic brackets and arch wires, gold-plated devices are available in the market and may be an option for nickel-allergic patients in selected cases, whereas individual gold

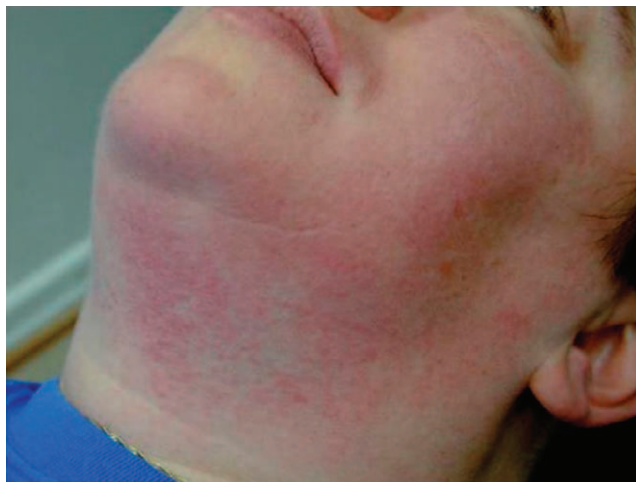
One week after cementation of the RME appliance, the patient awoke at night to heavy itching on the face and detected a red rash with tiny papules on the chin, cheeks, and neck. She also reported symptoms in the eyes and described them as similar to those caused by birch pollen. Clinical examination on the same day showed itchy papular erythema, which covered the skin from the cheeks to the chest (Figure 2). No intra-oral objective or subjective symptoms were present. The RME appliance was removed, and symptoms disappeared in 4 to 5 days. Two weeks later, the patient experienced a similar type of reaction with itchy rash and vesicles extending far from the contact site, caused by her old imitation-jewelry necklace, the wearing of which she had previously tolerated. The patient declined further orthodontic treatment because of the hypersensitivity reactions.

Figure 2. Allergic reaction on the skin caused by wearing the rapid maxillary expansion appliance (RME).

white petrolatum), 1% cobalt chloride, and 1% palladium chloride. Test results were read on the four and seventh days after placement of the patches. The patient showed a strong positive (++) reaction to both nickel and cobalt, and palladium showed positive (+).
