EVALUATION OF STRUCTURAL DAMAGES FROM 3D LASER SCANS

J.I. SanJosé^{a,*}, J.J.Fernández-Martín^a, J.D. Pérez-Moneo^b, J. Finat^b, J. Martínez-Rubio^a

Fig.1: Laser scanning of Villamorón (Burgos, Spain)

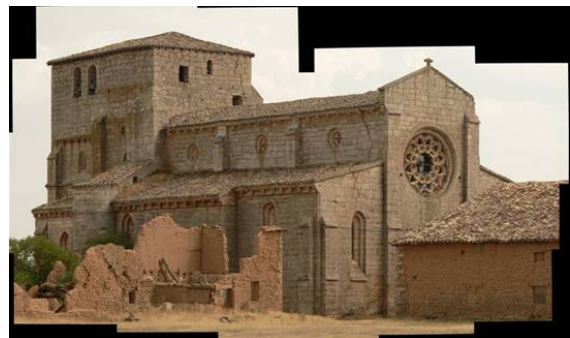
Fig.2: Panoramic View of the church of Villamorón (Burgos)

The western facade displays an important lack of verticality, which is in the issue of two large crashes going from the roof to the ground. In the head of temple, there appear serious crashes along windows which modify the continuity and the survival of structure. Inside, the vaults are apparently full of cracks and a meaningful number of stones located along arches are down-to-earth.

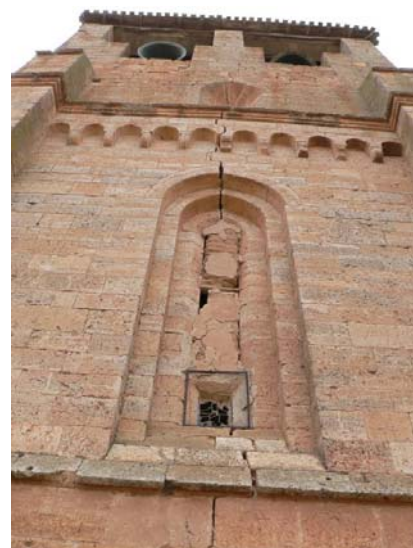
Fig3: Vertical crashes

Crashes are especially meaningful in the second part of the central nave, where lateral walls are literally detached from the roof. A large number of crashes appear also in the beginnings of arch nerves with walls.

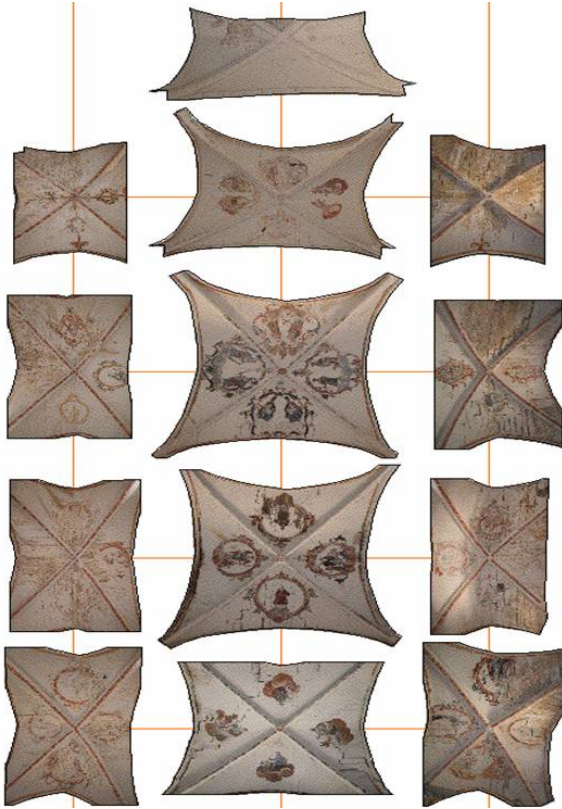
Fig.4: Visualization of the current state of the roof

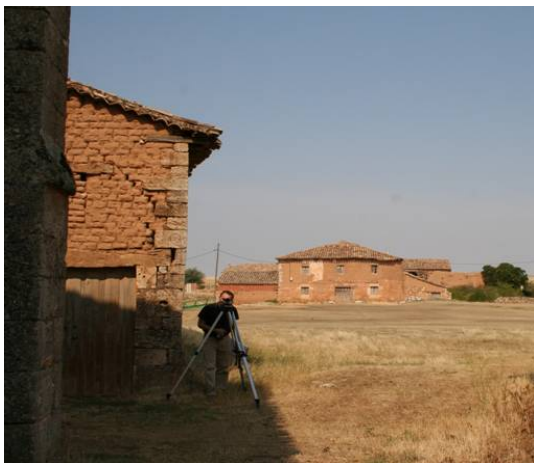
For granting a common general reference for the model, the clouds of points are referred to a superabundant mesh of reference points corresponding to the exterior and interior of the church. Levels have been verified with an automatic equi-heightmeter Pentax AL320.

Fig.5: Data capture in the outdoor for topographic network

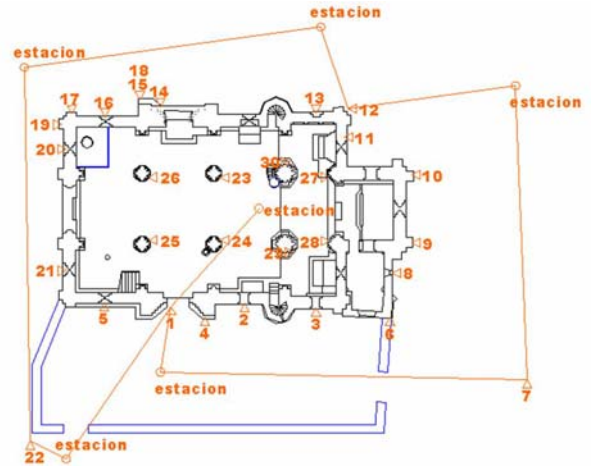
Fig.6: General representation of the topographic network

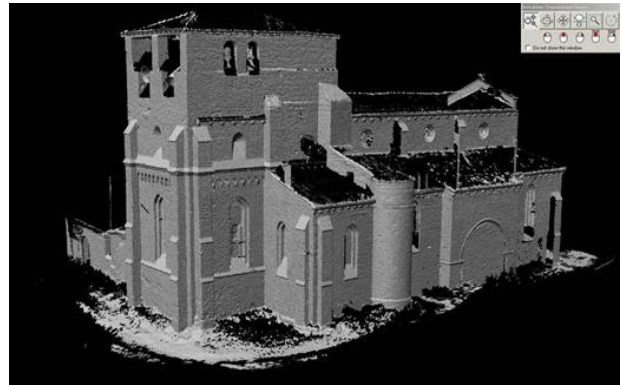
A dedicated software (Polyworks, Innovmetric) is used for registering, and match different scans in a global 3D model.

Fig.7: A general 3D representation of the outdoor

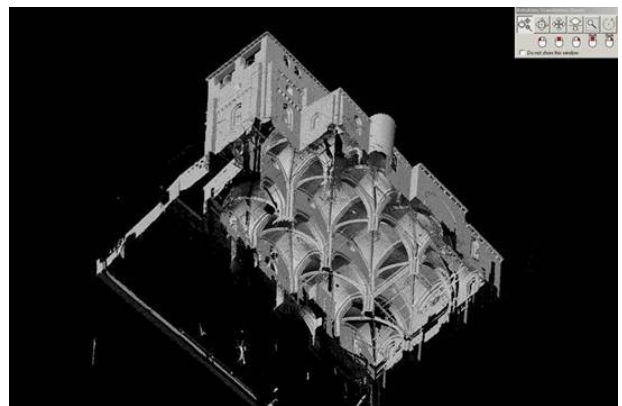
A more involved covering of scans of temple's interior provides a global model. By selecting a small number of common points, the interior 3D model is matched with the exterior model. In this way, a global model (including indoor and outdoor) is obtained:

Fig.8: An axonometric view of the global model

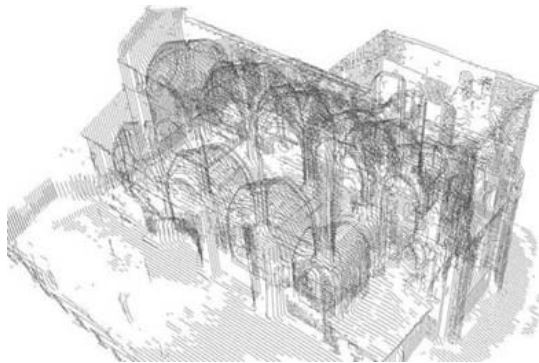
Fig 9: A map of sections along two families of equidistant vertical planes.

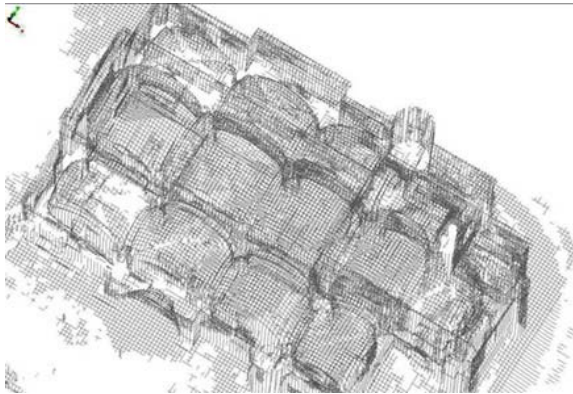
Fig 10: A map of sections along horizontal and vertical planes.

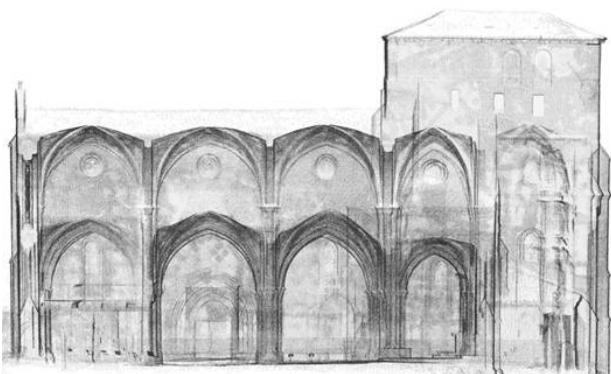
In particular, a collection of profiles is generated, and a parametrization following a rectangular mesh superimposed to the global 3d model. A visualization of the maps of superimposed longitudinal and transversal profiles corresponding to sections each 24 cm is showed in the next figures:

Fig 11: A map of longitudinal sections

The reprojection of sections on a common vertical plane of reference along the main longitudinal provides an information about meaningful deviations, mainly towards the West façade.

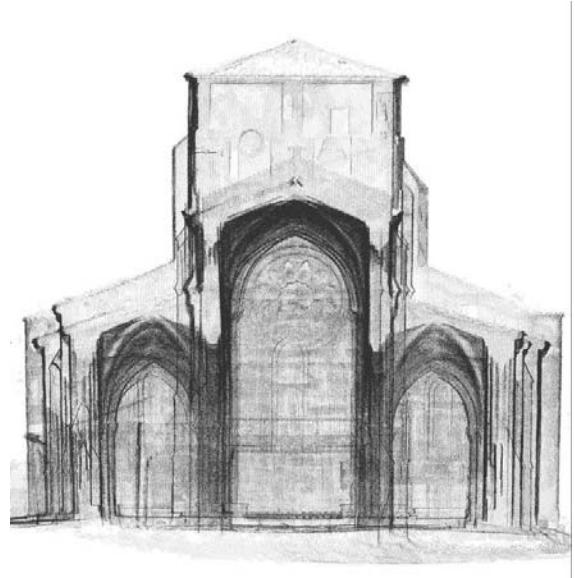
Fig 12: A map of transversal sections

In a similar way, the superposition of transversal sections on a common vertical plane allows to identify meaningful deviations of vertical walls towards the East façade.

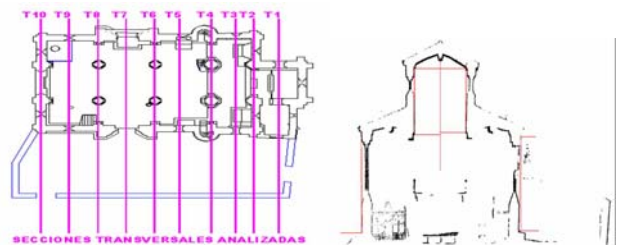
From the performed sampling of transversal sections, it is possible to verify that the main lack of verticality corresponds to the exterior south façade. It is comprised between 1.3 and 1.8 degrees.

Fig 13: A sampling of transversal sections for structural analysis

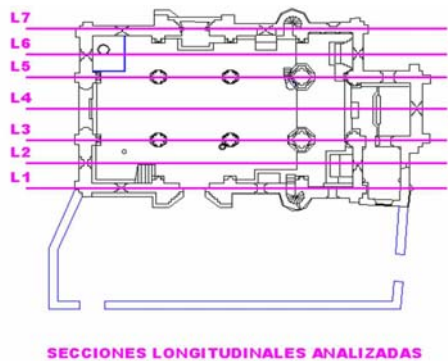
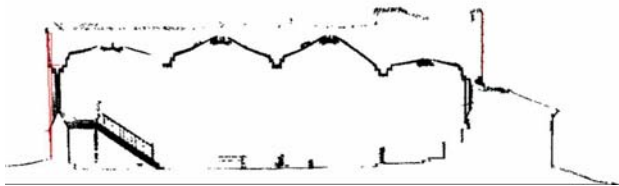
From the performed sampling of longitudinal sections, it is possible to verify that the main lack of verticality corresponds

to the exterior west facade. It is comprised between 0.5 and 2.8 degrees.

Figure 14. The map of analyzed longitudinal sections

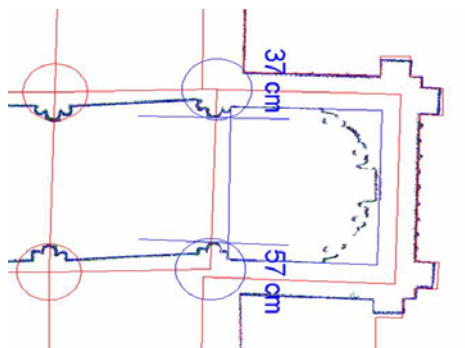
The axis of the south wall of the church head does present a discontinuity with respect to the axis of columns of the principal nave with a difference of 25 cm. The error is performed in the ampliation phase of the building construction from Romanesque to early Gothic style. In particular, supports are localized in different places and the axis of the network of pillars and half-pillars are not located following an exactly orthogonal disposition, but with angles around 88°.

Furthermore, the angle defined by a) the longitudinal axis defined by pillars separating the major of the south naves, and b) the axis defined by half-pillars in the south wall, presents a displacement in intermediate zones which is comprised between 8 and 10 cm. In symmetric axis with respect to the longitudinal axis of the central nave the difference is comprised between 2 and 3 cm.

Fig.15: An identification of misalignments in plant

By taking an ideal slice below any column chapitel, it is visible the variation generated in the alignment of axis, and the displacements of walls with respect to alignments of axis. This

effect is remarkable in the head of temple, where evident discontinuities in alignments induces to think of two different phases in the construction.

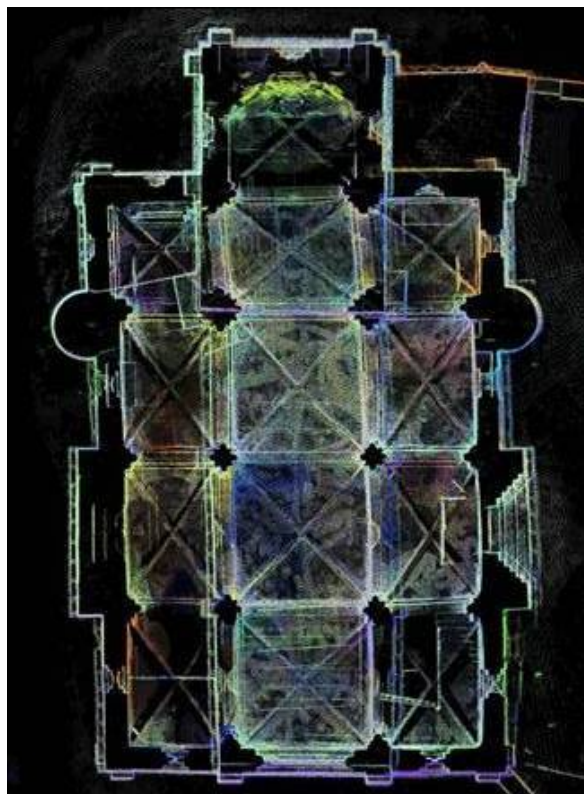
The worse lack of verticality involves to some zones of the south wall with 38 cm in 316 cm, giving a dangerous inclination of 6.72 degrees, where some vestiges of a Roman cisternae have been identified.

Fig.16: A general representation of the roof with appreciate structural defaults.

The structure is far from being stabilized. Indeed, recent corner stones falls and the crashing of the cementation (possibly due to water filtration, near to the Roman cisternae) induce to think a partial or total collapse of the building in the next future if there is no intervention. Luckily, after this work some consolidation interventions are in course of execution, currently.
