Flexural performance of fire damaged and rehabilitated two span reinforced concrete slabs and beams

Jiang-Tao Yu*¹, Yuan Liu¹, Zhou-Dao Lu¹ and Kai Xiang²

¹Research Institute of Engineering & Disaster Reduction, Tongji University,
Siping Rd, Shanghai, 200092, China

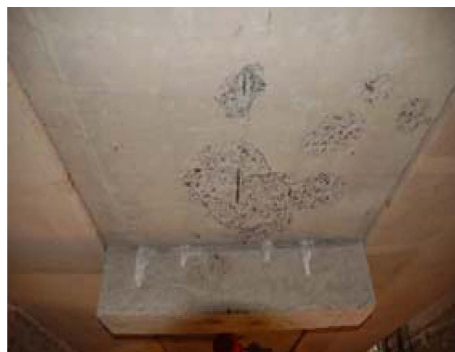
Fig. 5 Spalling on the bottom of slab

All the specimens were exposed to the ISO834 standard fire. In the heating process, visual cracks, perpendicular to the longitudinal direction, were observed at the upper surface near the middle support. The formation of cracks was expected as the combined effects of temperature, support constraint and applied load. After fire, explosive concrete spallings, about 15 mm in depth, were observed at the soffit surfaces of slabs and beams, as shown in Fig. 5. The other observations about the fire tests, such as color variations and thermal deflections of test specimens, are not included in this paper.

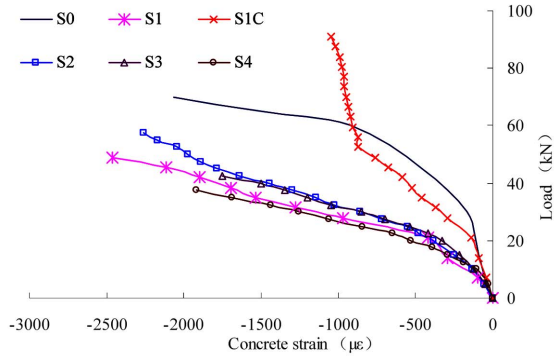
Fig. 12 Load-strain curves of concrete at the bottom surface near the middle support

Fig. 12 shows the strains of concrete at the lower surface of the hogging moment region. The compressive strains of concrete, even at the beginning stage, are obviously larger than that of S0. Comparing the strains of S0 and S1C, the effect of damaged concrete replacement is limited at beginning but remarkable at the latter stage. The load-strain curves of concrete at the upper surface of sagging moment region are shown in Fig. 13. Although the concrete in the upper layer was not directly exposed to fire, there are still differences in strain response among specimens. This may be attributed to the variation of moment redistribution from the hogging moment region towards the middle support.
