RECENT MORPHOLOGICAL CHANGE AT THE NARUSE RIVER MOUTH, JAPAN

Abstract: The Naruse River mouth showed stable topography at least for these 46 years. However, sediment deposit occurred in July 2002, which caused difficulty in ship operation going in and out of a port located in the river mouth. In addition, the behavior of the morphology of the river mouth after the flushing of the sand spit on the left-hand side has never been observed for these 50 years. In this paper, characteristic morphological change at the Naruse River mouth is shown with the use of aerial photographs and morphological maps. Furthermore, time-variation of water-level in the river mouth is compared with tidal variation. From this analysis, it can be concluded that the river mouth closure has occurred just before the flushing of the sand bar in July 2002.

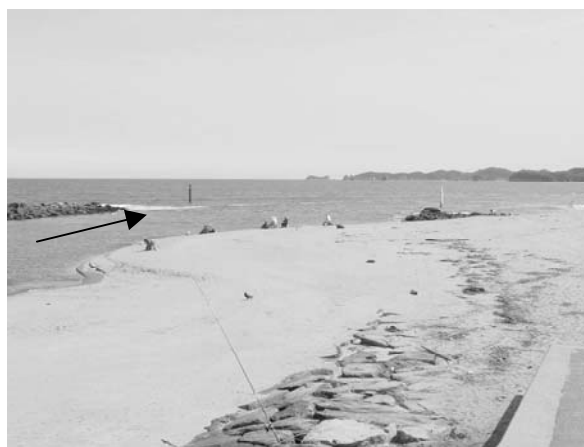
Photo 1 Naruse River mouth in 1998

The mouth of the Naruse River is located on Ishinomaki Coast, Japan as shown in Fig.1. The catchment area is 1,133km², and the length of mainstream is 89km. The Nobiru water level station is located in the river mouth about 0.5km upstream from the mouth. The river mouth is characterized by two training jetties along with fully developed sand spit on the left-hand side of the river mouth, as seen in Photo 1.

Almost all of the aerial photographs, which have taken since May 1956 to May 2002, show very stable topography of the river mouth as seen in Photo 1.

Photo 6 shows stable topography of the river mouth in 1956. In Photo 6, the sediment deposit between the jetties is not seen and the sand spit on the left-hand side of the river is fully developed, as same as Photo 1. It is supposed that sediment deposited inside the jetties was removed artificially, because there was no big flood between 1952 and 1956.

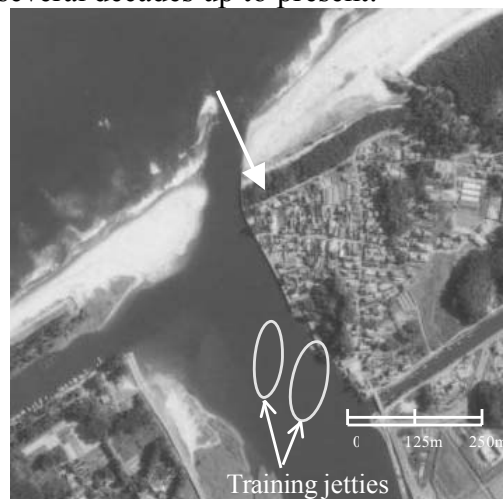
Photo 2 shows the sediment deposit observed between two jetties in July 2002. Considerable amount of sediment deposit can be seen on the right-hand side of the river between the jetties, by which almost half of the river mouth width was closed. Such a severe river mouth closure has never been observed for these several decades up to present.

Photo 2 Sediment deposit between jetties(Jun.14, 2002)

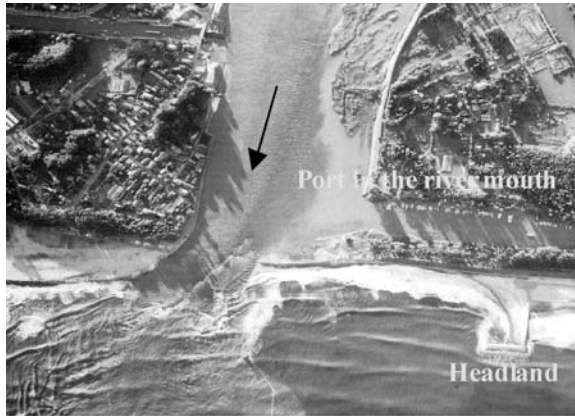
The sand bar between the jetties and the sand spit on the left hand-side were flushed during a flood in July 2002 as shown in Photo 3, in which one of the eight headlands can be seen on the right hand-side of the photograph.

Photo 3 Flushing of the sand bar
(Nov.7,2002)

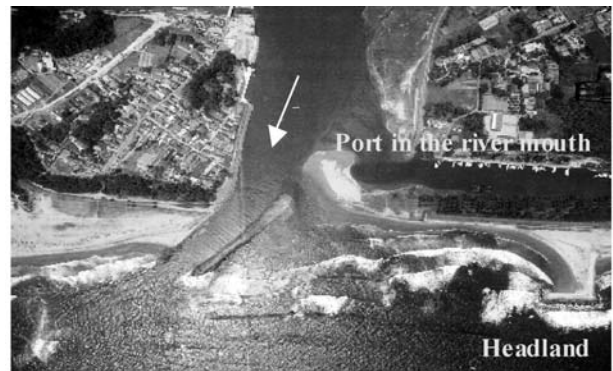
After the flood, the sand spit migrated into the river, as seen in Photo 4. The migrating sand spit caused difficulty of ship operation around the port in the river mouth. Another

concern is destruction of the river bank and the port in the river mouth caused by waves propagating through the gap between the sand bar and jetties and over the sand bar.

Photo 4 Migration of sand bar into the river
(Jul.27,2002)

River mouth topography similar to Photo 4 can be seen in Photo 5, which was taken in 1952 after two extremely big floods in 1947 and in 1948. In this photograph, the sand bar on the left-hand side of the river migrated inside of the river and the river mouth between the jetties was closed completely.

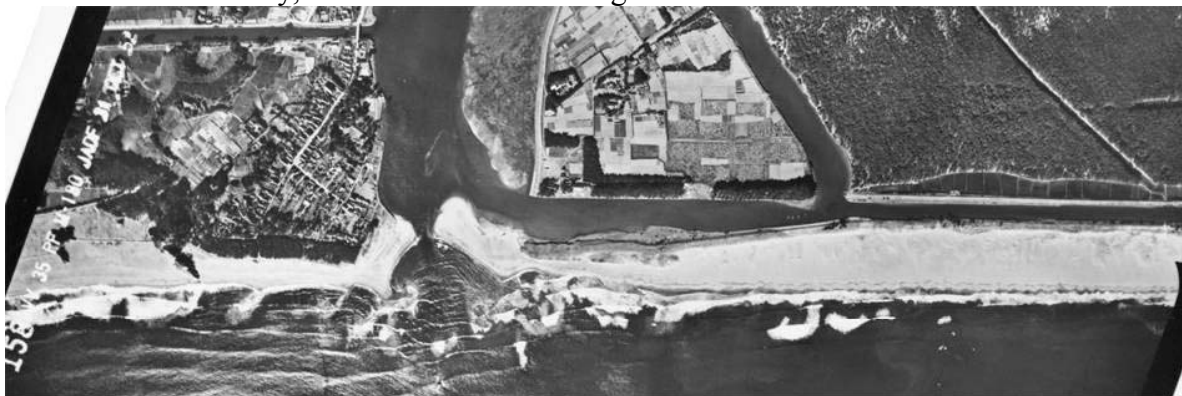
Photo 5 Naruse River mouth in October 1952

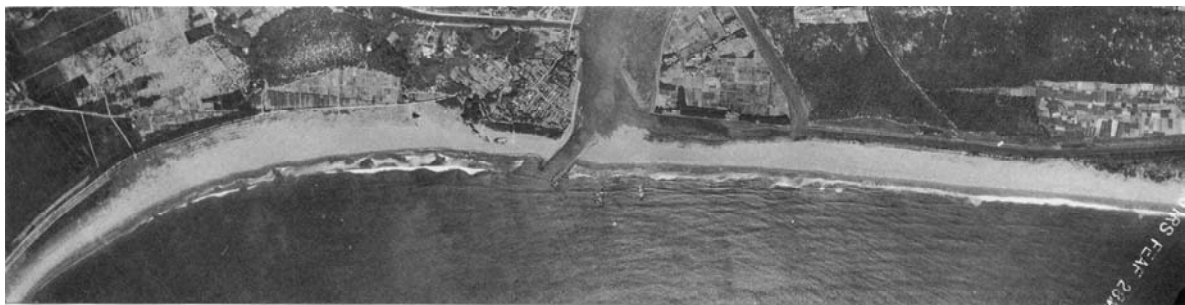
Photo 6 Naruse River mouth in June 1956

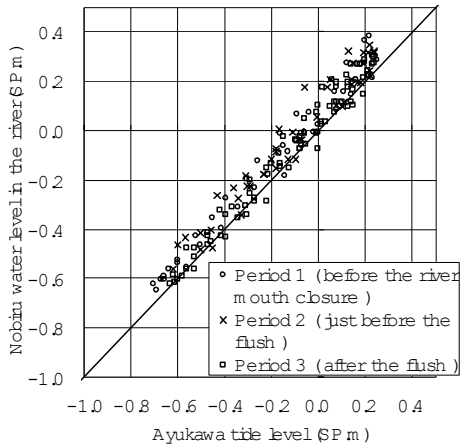
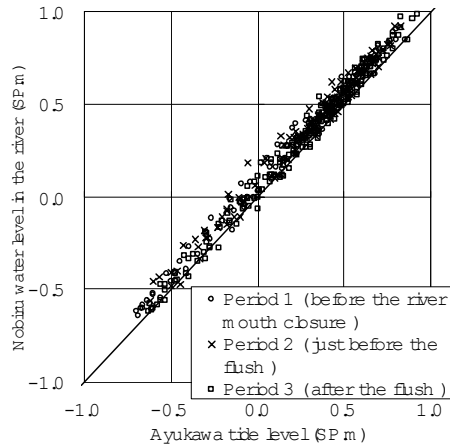
The relationship between water level and tidal level is shown in Fig.4(a). To remove the effect of the river discharge, the relationship is plotted only for the period when the river discharge is smaller than $40\text{m}^3/\text{s}$. Fig. 4(b) is the relationship while tide level is lower, i.e., the tidal level is lower than S.P.+0.25m.

Fig. 4(a) The relationship between water level and tide level

Fig. 4(b) The relationship between water level and tide level

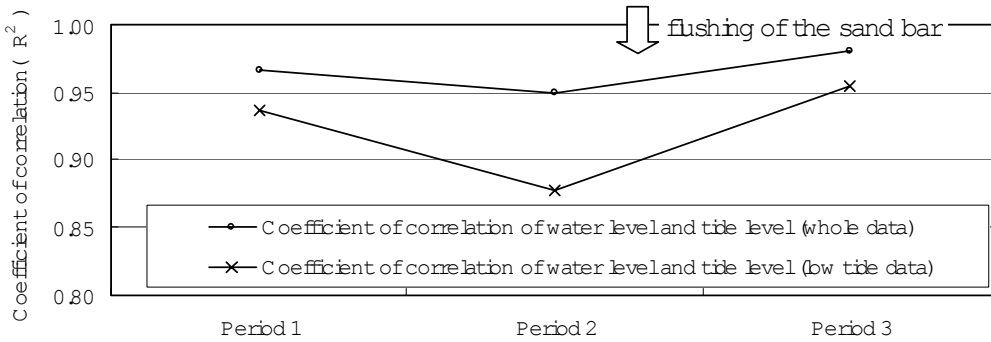
Temporal variation of correlation coefficient for these three periods is shown in Fig.5. The coefficient is smallest during Period 2 immediately before the flushing of sand spit. This trend is more clearly observed during lower tide. Therefore, it is concluded that the river mouth closure was occurred just before the flushing of the sand spit.

Fig. 5 Coefficient of correlation between water level and tide level

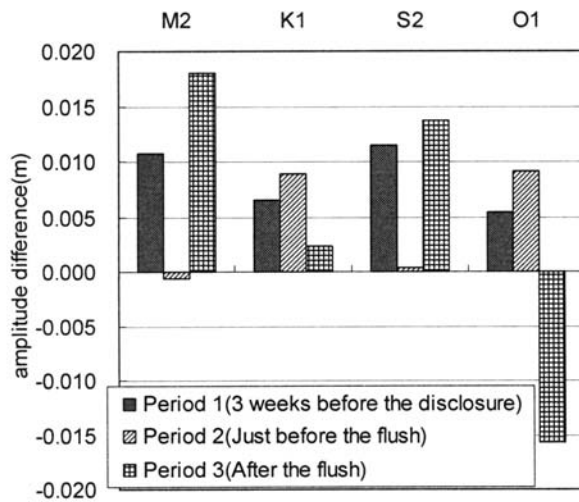
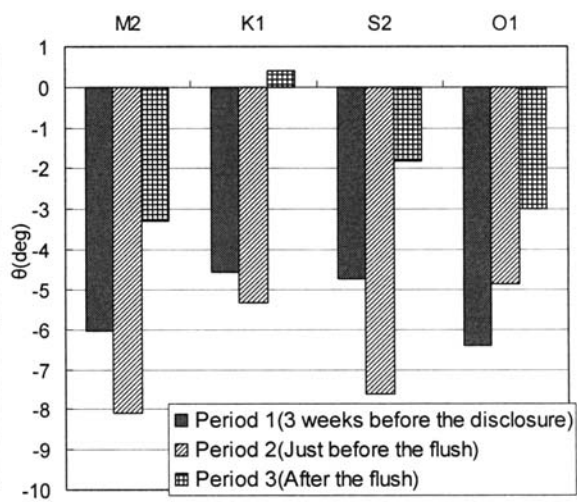
Harmonic analysis is applied to the time-variation of the water level and tidal level for the three periods. Fig. 6 and 7 show the amplitude difference and phase difference between water level in the mouth and tidal level, respectively. In these figures, M2, K1, S2 and O1 denote principal lunar semi-diurnal tide, luni-solar diurnal tide, principal solar semi-diurnal and principal lunar diurnal tide, respectively. Although the amplitude difference is very small in Fig.6, remarkable phase difference can be seen in Fig.7, especially for M2, K1 and S2 during Period 2 just before the flushing. From this analysis, it is concluded that the river mouth closure has occurred immediately before the flushing of the sand bar.

Fig. 6 Amplitude difference between water level and tide level for principal tidal constituents

Fig. 7 Phase difference between water level and tide level for principal tidal constituents
