The influence of plasterboard clad walls on the structural behaviour of low rise residential buildings

Y.L. Liew and C.F. Duffield

ABSTRACT

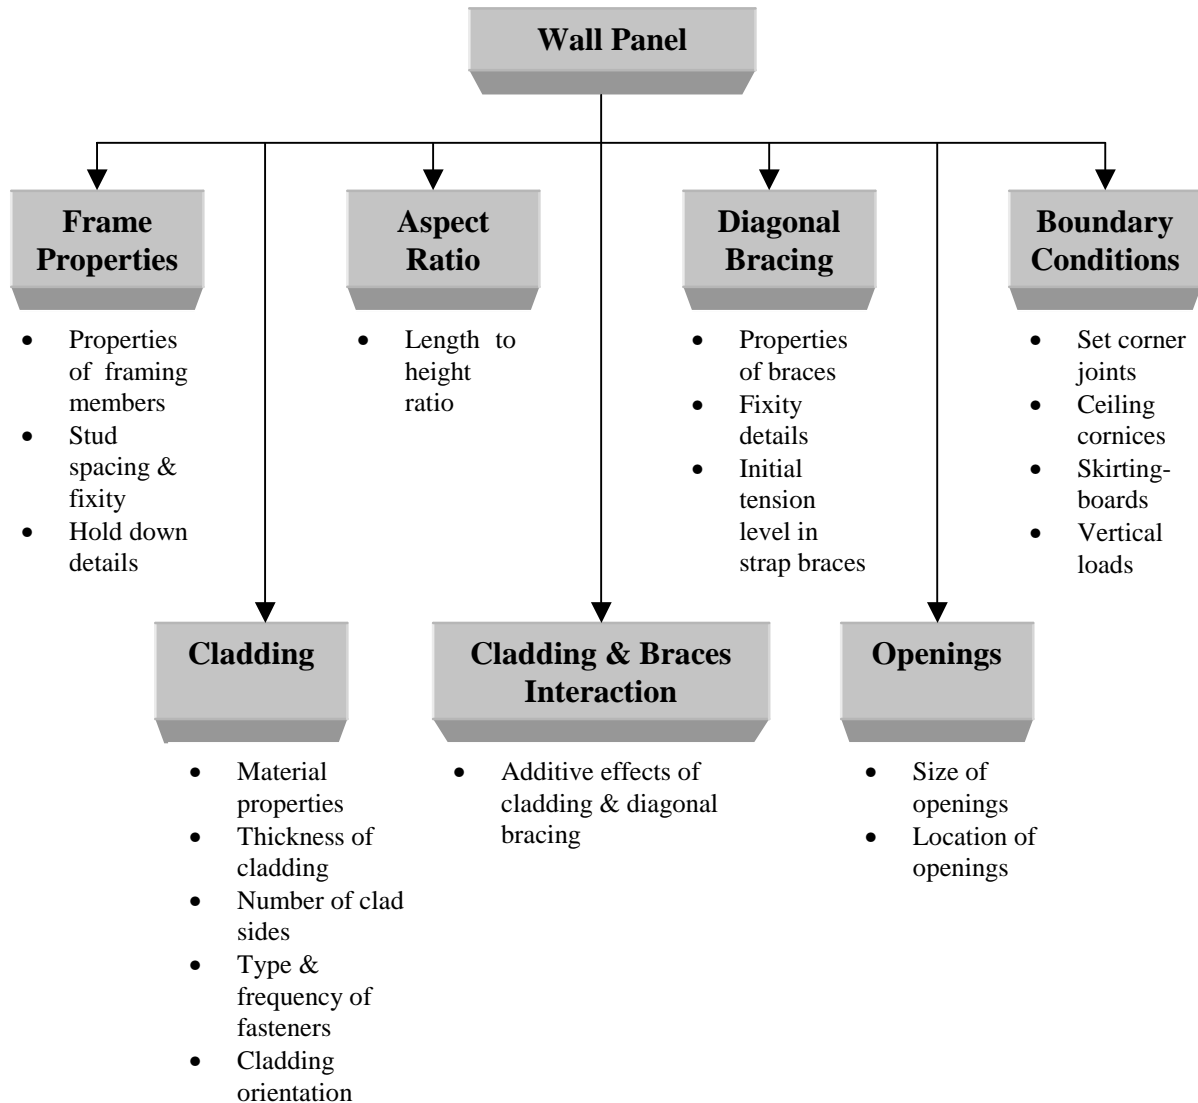
Fig. 2 Factors affecting wall panel behaviour under lateral loading. (Gad et al. [9]).

The lateral capacity of the bracing walls is quite complex and depends on factors such as material properties, configuration of the frame and the connectivity of all components. Factors that may influence the lateral capacity of wall panels are summarised in Fig. 2. Some of these factors have been investigated by various researchers such as Reardon [1], Barton et al. [3] and Gad et al. [4] in Australia; Wolfe [5], Tarpay [6], and McCutcheon [7] in the United States. A major finding from these investigations was that plasterboard lined walls, a non-structural component, contribute significantly to the lateral strength and stiffness of these light framed structures. The magnitude of this contribution was quantified by testing full-scale houses and assemblies by Reardon [8] and Gad et al. [9]. Gad et al. [9] found that plasterboard, combined with ceiling cornices, skirting board and set corner joints resisted 60% to 70% of the lateral load compared to a contribution of only 30% to 40% by strap braces.

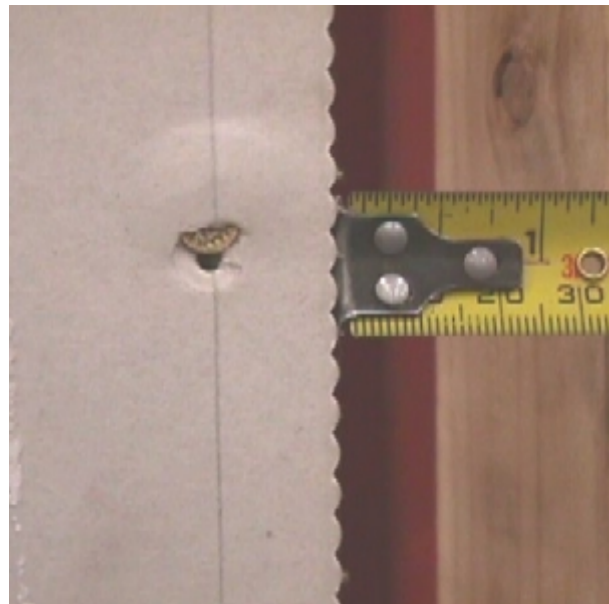
Fig. 5 Typical failure mode of a nail connection between plasterboard and frame in shear. (Note: Tearing of plasterboard and embedment of the nail head within the thickness of the board).

An example wall, shown in Fig. 4, illustrates the mobilisation of non-structural partition walls. It is assumed that this wall is not connected to any other adjacent walls. In this case the lateral loads (assuming wind load) would transfer from the roof (1), into the ceiling diaphragm (2), then to the ceiling cornices (3), into the wall plasterboard (4), then to the wall frame (5) (via the plasterboard fasteners) and finally to the floor (6). In this case the ultimate failure mode involves the tearing of the plasterboard around the nails or screws fixing it to the frame as shown in Fig. 5.

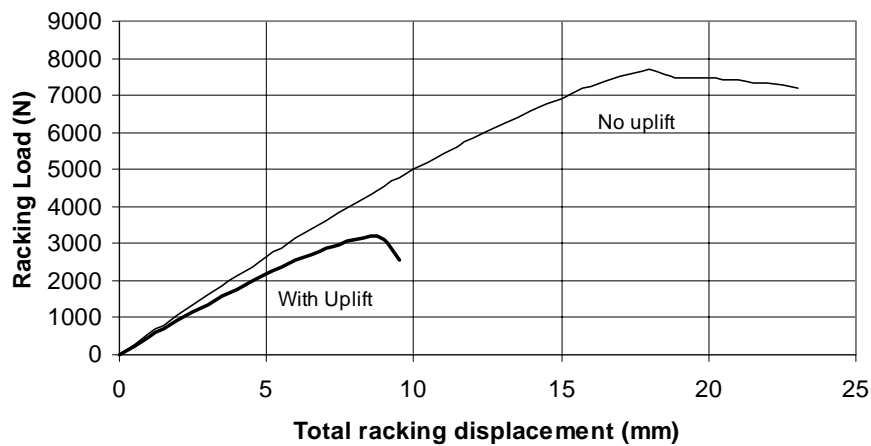
Fig. 12 Load-deflection curves for two plasterboard-clad walls with and without stud uplift

The bottom plate uplift does not reduce the racking capacity of the wall but decreases the stiffness. On the other hand, when stud uplift takes place, the ultimate capacity is reduced due to the premature failure of the connections between the cladding and the frame along the bottom plate. This is demonstrated by the load-deflection curves shown in Fig. 12 for two plasterboard-clad timber-framed walls each measuring 2.4m x 2.4m. These curves are obtained from a detailed Finite Element model [19] based on screw connections between the plasterboard and the frame, which are located at 150mm centres along the perimeter and 300mm along the intermediate studs.

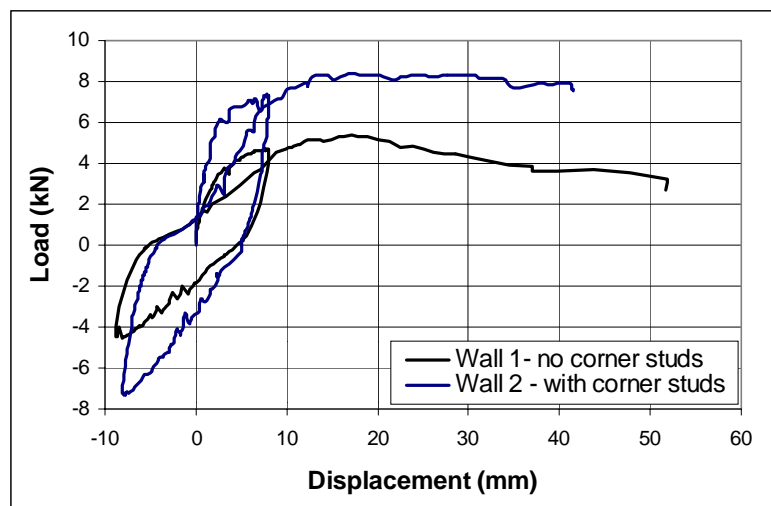
Fig. 3 Load-deflection curves for Walls 1 and 2.

The load-deflection curve for Wall 1 is shown in Fig. 14. The load path for this wall was similar to Mechanism A described in Section 4.2. It was observed in this test that the tearing of the plasterboard around the nails connecting it to the frame was not symmetrical (i.e., at the top and bottom of the wall). Indeed, the damage was concentrated at the top of the wall. The studs experienced excessive deflection at the top of the wall as shown in Fig. 15.

The load-deflection curve for Wall 2 is shown in Fig. 14. Wall 2 exhibited load transfer similar to Mechanisms A and C, which were described in Section 4.2. When the plasterboard was installed, a gap of approximately 2-3 mm was left between its vertical edges and the corner studs. Hence, the initial load path involved the lateral load being transferred from the frame to the plasterboard only through the connecting nails. As the frame deformed and the plasterboard rotated, the gap closed and the plasterboard started to bear against the corner stud at two diagonal corners, as shown in Fig. 16. This led to crushing of the plasterboard at these corners, as depicted in Fig. 17. Wall 2 achieved a maximum load approximately 50% higher than that for Wall 1.

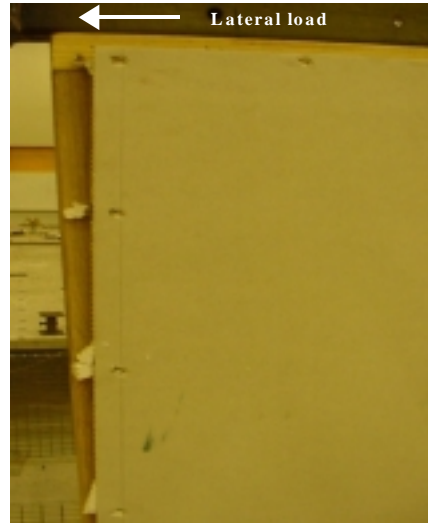
Fig. 4 A photo of a top corner of Wall 1 at displacement of about 35mm showing deflected shape of the end stud and failed plasterboard nail connections.

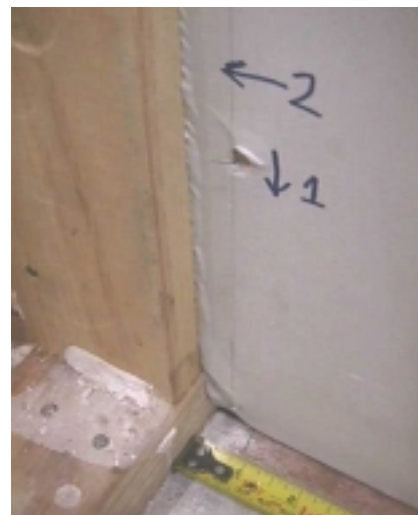
Fig. 6 A photo showing the plasterboard bearing on the corner studs for Wall 1 (as per bottom left corner of Fig. 16).

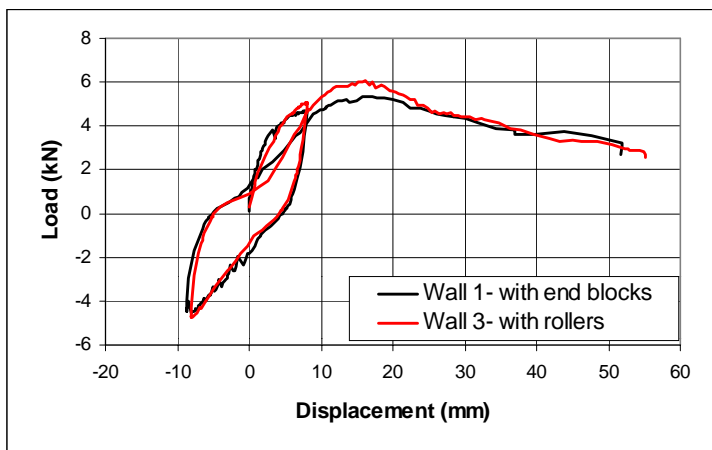
Fig. 7 Load-deflection curves for Walls 2 and 3.

Wall 3 exhibited almost identical behaviour to Wall 2. The load-deflection curves for Walls 2 and 3 are compared in Fig. 18. Both walls reached almost the same maximum load and both failed in the same manner, that is by tearing of the plasterboard around the nails at the top of the wall. The failure mode of Wall 3 is depicted in Fig. 19. It was observed in walls 2 and 3 that some intermediate stud uplift was taking place, however this was not large enough to cause premature failure.

The load cell measuring the uplift on Wall 3 (refer to Fig. 18) recorded a maximum force of approximately 5 kN which occurred at the ultimate racking load (approximately 6 kN). It is expected that the end block on the tension side for Wall 2 experienced similar uplift force and it was able to sustain that level.

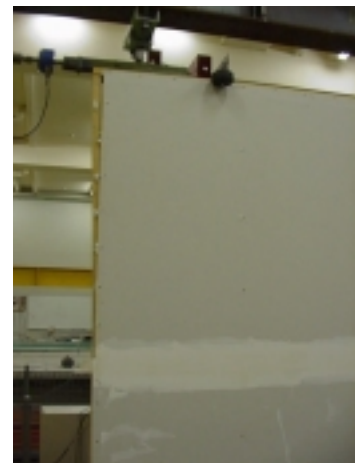
Fig. 8 Photo depicting the failure of Wall 3 (wall is pulled to the left).
