Submerged Cultural Resource Management on the Last Frontier: Reconnaissance, GIS Mapping, and Biotic/Geochemical Characterization of Threatened Shipwreck Sites in Southeast Alaska

Abstract

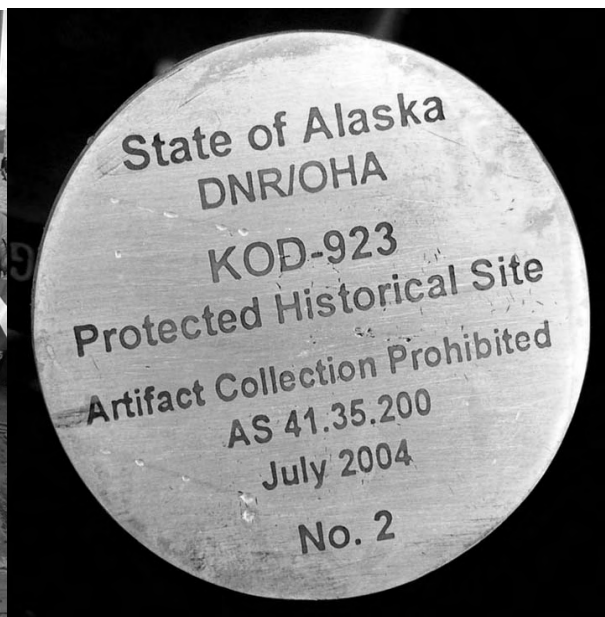
Figure 2. Example of one of the brass survey cap placed on the wreck sites, inscribed with the AHRS site number and proclamation of the site's protected status under State law.

To ensure that visitors to the sites are aware of their protected status, engraved brass survey caps were placed at the visited wreck sites, along with engraved plastic tags, identifying the wrecks as heritage sites protected under state law (Alaska Statute 41.35) (Figure 2). Finally, the team collected GPS data for each wreck site, deploying pelican buoys from key features when possible. The data were used to update the Alaska Heritage Resources Survey (AHRS) database, the official inventory of Alaska's archaeological and historical sites. AHRS data are available to land and resource managers, as well as to authorized researchers, but are restricted from public access due to potential for site vandalism. The coordinates will also be used to update the MMS shipwreck database and incorporated into their GIS product. Like the AHRS, the MMS database withholds specific coordinates from public access to help protect the resource. Data is also being provided to NOAA, who plans to conduct a hydrographic survey at the *Clara Nevada / Hassler* site in support of archaeological recordation efforts.

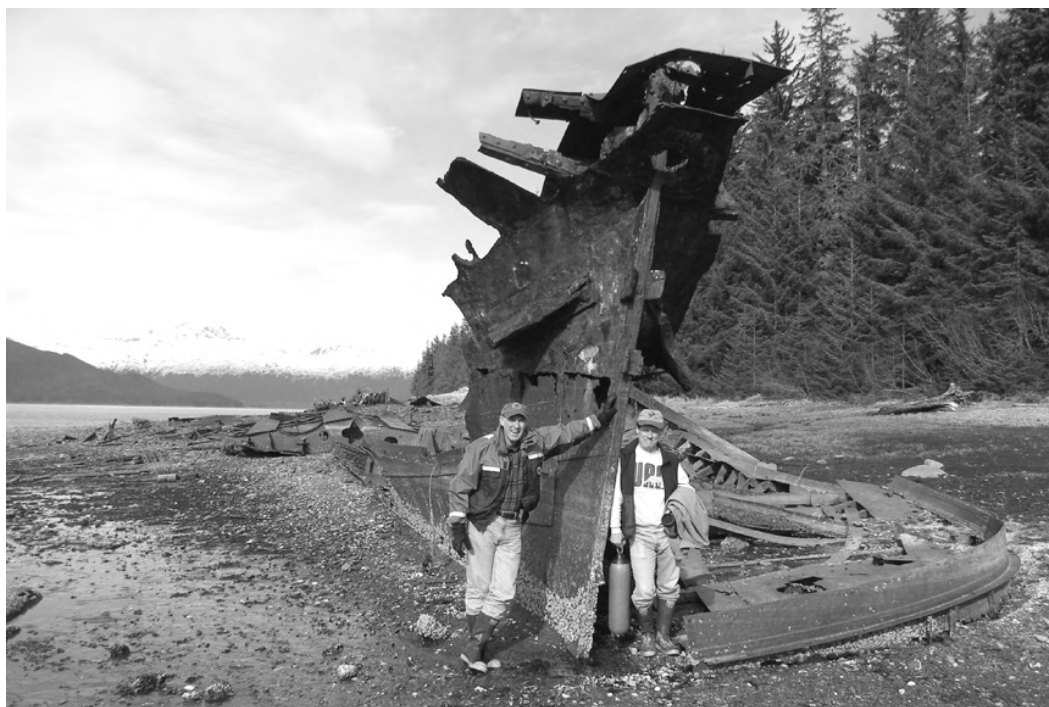
Figure 8. Stephen Jewett (L) and Ed Grossman (R) by the steamer *Islander's* sternpost in April 2006.

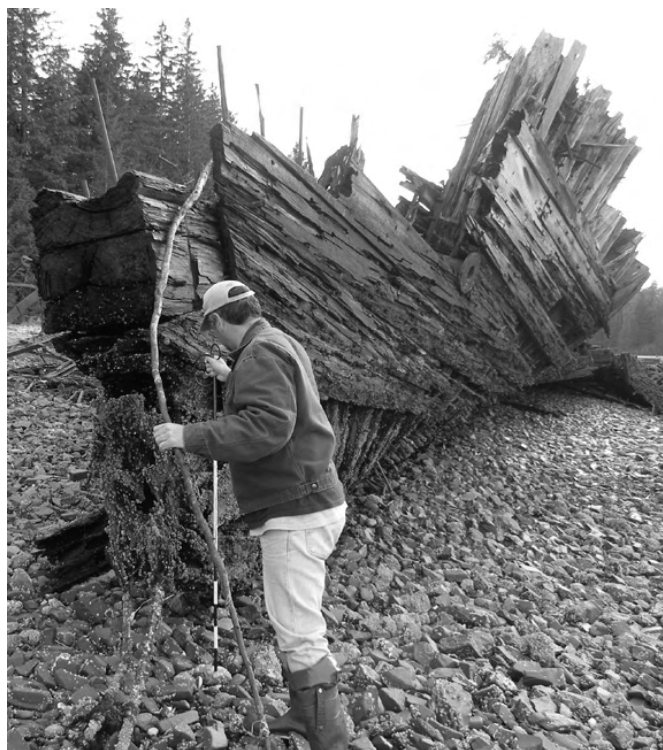
Figure 9. Hans Van Tilburg measuring the schooner barge *Griffson* wreckage in April 2006.
