Gold-Cobalt Electrodeposits

MICROSTRUCTURE AND SURFACE TOPOGRAPHY

S. J. Harris and E. C. Darby

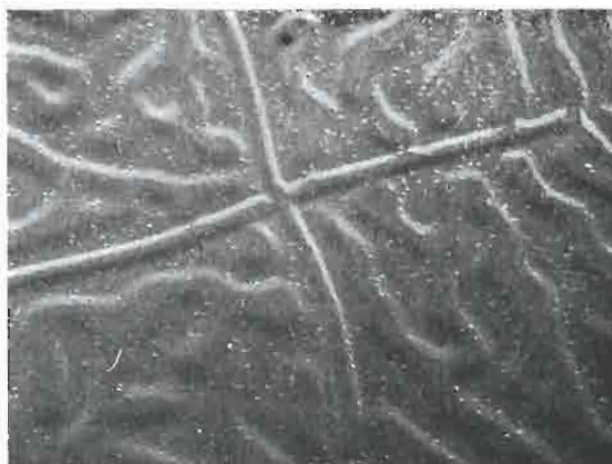
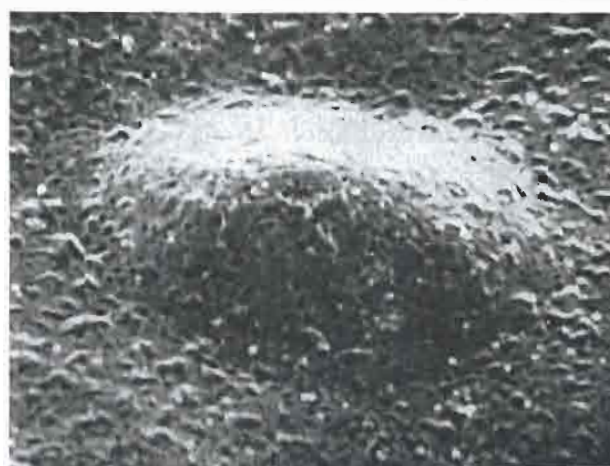
Fig. 4 Scanning electron micrographs of the surface of a gold-cobalt deposit after annealing for 1 hour at 400°C
Fig. 4a (top) ×40, Fig. 4b (bottom) ×4000

The surface of as-deposited gold-cobalt is extremely smooth and almost featureless when examined at a magnification of $\times 5000$ in the scanning electron microscope. However, when the deposits are heat treated changes begin to occur as the annealing temperature approaches 300°C. Examples of the changes in surface topography after treatment for one hour at 400°C are shown in Figure 4. At low magnifications, a series of ripples is resolved ($\sim 60 \mu\text{m}$ in width) evenly spaced over the whole surface. Distributed on the rippled peaks and valleys are numerous small apparently white features. Examination at higher magnifications resolve these features as hemispherical bubbles, each $\sim 15 \mu\text{m}$ in diameter. Increasing the magnification still further reveals a series of small pores over the whole surface; these pores have a diameter of $\sim 0.3 \mu\text{m}$ (Figure 4b). Also present are a number of surface protrusions of similar dimensions to the pores. Increasing the temperature of the annealing treatment above 400°C results in an increase in pore and protrusion sizes, together with an increase in the incidence of loose debris.

The degradation of the surface that takes place during this treatment may result from a number of sources: (i) relief of stress, (ii) expansion of gas, e.g. hydrogen, or from water occluded during electrodeposition, (iii) decomposition of the cyanide polymer and (iv) oxidation of the base metal component. On the basis of observations taken over the whole temperature range and relating wherever possible to the available insight

into internal microstructure of the deposits, it seems more likely that the major changes in surface topography have come about because of polymer decomposition. If damage of the kind indicated begins to take place during fabrication or after long periods in service then the effective surface area of contact will decrease appreciably and thus contact resistance will increase rapidly.
