DAMAGE TO CONCRETE BRIDGES DUE TO REINFORCEMENT CORROSION. PART I. SITE INVESTIGATIONS

Zenonas Kamaitis

Keywords: concrete bridges; concrete carbonation; chlorides; reinforcement corrosion.

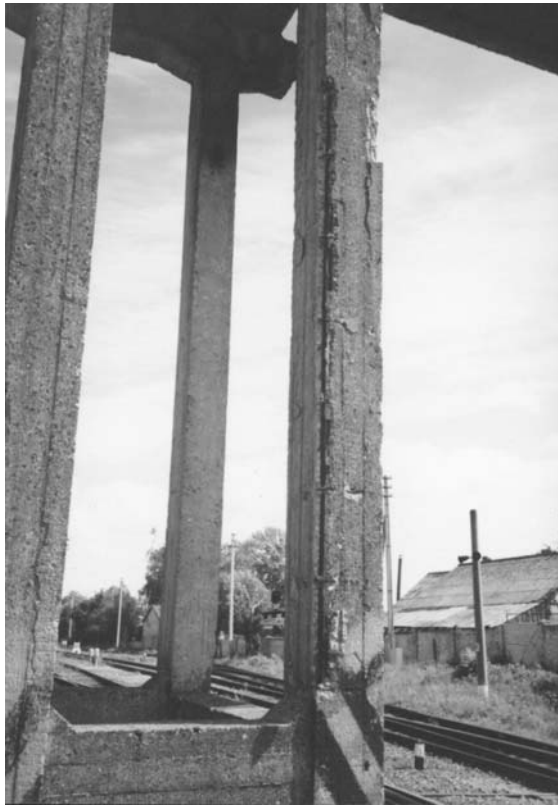
Fig 4. Corrosion of reinforcement of the multiple-column pier accompanied by cracking and deterioration of concrete cover

The measurements confirm that the placing of reinforcement often varies widely. In the investigated bridges poor control of cover was the most frequent cause of early corrosion of reinforcement (Figs 4 and 5). As it is mentioned above it is not uncommon to see delaminated and spalled areas even after few years of service.

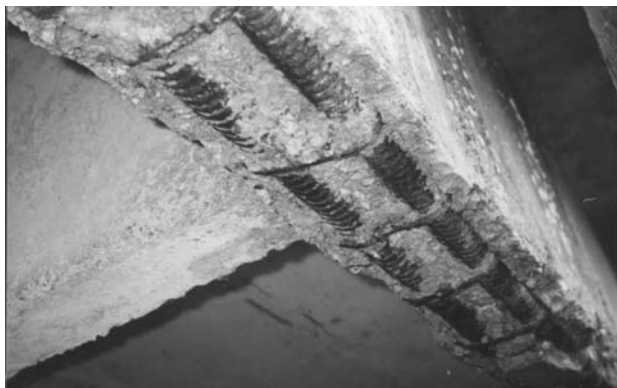
Fig 5. Debonding and corrosion of longitudinal bars and stirrups of reinforced concrete bridge beam

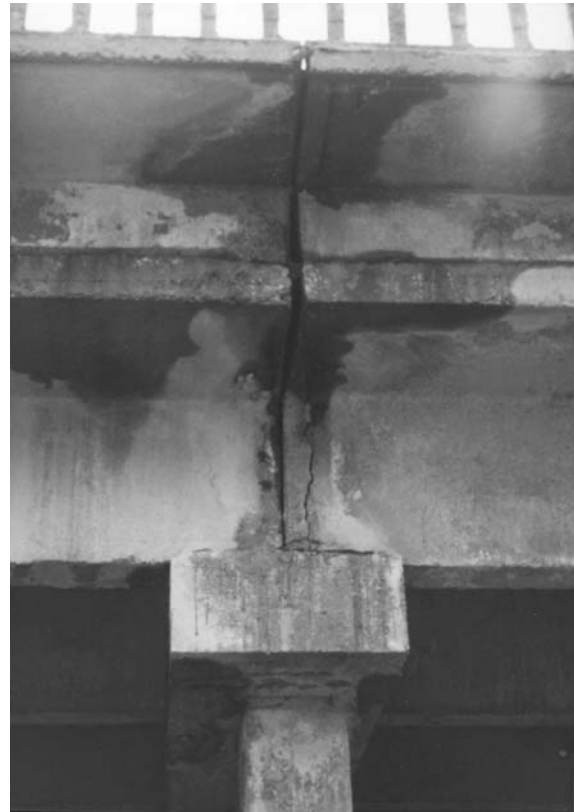
Fig 9. Deterioration of edges of beams and cap of pier due to leakage of expansion joint

For bridge super and substructures the process is much more complex. Deficiency of waterproofing system and expansion joints permit the penetration of water and de-icing salts to the caps of piers and abutments, edges of beams, bearings (Fig 9). The deterioration of bridge structures caused by chlorides is due to constantly changing amount of moisture as a result of improper drainage, concentration of chlorides, and the degree of concrete saturation.

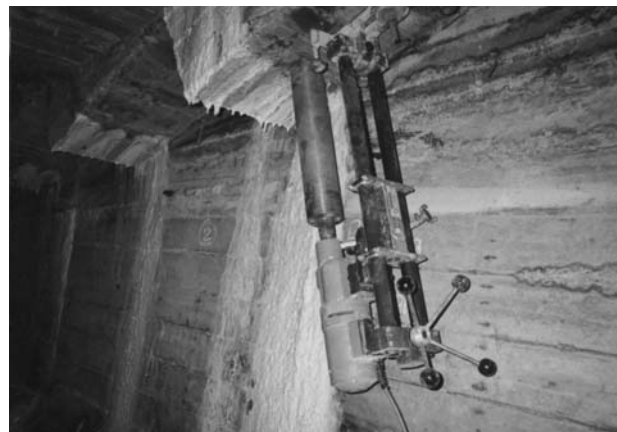
Fig 10. Special coring equipment for inspection of prestressed tendons and their ducts

The detection and evaluation of prestressed tendons condition were performed on existing pre-tensioned and two post-tensioned bridges after 16 and 23 years of service. In post-tensioned structures the inspection 60 and 100 mm diameter holes were drilled (Fig 10) and concrete samples were taken for laboratory analysis (Fig 11). It has been found that in the prestressed concrete precast post-tensioned bridge decks the voids and the water are often present in the ducts. The absence of grout in some parts

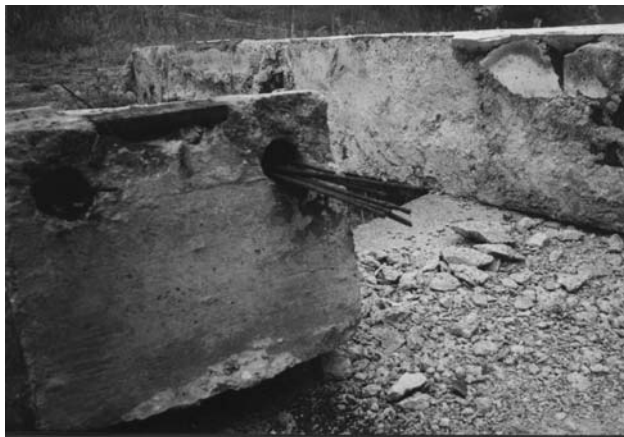
Fig 12. Rupture of bridge staircases due to corrosion of prestressed tendons

port of the UK decided no longer to permit any post-tensioned bridge with grouted duct tendons to be built [5]. In Switzerland three bridges were dismantled after 30 years (in 1992) of service due to significant corrosion damages [6]. Sudden collapse without prewarning of bridge staircases in Vilnius due to prestressed tendons corrosion and rupture can be mentioned (Fig 12).

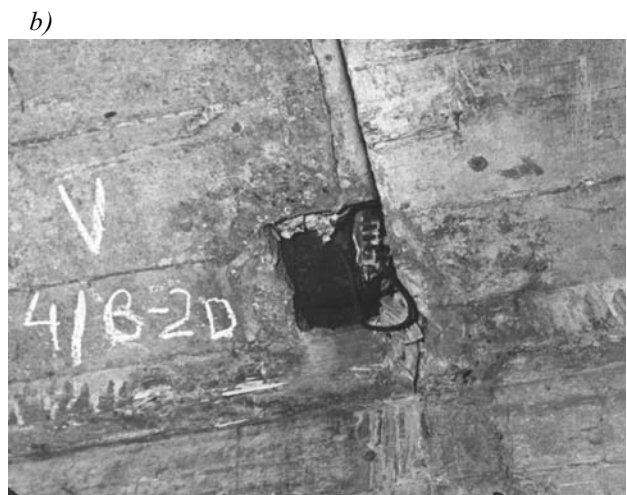
Fig 13. Corrosion of exterior anchors of tendons: a) – at the edge of simple beam; b) – at the joint of segmental post-tensioned bridge beam

The effect of leaking expansion joints is also the corrosion of anchors of prestressed cables (Fig 13) and areas of beam supports. Chloride contaminated water flows down to the lower flange areas and then penetrates into the concrete. In the pre-tensioned beams corrosion products around the prestressing tendons were observed losing their bond [7].
