MODERN SOLUTIONS TO ELIMINATE CAPILLARITY MOISTURE FROM BRICK WALLS – COMER METHOD

FLORIN-L. TAMAȘ and I. TUNS

Key Words: Waterproofing; Comer Method; Capillarity Moisture; Brick Wall; Holes; Wedge.

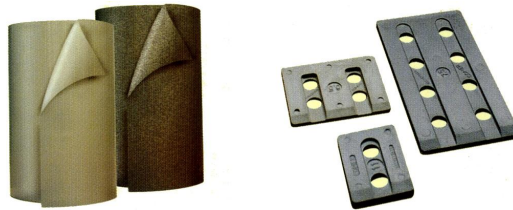
Fig. 1. – Foil with insulation characteristics and wedges for wall wedging.

The first stage consists in removing a certain height of the mortar from the wall. If the mortar is presented in very bad conditions, it is better to be removed before the completion of cut, to encourage, in this way, the process of evaporation. Then, a cut in the wall is made, on a specific length, with a special cutting machine which works with a chain with diamond teeth. In the horizontal slot a special foil (Fig. 1) is introduced. This foil works as a barrier against moisture (Fig. 2).

Wedges made from a special material are then introduced, in order to ensure wall stability in the slot.

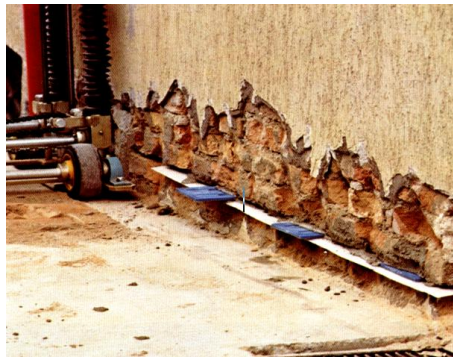
Fig. 3. – Placing wedges into the slot.

Normal procedure in such a method involves applying a mortar on insulating material, then the introduction of the plastic wedges anchorage into the slot. These wedges compress the mortar, securing insulating material and providing stability of the wall, until the mortar reaches required strength [1].

In this way the wedges are first placed into the slot, and then a non-contractile mortar is injected into the notch. This mortar not only penetrates into the wedges holes and the slot but also in wall's cavities, strengthening it at the base. The

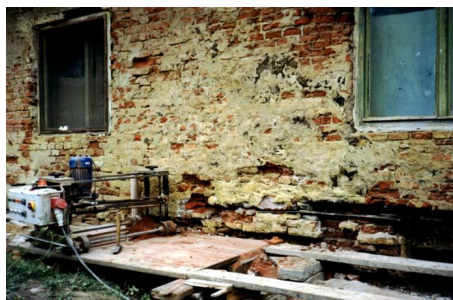
Fig. 4. – Previously described method applied on a brick wall.

mortar's maximum injection pressure is 2 atm. It is very important to wait until the wall is dried out deeply before applying a new layer of plaster.
