RESEARCH CONCERNING THE WATER SEEPAGE IN THE BASEMENT OF THE ORTHODOX CATHEDRAL OF BACĂU, ROMANIA

Abstract. Most basement water problems appear and it is always necessary to prevent and to eliminate them. If these problems occur at a new and very important building, the solutions must appear immediately. The paper describes the research made at the Orthodox Cathedral of Bacău, Romania, from the point of view of the water appeared in the basement and in the Civil Defense Shelter in the early 2007. The research used the results of two geotechnical profiles, which show bedding consisting of a packing layer of 2.00 m thick, a fine sedimentary horizon of 6.00 m thickness and a coarse sedimentary horizon at -8.00 m depth. Groundwater is quartered in the coarse sedimentary horizon, the latter ranging from 10.00 m to 11.00 m below the Natural Ground Elevation. After the presentation of sources from where water could come, the paper presents some water leak mitigation methods to be used at the Orthodox Cathedral of Bacău.

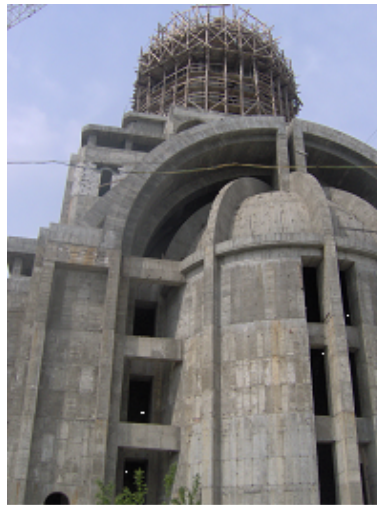
Fig. 1. – Cathedral's dome from where rain infiltrates in the Civil Defense Shelter.

The Cathedral's exterior roof drains were strictly necessary to realize as soon as possible since in rainy periods the unsupervised rainfall waters are leaking through the elevator hole into Civil Defense Shelter.

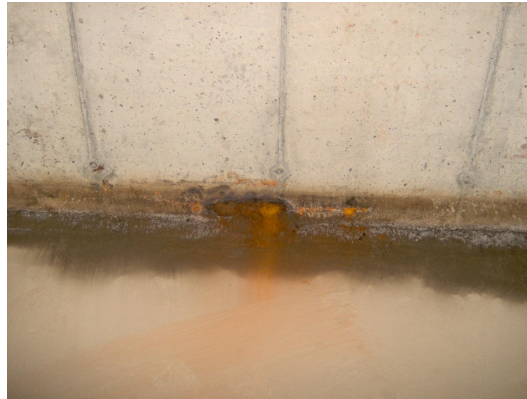
Fig. 2. – Massive seepage in the Civil Defense Shelter through the metallic sheaths of formworks.

Taking into account this situation in the first stage the holes of sheaths used in the implementation of infrastructure formworks were blocked off by injection of a particular material using a relevant technology (Figs. 2, . . . , 4). In the next stage impermeable plasters at infrastructure's walls were realized [7].

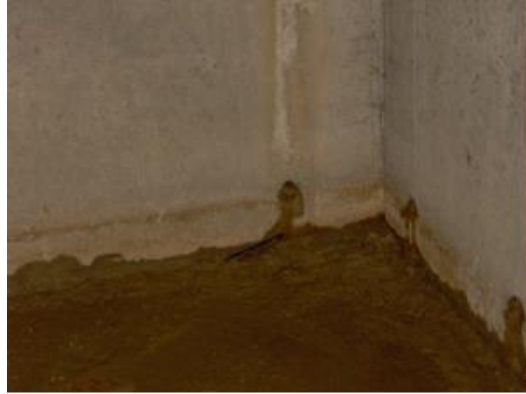
Fig. 3. – Seepage through the metallic sheaths.

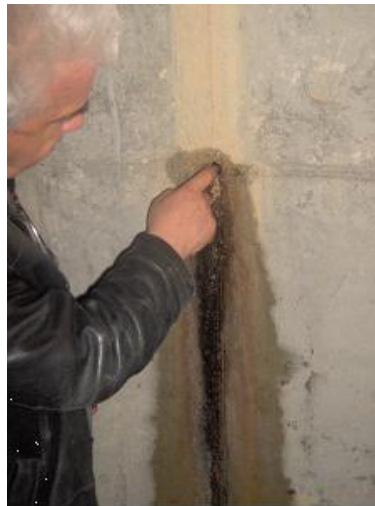
Fig. 4. – Seepage with sediments from metallic sheaths.

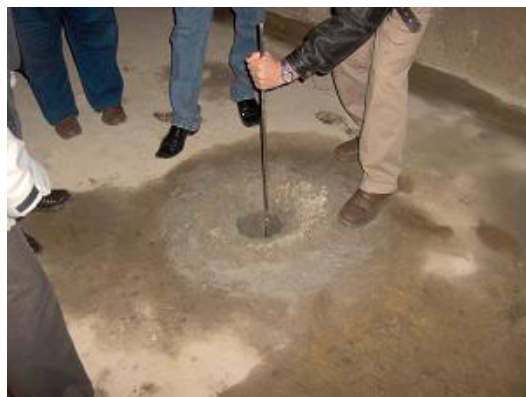
1. The larger part of water comes from losses originating from sewer with oviform section as well as from surface water infiltrated in relatively low permeability layers located above the gravel. The carry over water penetrates in the basement moving beside the Cathedral's walls through the gravel layer.

Fig. 5. – Borehole through floating slabs of the Civil Defense Shelter.

If the direction and source of water are correctly identified, it is recommended to realize the drain on the ovoid side, may be renouncing at two of four drains.
