**Seepage Test Loss Results
The Main Canal
Valley Municipal Utility District No. 2**

January 21, 2004

This report summarizes the results of a seepage loss test conducted on a segment of the Main Canal of the Valley Municipal Utility District No. 2 (Rancho Viejo) during October 22 - 24, 2003.

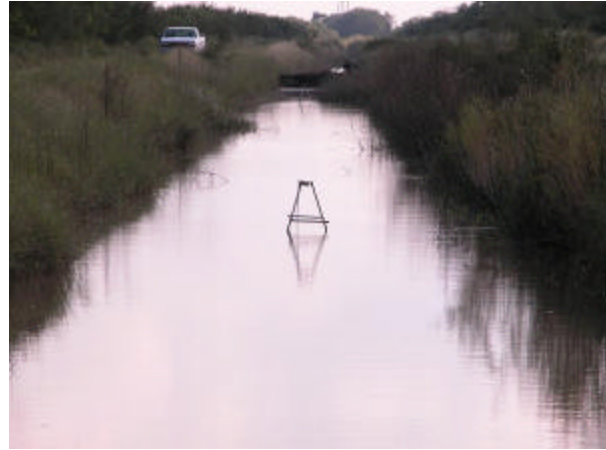
Figure 1. View of the Main Canal test segment with staff gauge.

The canal segment tested was located 1.95 miles north of 281 Military Hwy. The test segment was an unlined canal, approximately 600 ft long and varied from 23.8 to 25.3 feet in water-span width (Fig. 1 and 2).

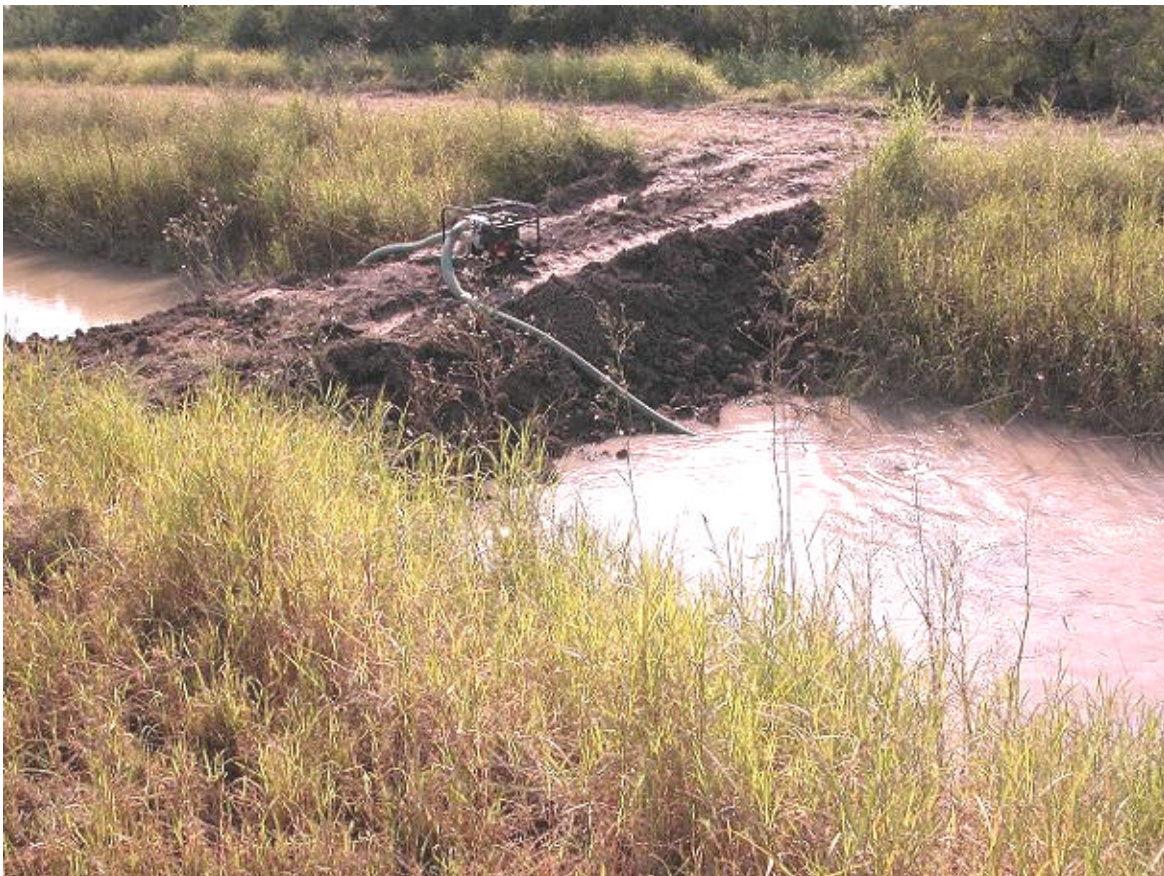
Figure 3. Upstream test dam and the centrifugal pump (a 3-inch "gator-pump") used to fill the test segment to normal operating depth.

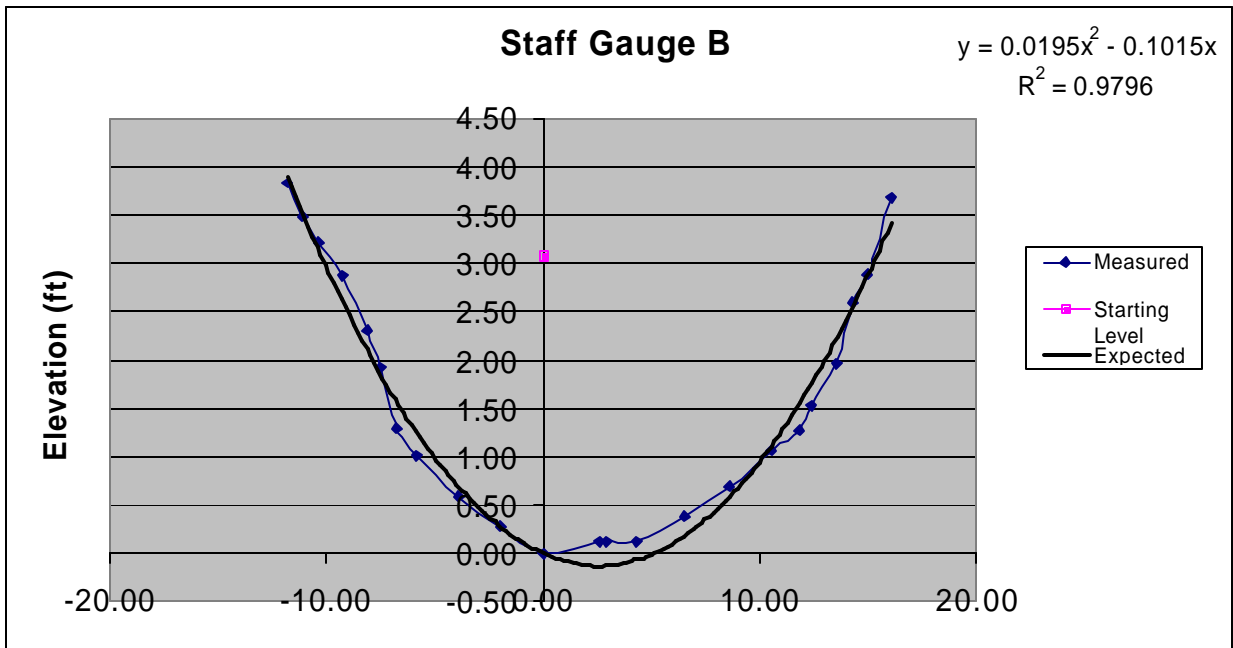
Figure 5. Cross-section at Staff Gauge B.

Table 3 provides details on the test segment, data collected and recorded changes in water depths during the test. The canal cross sections at the two staff gauges are illustrated in Figures 4 and 5. Also shown on these charts are the water depths at the beginning of the test. A photograph of the staff gauge and its located in the canal is shown in Figure 6.

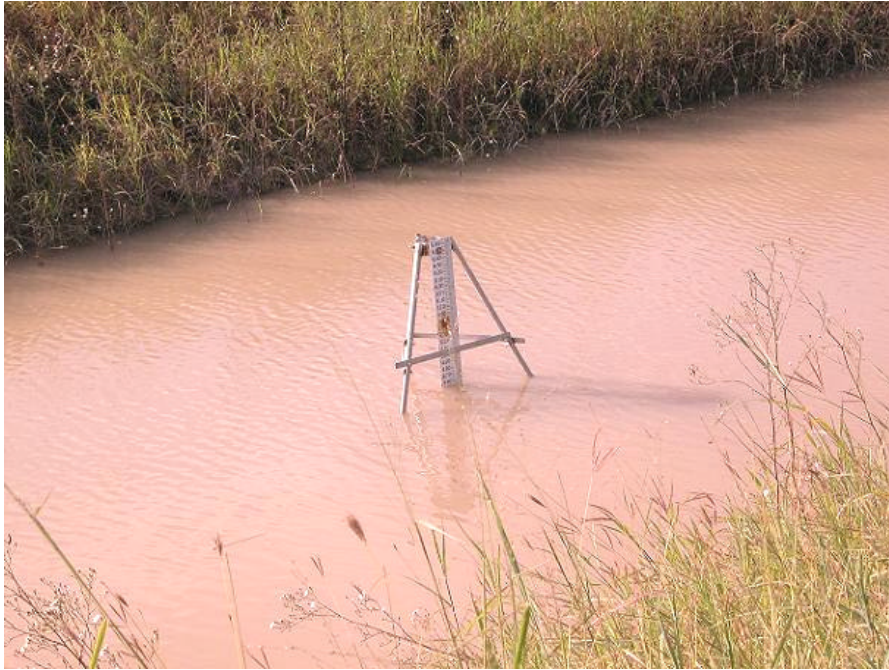
Figure 6. Test canal shown with Staff Gauge.
