Measured Seepage of the Main Canal Brownsville Irrigation District

April 2011

Texas Water Resources Institute Technical Report No. 372
Texas A&M University System
College Station, Texas 77843-2118

This report summarizes the results of a seepage loss test conducted on a segment of the “Main Canal” of the Brownsville Irrigation District, June 17 - 19, 2003.

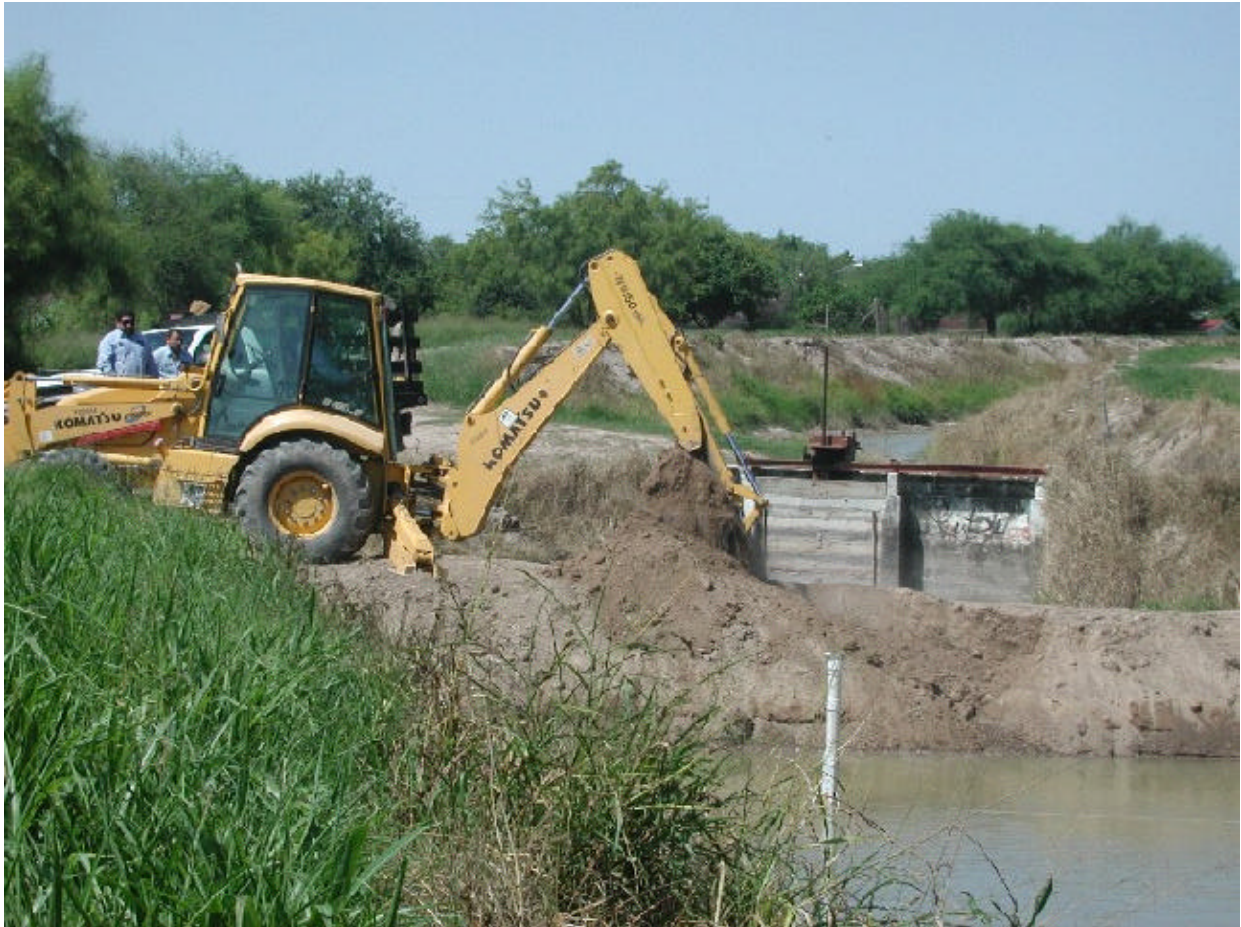
Figure 2. Downstream test dam being removed by the Brownsville Irrigation District.

Seepage was measured using the ponding method. In this method, the two ends of a canal segment are closed or sealed with earthen dams. Once sealed, water elevations are taken for approximately 48 hours. Four continuous-stage level recorders were placed in the test segment to supplement the four locations where stage levels are recorded manually (however, data from the continuous stage recorders was not used in this analysis). Canal dimensions and water spans were also surveyed during the test. The segment did not contain valves or gates within the canal; thus, the seepage rate was measured. The location of the test segment is shown in Figure 1.

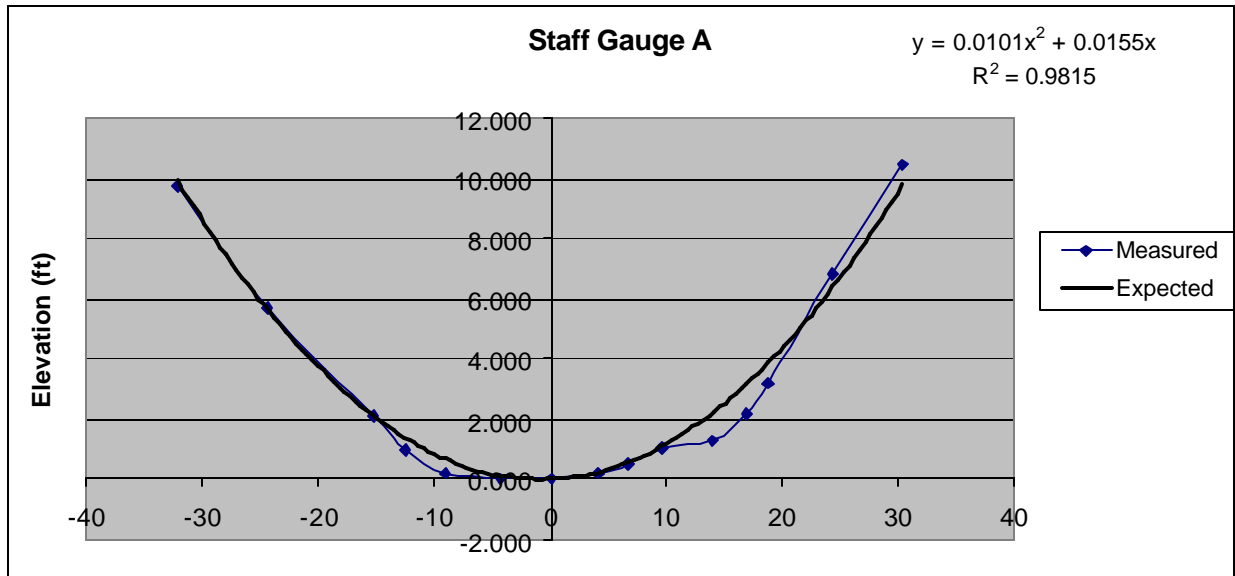
Figure 3. Cross-section at Staff Gauge A.

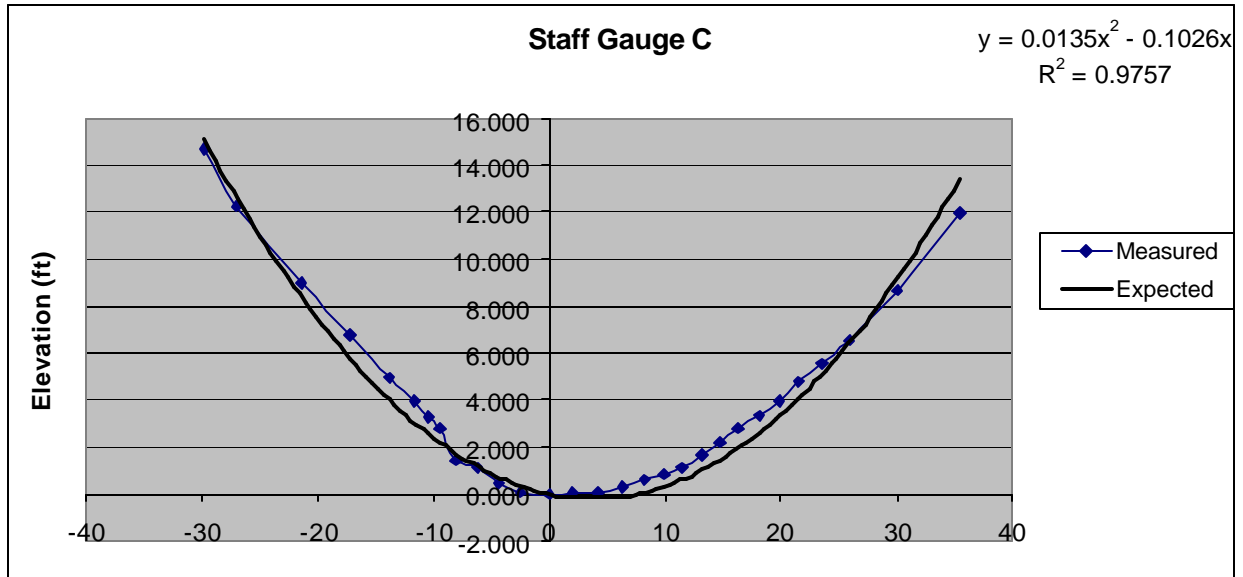
Figure 5. Cross-section at Staff Gauge C.

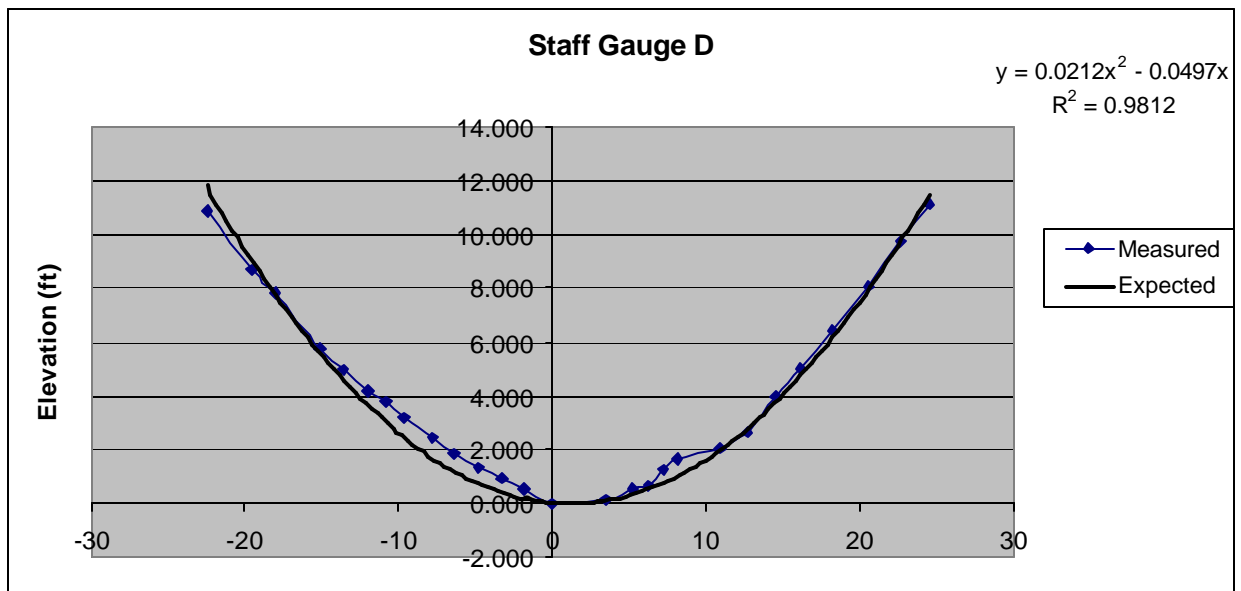
Figure 6. Cross-section at Staff Gauge D.

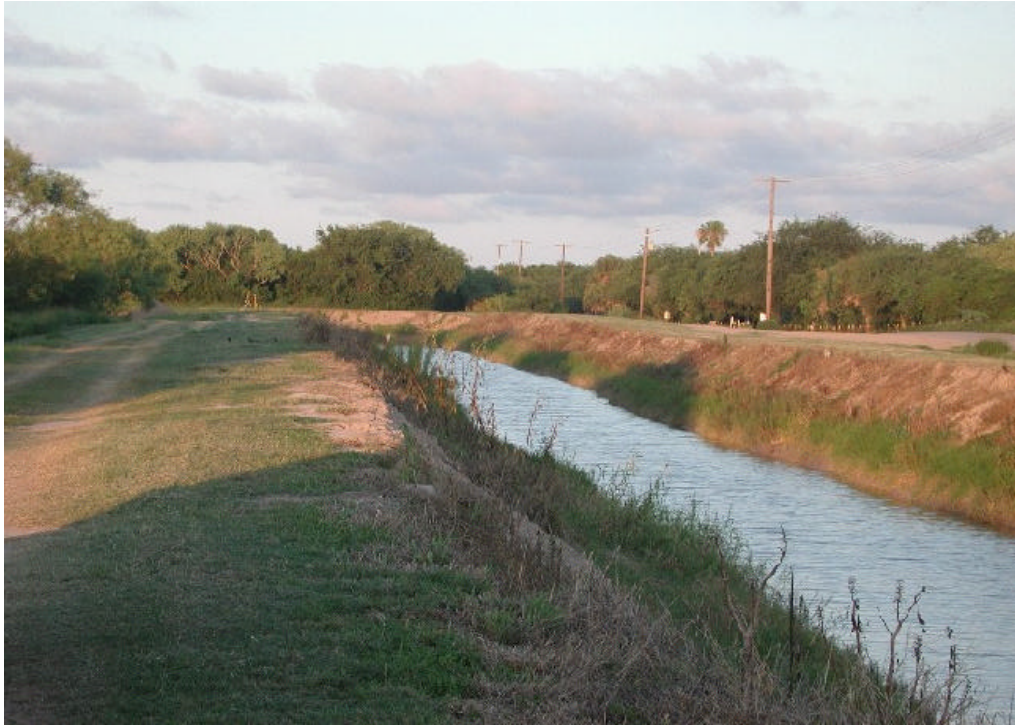
Figure 7. View of the Main Canal Test Segment.

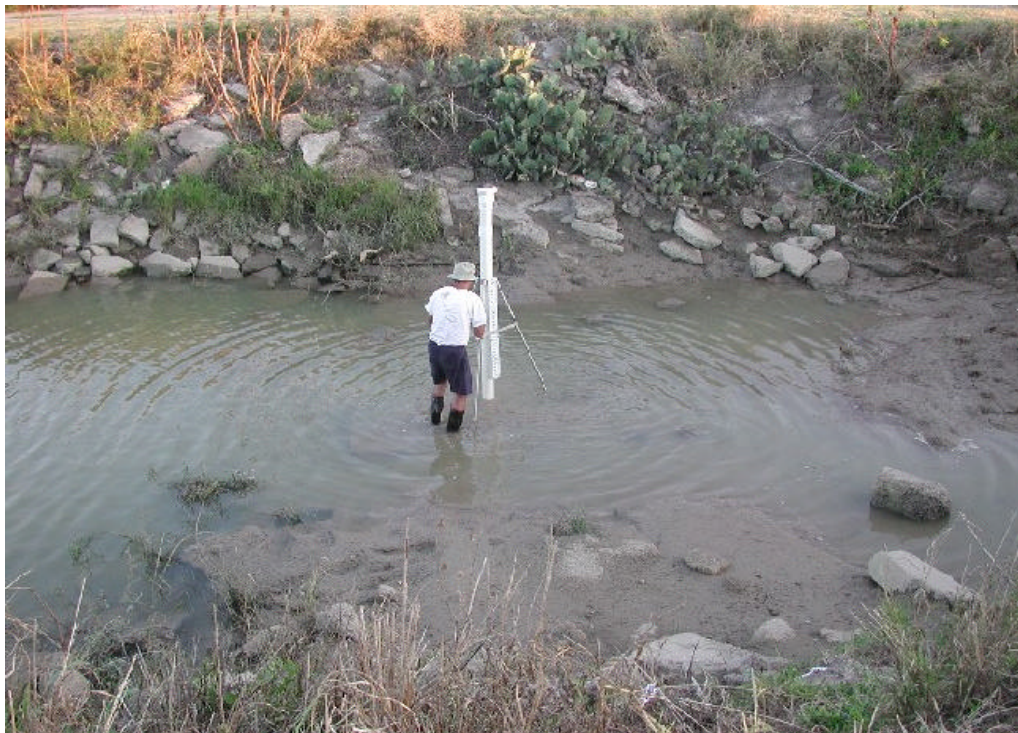
Figure 8. Staff gauge A and water level near the end of the test.
