Relation between surface temperature and dryer operation

I. VITÁZEK, J. TIROL

The paper presents the selected results from a check measurement on MC 3180 grain dryer where a thermovision camera was used for the measurement of the dryer casing surface temperature, while the thermovision screenshots obtained can be used for assessing the proper operation of the dryer and for carrying out or planning an early action for the maintenance of the dryer. The use of the thermovision method for the measurement of the surface temperature of the drier and the examination of its effective running is presented in this work.

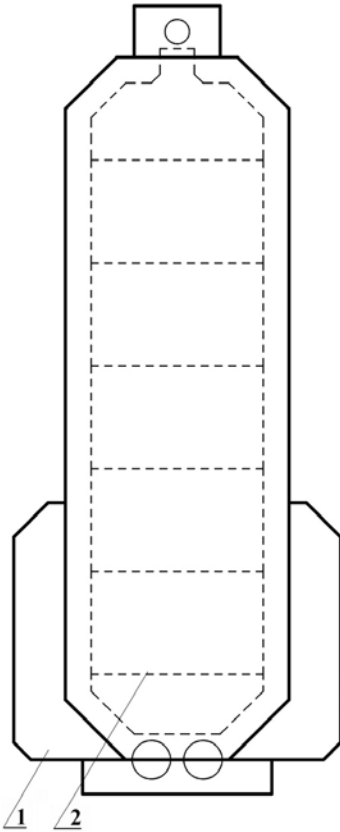
Figure 1. Design of MC 3180 dryer
1 – recirculation, 2 – individual sections

The MC 3180 is a continuous flow shaft dryer divided horizontally into six drying sections and one cooling section, which may be altered to a drying section (Figure 1). A Venturi burner with a separate fan is located in each section. This means that the drying medium consists of a mixture of flue gases (of natural gas) and ambient air. The mentioned struc-

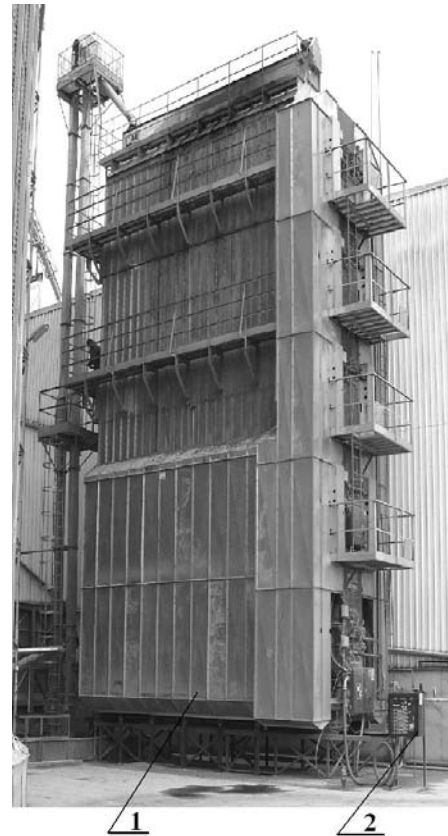
Figure 2. View of the examined MC 3180 dryer
1 – metal plating for recirculation, 2 – controlling console

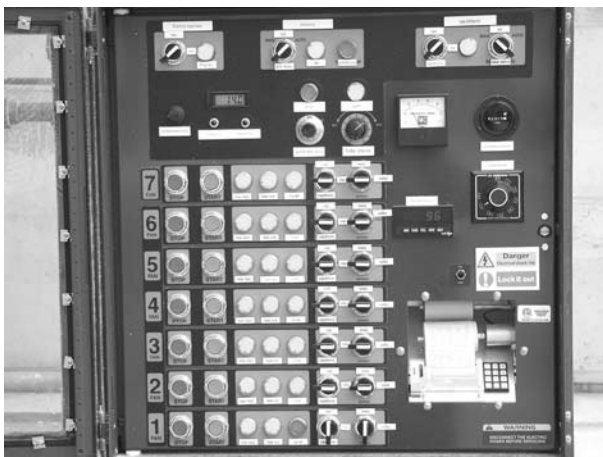
Figure 3. Controlling console of the dryer
1–7 – regulation of fans and burners

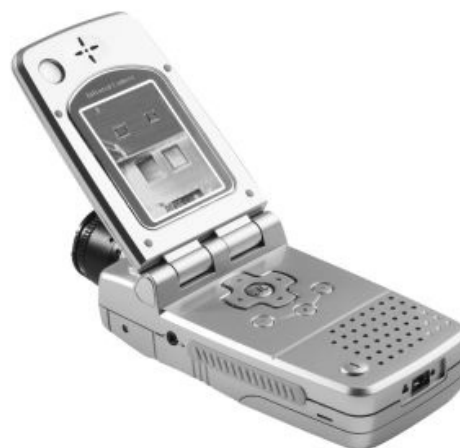
Figure 4. Thermo-camera micronix mobIR M3

The method of the check measurement was adapted for the continuous mode of the dryer operation. It was not a check measurement in terms of STN 12 6013 (1995) technical standard. The thermovision method was used for measuring the surface temperature at stable-state operation of the dryer. Thermo-camera micronix mobIR M3 (Figure 4) enables making thermovision shots which allows for a quick and precise measurement of the temperatures on the dryer casing. The camera measures temperatures in the range from -20°C to $+250^{\circ}\text{C}$ with accuracy of 2%. The resolution of the scanning chip is 160×120 pixels. The camera display can be used right on the spot to determine the temperatures. The camera can be connected to PC through USB 1.1 interface, the photographs can be downloaded to the computer, and precise data can be evaluated using a software. Thermocamera mobIR has a built-in memory for storing up to 100 images. The advantage of this camera resides in its small size and weight.

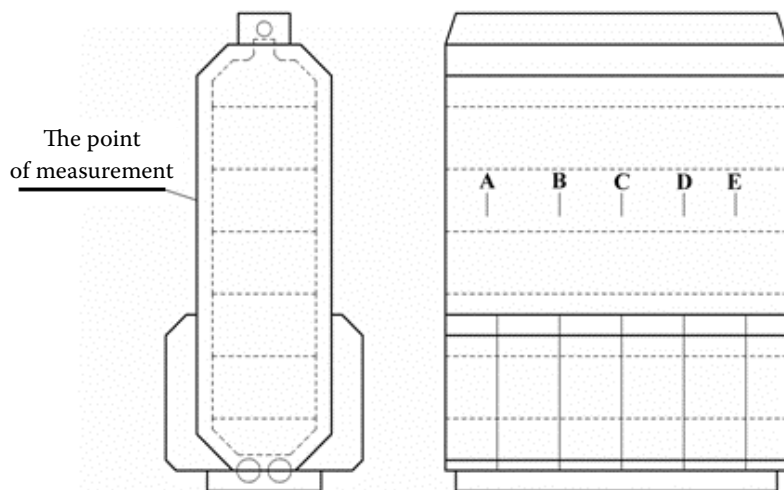
Figure 5. Diagram of the dryer with the points of measurement marked

In selected time intervals, we recorded the parameters of ambient air (t_0, ϕ_0), temperature of the drying medium at its entry to the layer of the material t_1 , and the parameters of the drying medium at the outlet from the dryer at selected points (Figure 5) of the outer casing (t_2, ϕ_2). We analysed the parameters of the drying medium through displaying them on the i-x diagram of wet air. We used the i-x diagram of wet air of up to 200°C (CHYSKÝ 1977; VITÁZEK 2005) containing mixing lines for natural gas (Figure 8). Point 0 represents the state of the ambient air; point 1 represents the state of the drying medium at its entry to the layer of the dried material.

The average values of the drying medium parameters measured at the points shown in the diagram in Figure 5 are presented in Table 1.

As the measured data suggest, the temperature and humidity of the drying medium at the outlet from the dryer varied depending on the point of measurement (A to E). However, in each given point of measurement, they did not change significantly, which means that the dryer was operated in a stable state. Significant differences exist between points A, B, and E on one side, and points C and D on the other side. In the first case (A, B, E), clearly higher temperatures and lower relative humidities of the drying medium were found, while in the second case (C, D) vice versa.

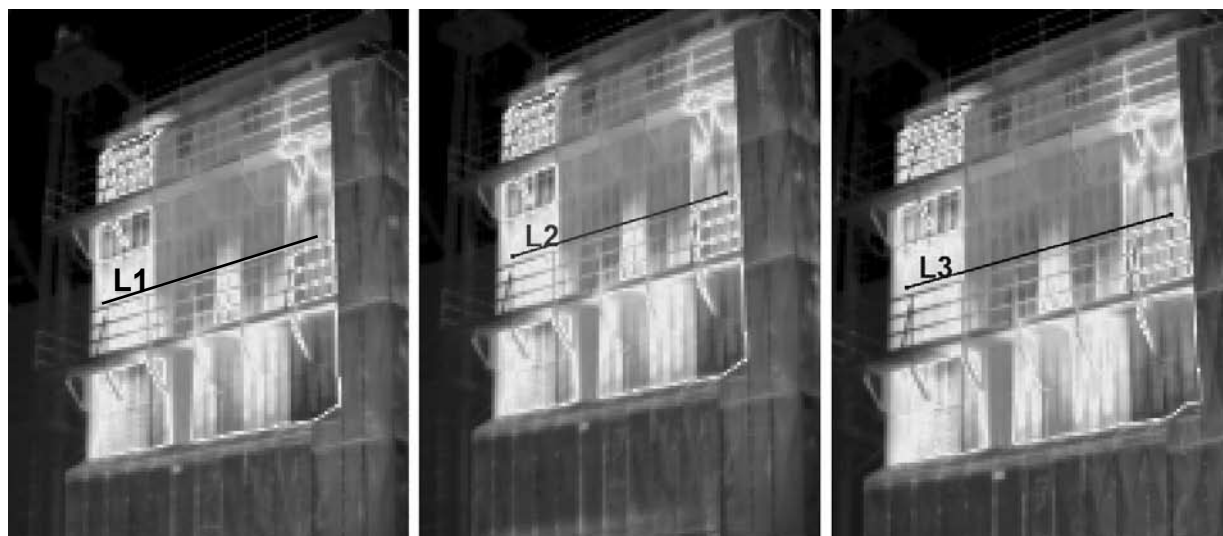
Figure 6 shows the thermovision camera shots of the examined dryer, with lines L1 to L3 marking the points of measurement at times 10.20, 10.50 and 11.50 h, as done by the manual measurement (results in Table 1). The courses of temperatures at points L1 to L3 are shown in Figure 7 using the provided

Figure 6. Thermovision camera shots

The thermovision shots taken in the check measurement on the given MC 3180 grain dryer using a thermovision camera can be used for assessing the proper operation of the dryer and carrying out or planning an early action for the maintenance of the dryer and so make the goal in its introduction. Even without a close examination, the shots mentioned suggest different surface temperatures in the individual drying sections, and thus the necessity to eliminate the unfavourable conditions. As confirmed by further examination, silting up of the outer casing was the matter of concern.

The analysis of the data gained through a thermovision camera enables making a simple assessment of the state of the dryer outer casing and doing an immediate correction without a long and demanding observation. It allows for a continuous reaching of high performance at a very favourable consumption of heat per unit of moisture, which gives the reason for high popularity of Mathews Company dryers.

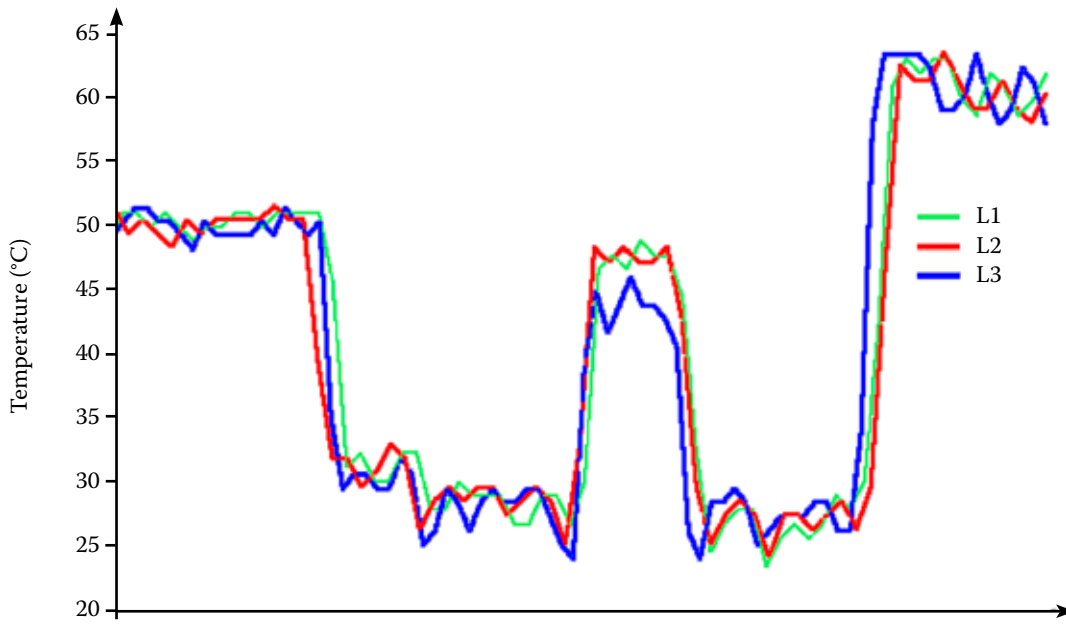
Comparing the data from Table 1 with the data of the temperature course from Figure 7, we can state the following:

- The courses of temperature are mutually related according to the point of measurement (A to E).
- The cause for the dryer casing temperature drop (two significant drops – Figure 7) lies in silting up of the outer perforated casing, which results in reduced sizes of the openings or even their total congestion. These are the obvious dark spots in the thermovision camera shots (Figure 6). For this reason, the drying medium flows through the given places at a lower speed, thus cooling off more and becoming more moist at the same time. Reducing the air flow through these places

of the dryer, however, increases the drying medium flow at the places not silted up, which is shown through its higher temperature and lower relative humidity (places A, B and E).

- Different flow rates of the drying medium will result in an uneven drying of the material throughout the whole cross-section of the drying shaft, a lower exploitation of the drying power of the drying medium and thus a lower utilisation of the energy supplied for heating the drying medium, and also a non-uniform temperature in heating the dried material. This temperature is impossible to examine more closely due to the casing of the cooling section for the reason of drying medium recirculation.

Figure 7. Time course of temperatures at selected points according to Figure 6

As other measurements and data given by the producer suggest, the MC dryers meet the required emission limits. Silting up of the outer casing of the dryer is caused by the causes already mentioned. It can be also caused by an insufficient cleaning of the material before drying (VITÁZEK & TIROL 2006), inconsistent handling or even reluctance to interrupt the operation of the dryer due to a high intensity of the maize supply.

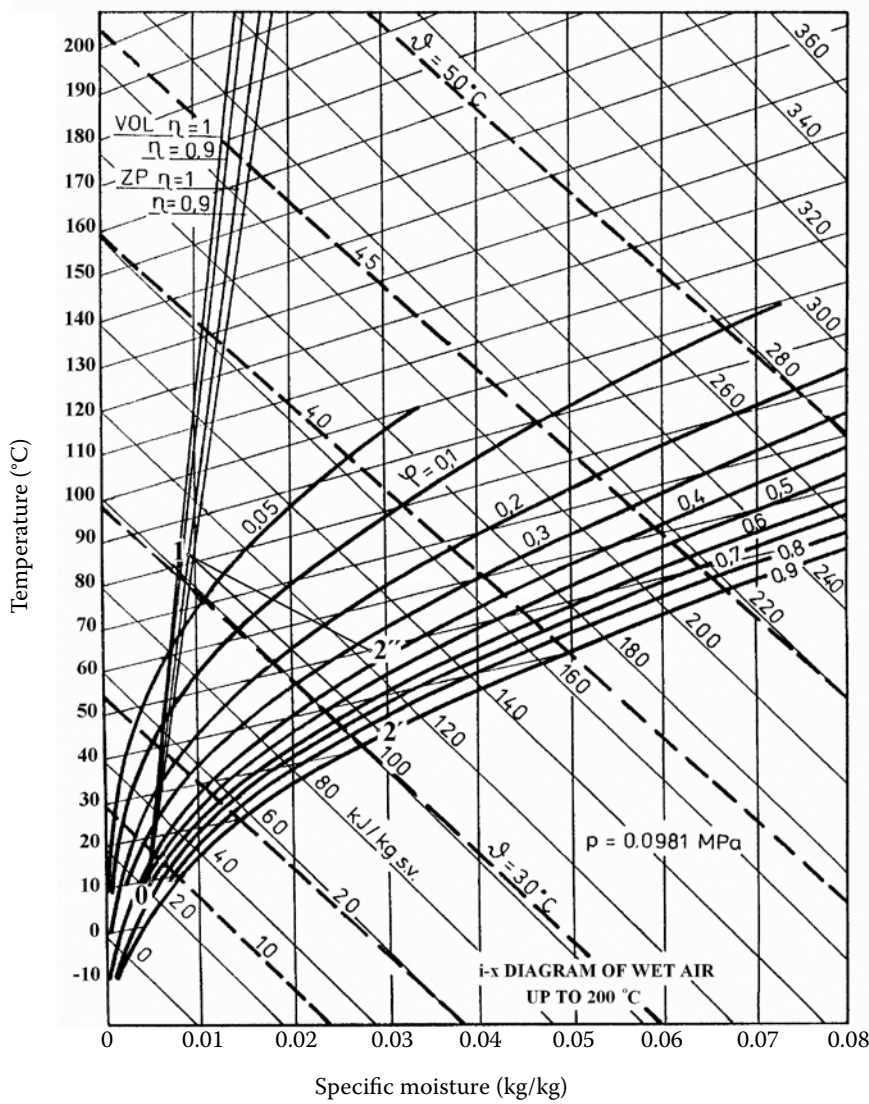
The selected measured states of the drying medium are drawn into i-x diagram of wet air of up to 200°C containing mixing lines of the fuel used. The

Figure 8. Course of state changes of the drying medium in i-x diagram of wet air

state of the drying medium denoted 2' represents still an almost standard course. State denoted 2'' already represents a course atypical for hot-air drying. Although the humidity of the drying medium increased and its temperature decreased, its enthalpy increased.

The illustration of the way of the drying medium state change in *i-x* diagram of wet air allows for the

assessment of the drying process itself, utilisation of the added energy, and thereby the exploitation of the drying power of heated air (VITÁZEK 2006). In the given case, it depicts an extreme situation when the drying medium is indeed being saturated with moisture, but its enthalpy is rising at the same time.
