Experimental and Numerical Study of Fire Spread upon Double-skin Glass Facades

Lei Peng, Zhaopeng Ni and Xin Huang

(Tianjin Fire Research Institute of the Ministry of Public Security of China)

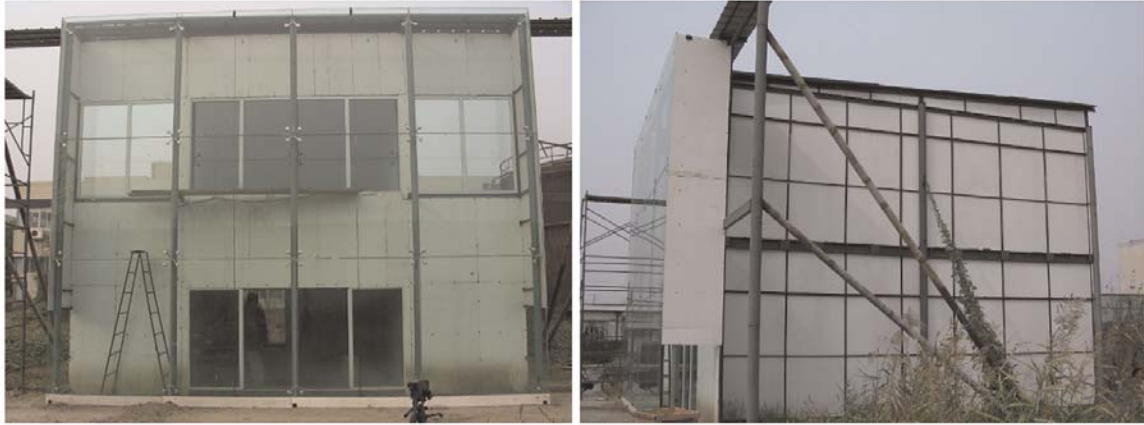
Figure 1 Two-storey test rig.

The test rig was built to simulate hotel rooms with the double-skin facade installed, shown in Figure 1. The lower and upper rooms had dimensions of 4×9 ×3.3m³ (high). The cavity depth between the inner and external skin was 860 mm.

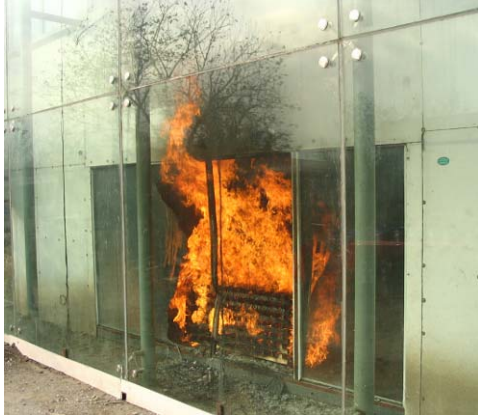
(a) flame spread into the cavity;

Test C were performed with initial openings on the internal skin, since two of the glass panels on the internal skin were removed. Therefore, the smoke and flame could enter the cavity through the opening at the very early stage. The other two inner glass panes broke at about 5-6min. At about 9 min, the inner glass panes of the external skin broke at the lower part of the facade, as the hot air and smoke in the cavity were more likely to impinge on the external skin rather than the internal skin. After breaking of

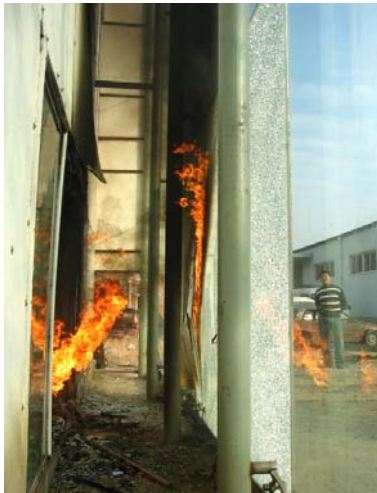
(c) burning of gel layer of the external skin

the external skin, the intervening gel between two glass panes were exposed to fire and ignited. This resulted in breaking and partial falling of the outer glass on the external skin. The test pictures of Test C are shown in Figure 3. During the test, the temperatures of smoke plume in the cavity were not hot enough to break the internal glass on the upper floor.
