Historical earthquakes and damage patterns in Potenza (Basilicata, Southern Italy)

Fabrizio Terenzio Gizzi and Nicola Masini

Abstract

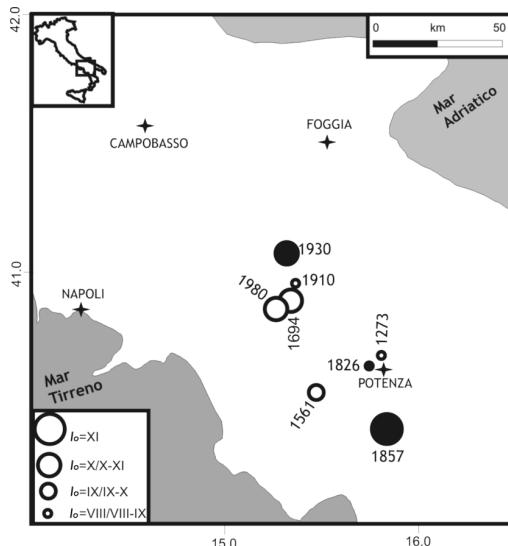
Fig. 1. Strongest historical earthquakes that affected Potenza. The circle diameter is proportional to the epicentral intensity (MCS). The black circles show the seismic events analysed in this paper. Data are drawn from Boschi *et al.* (2000).

Southern Apennines where an axial-active, 30 to 50 km wide seismic belt produces strong earthquakes (Boschi *et al.*, 1999). Large past earthquakes originated in both inner areas of Basilicata and in areas located at the western and north-western boundaries, between Basilicata and Campania (fig. 1).

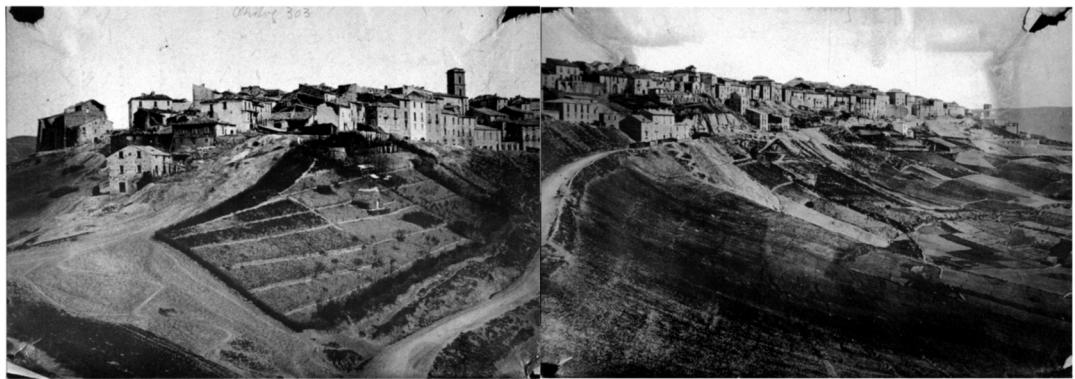
Fig. 2. General view of Potenza after the 1857 seismic event according to the Mallet's report (Mallet, 1862) (from the monoscopic photos no. 302 and 303).

The seismological importance of this earthquake led the Irish engineer Robert Mallet to visit the affected towns, including Potenza. For this locality, the scientist noticed that «...The damage done was very diffused over every part of the town, though greatest upon the free lying flanks, to the east, west, and N.W., and many buildings are prostrated or fractured ...» (Mallet, 1862) (fig. 2).

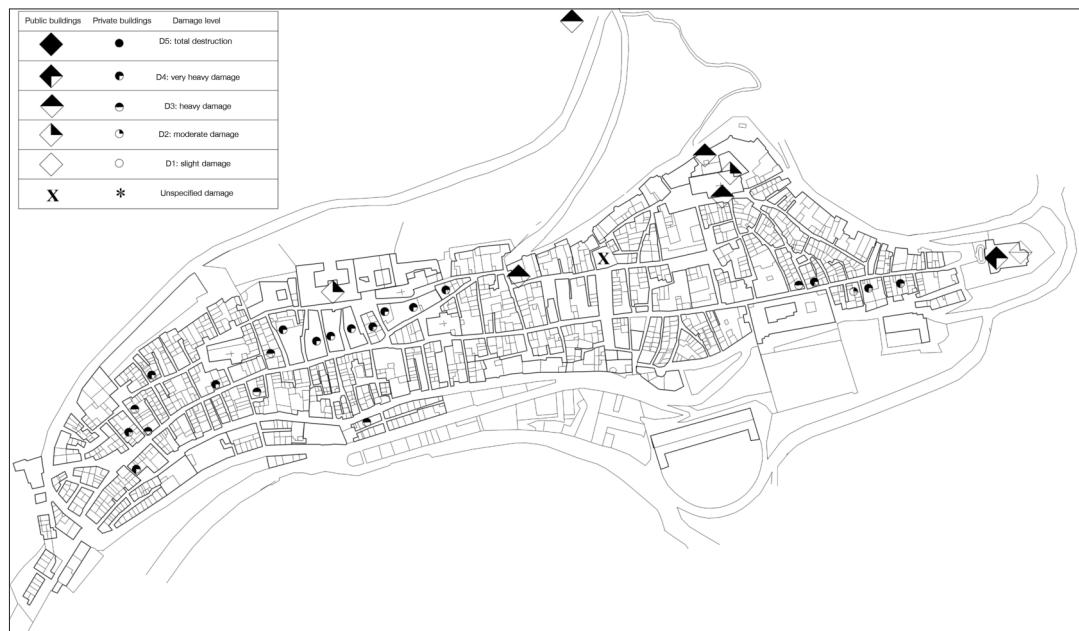
Fig. 3. 1826 damage 'scenario' for Potenza. The map highlights effects on the western flank of the hill and in the central-western area of the historical centre.

The analysis of this earthquake highlights effects on the western flank of the hill and in the central-western part of the historical centre (fig. 3).

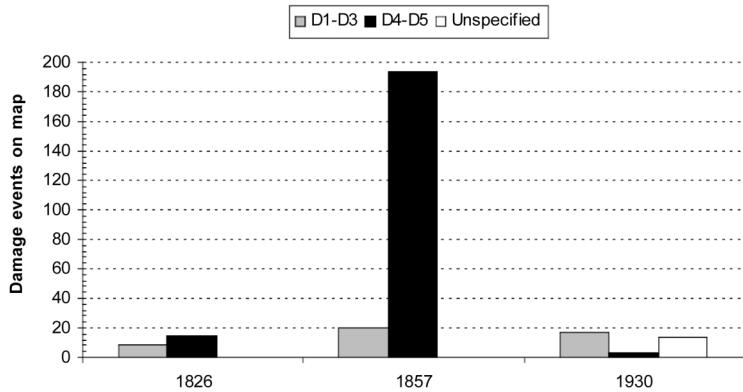
Fig. 4. Number of damage events pinpointed on the urban maps. Events are plotted as two different group of EMS damage classes (D1-D3 and D4-D5). The predominance of the higher classes of damage is due to the economic-administrative filter (see text).

dies. The subsidies were assigned if a twofold condition was met: significant damage to the buildings and poor house owners. Obviously, this criterion filters damage evaluation and must be considered in the analysis of the effects (fig. 4).

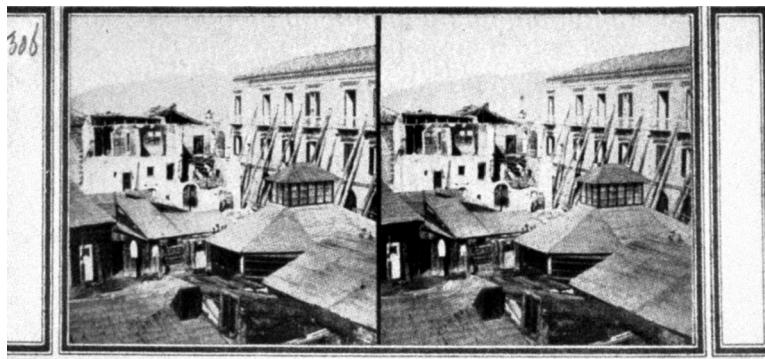
Fig. 5. Damage to the Palace of Intendenza (on the top in the right corner) according to the Mallet's report (Mallet, 1862, stereoscopic photo no. 306). Huts are also evident in the foreground.

Damage to public or religious buildings was considered in both the archive sources and the surveys or photos attached to the Mallet report (Mallet, 1862) (figs. 5, 6). These photos helped locate some collapsed or affected buildings on the urban map.

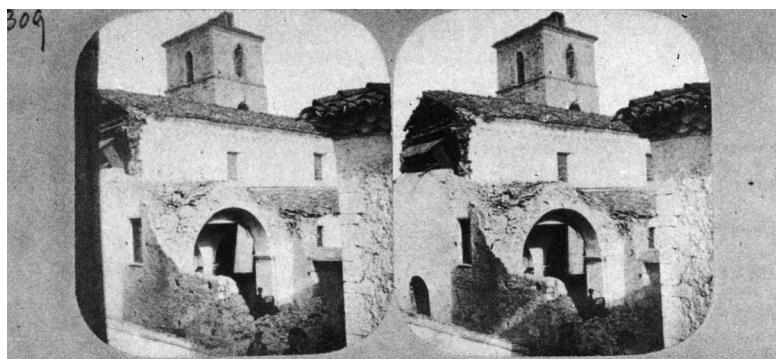
Fig. 6. Damage to the Church of St. Angelo della Trinità according to the Mallet's report (Mallet, 1862, stereoscopic photo no. 309).

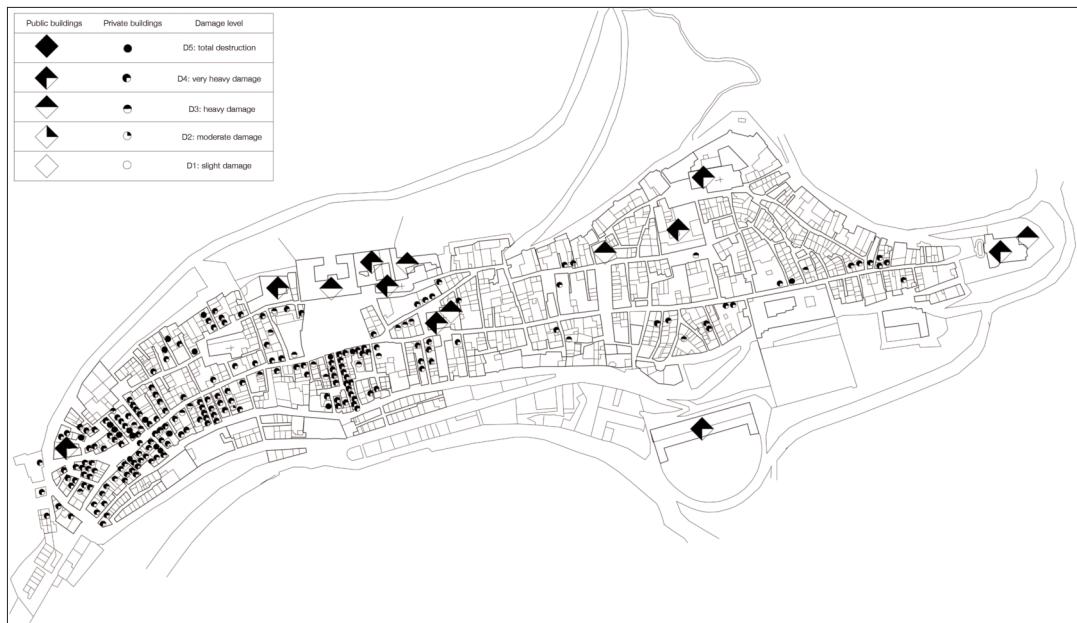
Fig. 7. 1857 damage 'scenario' for Potenza. It is evident that the effects are mainly localized in the western and central-western sector of the historical centre, the so-called Portasalza and Portamendola quarters, where many buildings collapsed (see also fig. 8).

Using all the sources mentioned above, the localised damage events were pinpointed on the 1875 urban map. Figures 7 and 8 indicate that the effects were mainly localized in the western and central-western sectors of the historical

centre, the so-called Portasalza and Portamendola quarters, where many buildings collapsed. The eastern flank of the hill on which the town lies was also heavily hit.

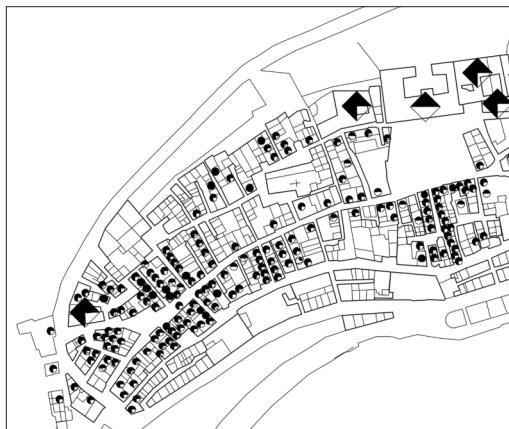
Fig. 8. 1857 ‘scenario’ for Potenza: detail of damage in Portasalza-Portamendola quarters, where many buildings collapsed.

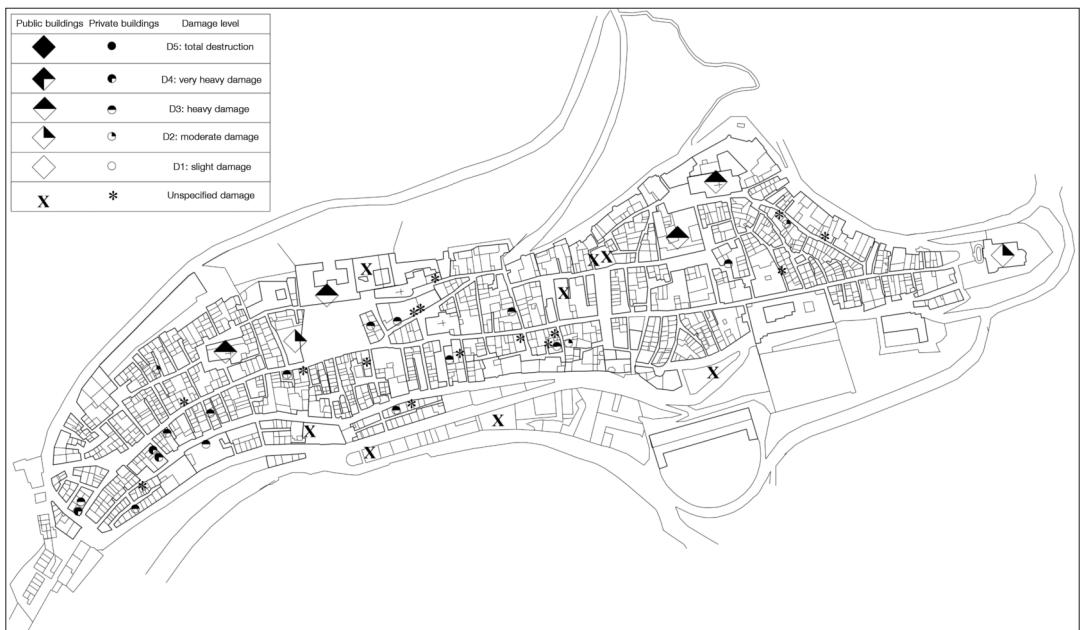
Fig. 9. 1930 damage ‘scenario’ for Potenza. It can be noticed that the damage is especially located in the central-western and western portion of the historical centre.

Due to the documents consulted, accurate damage classification was not possible in many cases. However, completing the damage map represents a significant increase in knowledge about seismic impact at this location. Indeed, the ‘scenario’ map clearly shows that damage was mainly localized in the central-western and western parts of the historical centre (fig. 9).
