FAILURE MECHANISMS THAT CAUSE HIGH ELECTRICAL LEAKAGE IN MULTILAYER CERAMIC CAPACITORS

HIROFUMI IKEO, SANPEI SAKAMOTO, KEN SATO[†], HISAKAZU NISHIURA[†], and KATSUHIRO OHNO[‡]

Kita-Itami Works, Mitsubishi Electric Corporation, Itami, Japan 664

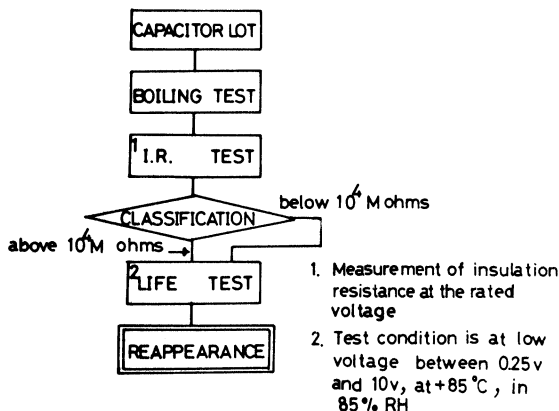
FIGURE 2 Reappearance test flow chart.

Reappearance of failure tests were performed by the procedures as shown schematically in Figure 2. Capacitors were boiled in water for several hours. Afterwards the capacitors were dried, and insulation resistance was measured at the rated voltages. The boiled capacitors were classified according to the resistance level: below 10^{10} ohms (rejected capacitors) and above 10^{10} ohms (acceptable capacitors).

Every capacitor was subjected to dc voltage stresses from 0.25 V to 10 V in an atmosphere of 85% RH and at $+85^{\circ}\text{C}$ in a thermo-hygrostat. Under voltage stresses, some of the capacitors failed at less than 10^4 ohms for applied voltage between 0.5 V and 3 V as shown in Figures 3 and 4. Acceptable capacitors after boiling did not fail at any voltage. The electrical properties of failed capacitors in this reappearance test were the same as those of the failed capacitors in the reliability test. This reappearance test method was evolved by taking account of the electrical properties and the environment of the failed capacitor.

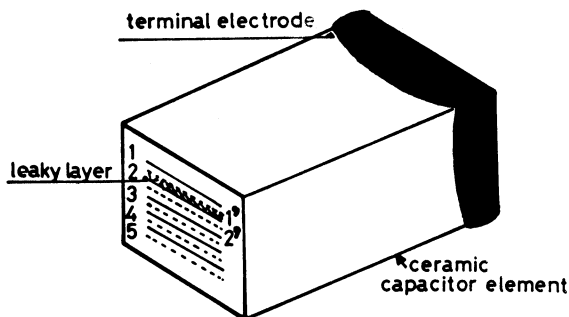
FIGURE 6 Procedure to clarify leakage layer (in this case leakage layer is between 1' and 2).

First step: After confirming that there was no leakage on the ceramic surface, the individual inner electrodes were isolated by removing one of the outer electrodes. The leaky ceramic layer was determined by measuring the resistance between each isolated electrode and the other outer electrode as shown schematically in Figure 6.

Second step: The ceramic was planed down parallel to the inner electrode plate by sand paper or sand/air abrasion, until the dielectric layer between the electrodes (1 and 1' - in Figure 6) appeared. One of the inner electrode plates across the dielectric layer was then exposed by using a narrow beam sand/air abrasion system and afterwards the outer electrode which had been removed by the first step was reconnected using silver paste. Careful removal of the electrode plate a

- 1-5 : Isolated inner electrodes (formerly, connected to leftward terminal)
- 1'-2' : Opposite electrodes (dotted line)

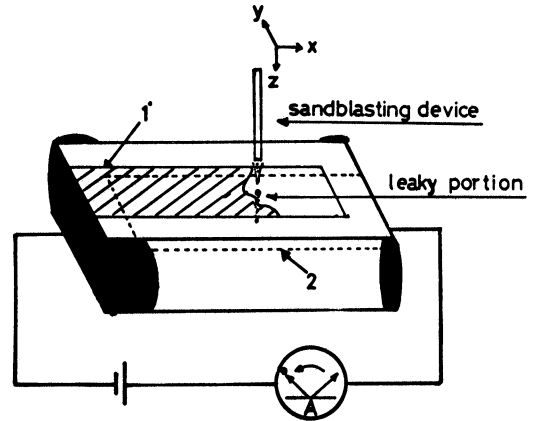
FIGURE 7 Procedure to clarify macroscopically leaky portion of capacitor.

little at a time, whilst watching the current across the dielectric, was performed until the observed resistance suddenly became infinite. This location, just before the resistance became infinite, is the macroscopic high leakage portion of the dielectric (as shown schematically in Figure 7).
