DOCUMENTATION OF DESTROYED PARTS OF MONUMENTS USING LOW COST RECTIFICATION TECHNIQUES

Georgios P. Antoniou

KEY WORDS: Dodona, Ancient Castle, Ancient theater, Ancient tower, Amorgos, Orthorectification

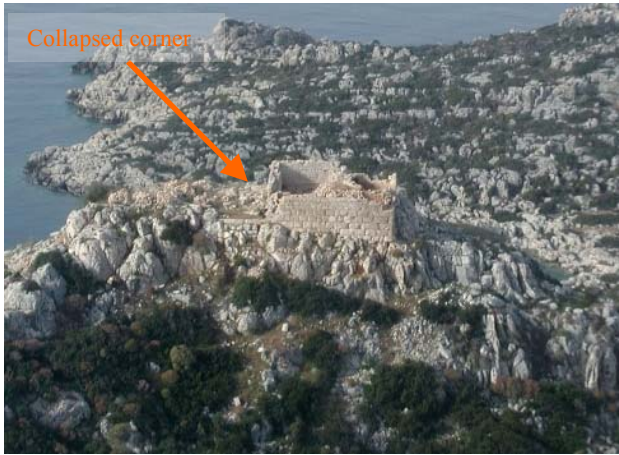
Figure 2. Aerial view of the ancient fortress. © G. P. Antoniou

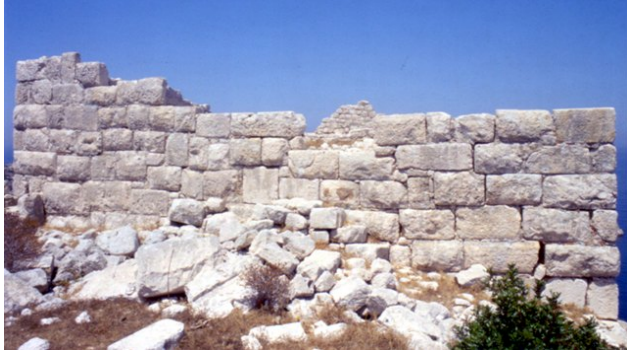
Figure 3. Photograph of the east facade before the collapse of the northeast corner (KB' EPKA)

Many measurements on site provided an accurate network of the regulated masonry joints from the existing part not only on the north wall but also on the eastern one. That network was used for the rectification of the photograph. The picture was inserted in a CAD application. The precision of $\pm 5\text{cm}$ acquired was adequate to determine the dimensions of the missing stone blocks after the drawn elevation of the whole north face of the fortress.

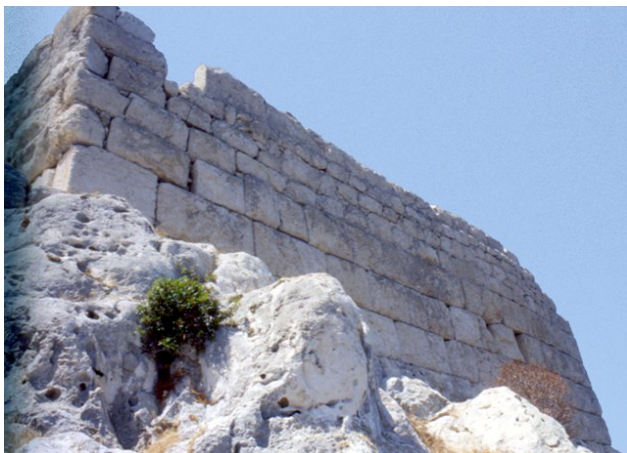
Figure 4. The north facade before the collapse. (KB' EPKA)

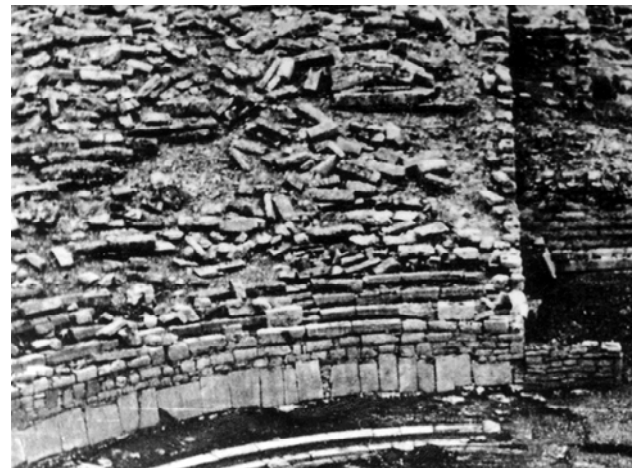
Figure 6. View of seat tier 1, Zone A before the intervention of 1960

A part of the study for the Restoration of the Ancient Theater required the identification of the numerous seats and parts of the cave which were misspositioned during the intervention made in 1960, without any previous documentation. Such identification of the original position of many parts was possible using some simple general view photos, taken before that intervention and the detailed documentation of the cave made by the photogrammetry experts of our team. Because of the curved layout of the cave, the method was applied with multiple partial rectifications of the most suitable photograph. (Fig. 6)

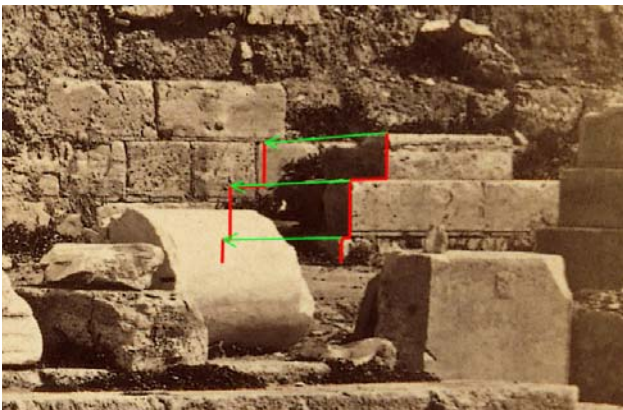
Figure 8. The historic photo with the projection of the base on the wall

The base, which does not exist any more, is shown in an historic photograph of the 2nd half of 19th century, illustrating just the west part of it. The base is consisted of 2 steps plus the foundation stone which was originally protruding out of the ground. (Fig. 8)

In the historic photograph all the pieces are illustrated clearly. At the background of the base, it is visible part of the retaining wall of the east parodos of Dionysus theatre in Athens. All that part of the wall survives today and could be recorded in details.

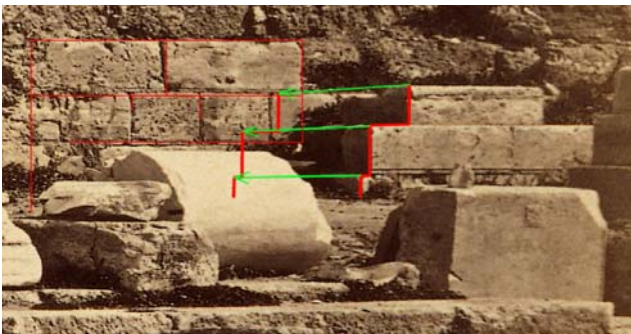
Figure 9. The rectified photo with the projection of the outline of the base.

According to the methodology of that case the outline of the base was projected and marked on the wall. Afterwards the photograph with the marked outline was rectified using as reference the measured grid of the masonry of the retaining wall (Fig. 9). At the end, in the same CAD application, the elevation of the monumental base was drawn in its original dimensions (Fig.10)

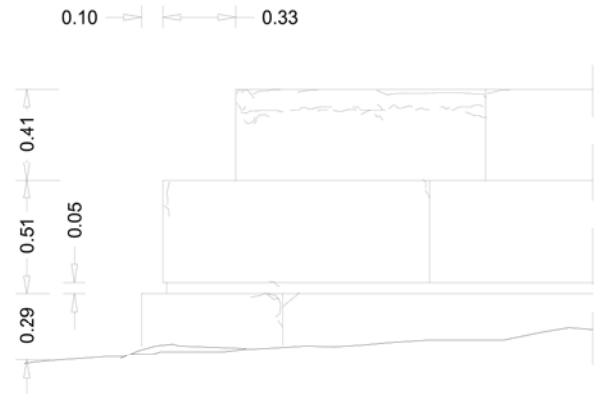
Figure 10. Front elevation of the base in its original dimensions

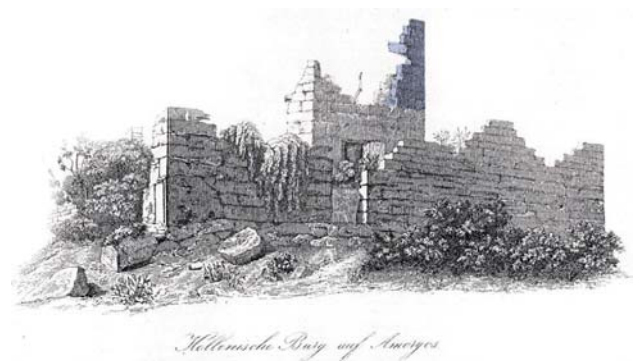
Figure 11. The engraving of L. Ross, 1843 (Ross, 1843)

The engraving of Ludvich Ross, published in 1843, shows the tower of Ag. Triada on Amorgos, from the southeast -outside the yard. Among other parts which survived then much higher than today, is the northeast corner of the central tower. That corner collapsed later on and the stoneblocks fell in the yard where they were recorded in details by the author in 2003, (Fig. 12) after a commission by KB Ephorate of Classical Antiquities for the study of the removal of the stones and other small scale interventions in the yard.

The engraving was classified as a very detailed one and many of the illustrated parts in it were indisputable identified on the monument today. Therefore it was practiced experimentally the process for the identification of the original position of the stoneblocks of the collapsed corner. The rectification of the engraving using the methodology of case 3.1, resulted in the ability for dimensioning of these stones, as they appear up in their original position. Using those dimensions many of the

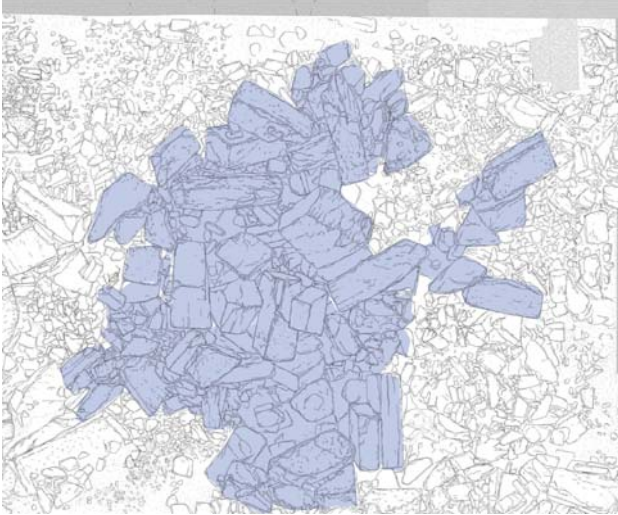
Figure 12. The stoneblocks of the NE corner of the tower after their collapse.
