## NEW APPLICATION FIELD FOR THE HANDYSCAN 3D: THE RES GESTAE DIVI AUGUSTI OF THE AUGUSTUS TEMPLE (ANKARA). A RESTORATION SURVEY

The present paper concerns the results of a survey carried out as part of the international project named the Ancyra Project.

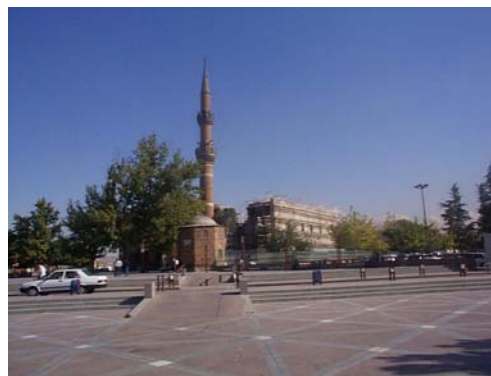
Figure 1 – The Augustus Temple near the minaret of the Haci Bayram Camii, Ankara

The *Augusteum* in Ankara was a *pseudodipteros* temple of the Corinthian order (36 x 54.82 m) standing on a podium about two metres high (Figs.1-2-3).

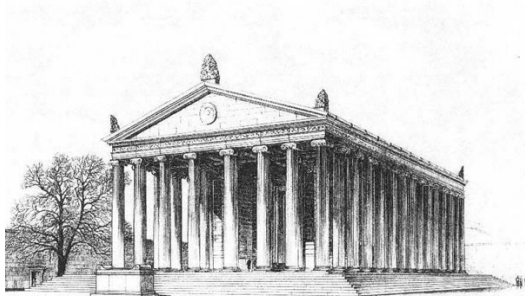
Figure 2 – The Augustus Temple in Ankara - M. Schede - D. Krencker 1936

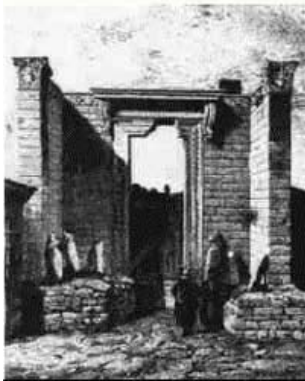
Figure 3 – The entrance of the temple in an ancient print

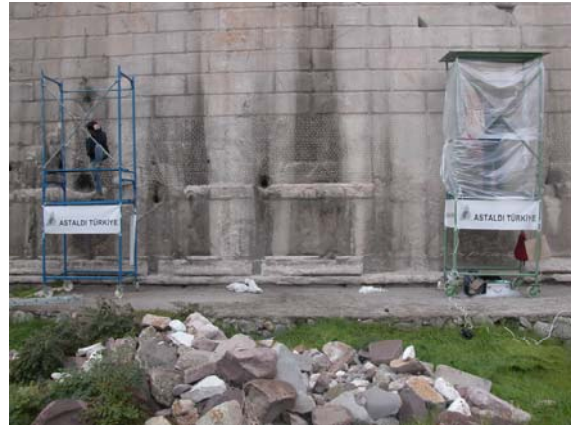
The inscriptions of the three separate walls of the temple of Augustus stand above the ground: the Greek epigraph is situated about 2 m from the ground, and the two Latin inscriptions are higher than the Greek one. This position is strategic to make the epigraph visible from a distance, but it is not very easy to survey. For this reason two trestles were used to reach the carved stones (Fig. 4).

Figure 4 – The Greek epigraph with the used trestles

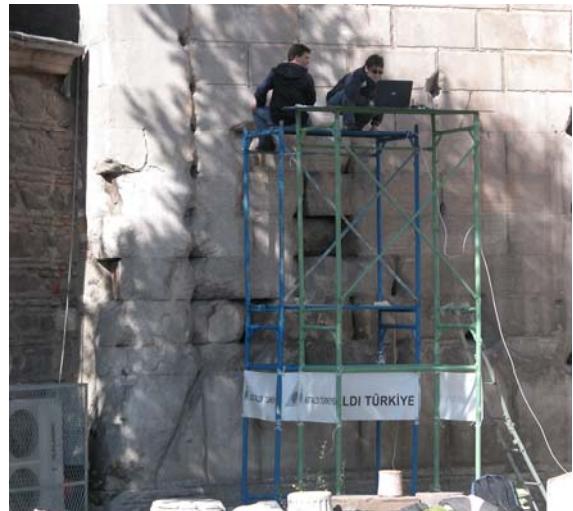
Figure 5 – A scan acquisition from the trestle of a portion of one of the Latin epigraphs

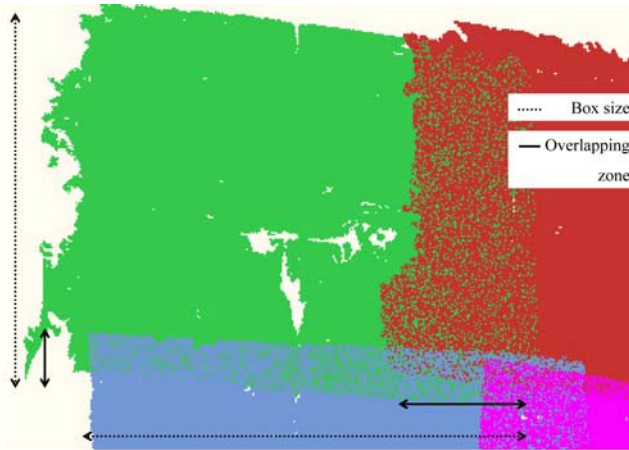
The three areas were subdivided into several 80x80 cm sub-areas so that there was an overlapping zone between each scan (Fig. 6).

Figure 6 – The Augustus Temple in Ankara

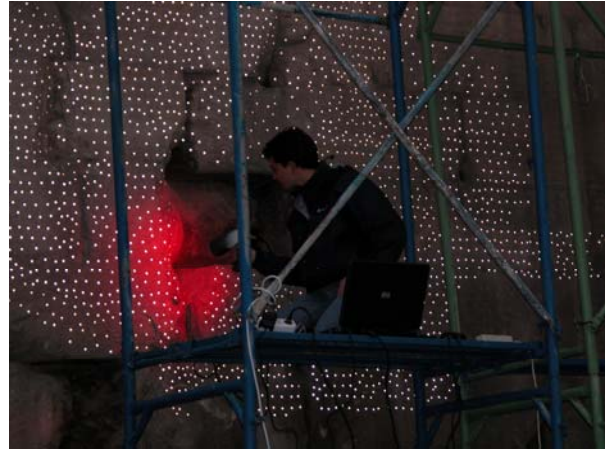
The reference system was set up by fixing reflective targets onto the object creating an irregular mesh with sides that sometimes reached up to 10 cm. The reflective targets were surveyed using the two stereoscopic cameras and eight spots around them. The targets were then placed in a unique reference system which was then fixed onto the object. During the survey, the stereoscopic cameras performed the absolute orientation using the previously acquired reflective targets (Fig. 9).

Figure 9 – A portion of wall covered by the markers

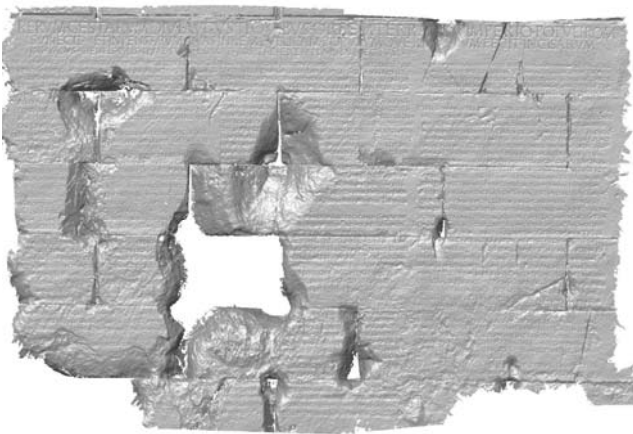
Figure 7 – Rough 3D models of the Latin inscription (right and left sides)

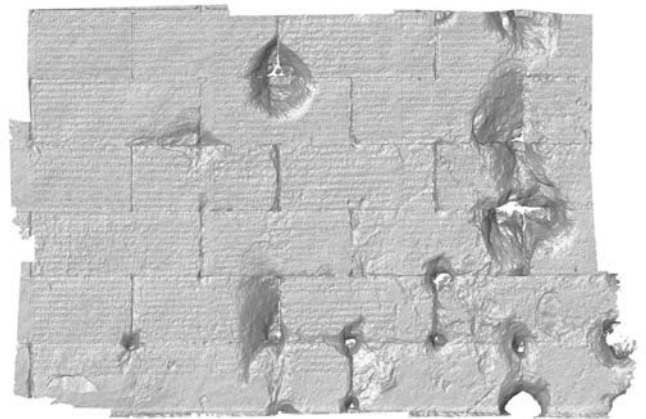
Figure 8 – Rough 3D models of the Greek inscription

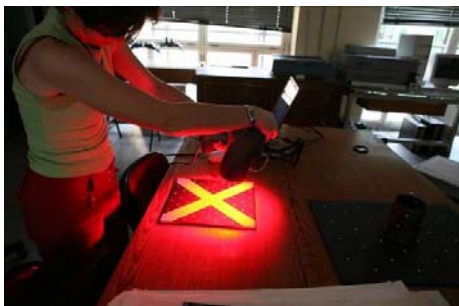
The geometric calibration was performed using a special control plate which is provided with the instruments (Fig.10).

Figure 10 – The geometric calibration of the Handyscan

The scope of this phase was to refine the relative orientation of the two digital cameras in order to avoid small movements of the mechanical components that occur during transportation or due to the change in environmental conditions and so on. The geometric calibration fixed the base of the photogrammetric system and therefore the scale of the survey.

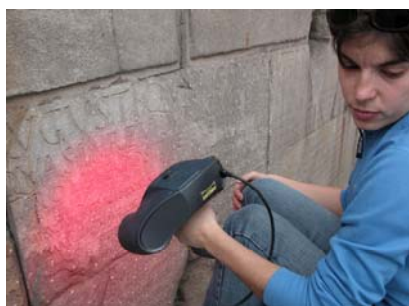
Moreover, the wall surfaces present different colours due to pollution and mould and these characteristics also made it necessary to repeat the radiometric calibration before starting the acquisition on the portion of interest (Fig. 11).

Figure 11 – Example of radiometric calibration of the Handyscan

The radiometric calibration was aimed at setting the photographic parameters for the two camera lenses and the intensity of the laser tracker in order to speed-up the measurement process. This procedure was performed by acquiring some parts of the object with a common texture.

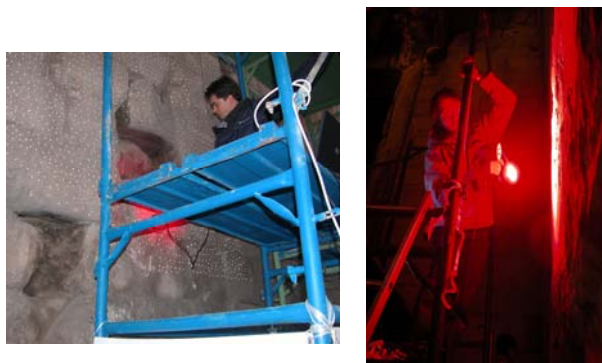
Due to all the previously mentioned problems, the best working time was in the early hours of the morning, the late afternoon and the evening when the markers only reflected the red light of the eight leds, as shown in Figure 12.

Figure 12 – Example of acquisition in the morning and in the evening

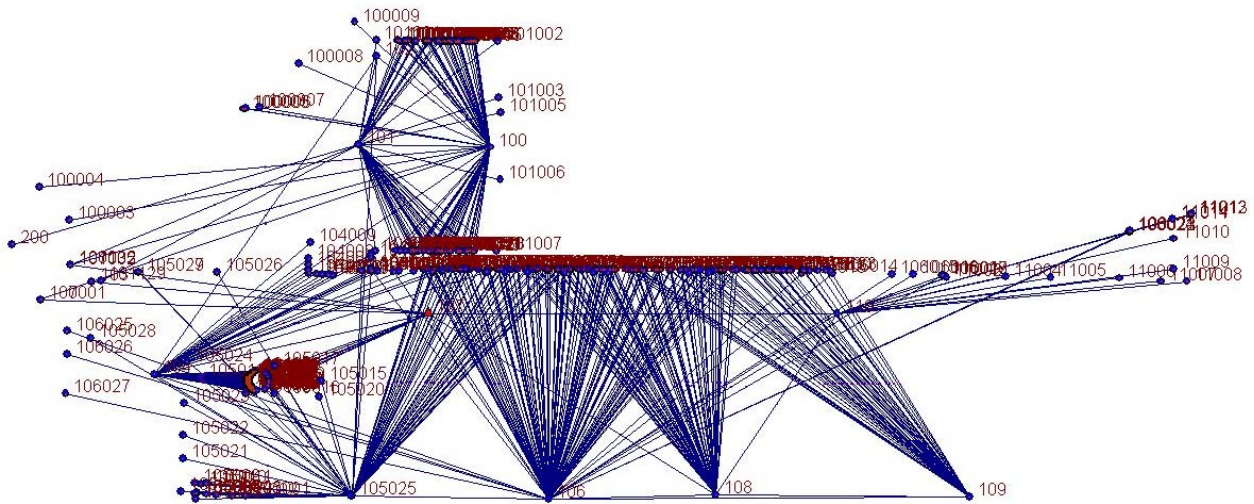
The topographic network and a chosen part of the markers were topographically surveyed in order to express all the acquired data in a unique reference system (Fig. 13).

In this way each surveyed portion could be referred to a unique reference system defined by means of a control network. The network was surveyed using a traditional topographic survey total station (Fig. 14) and using the rigorous approach of redundant observations.

Figure 13 – The measured topographic network

Measured angles	1302
Measured distances	342
N. of vertices	446
m.s.e. in the X and Y directions	0.002 m
m.s.e. in the Z direction	0.001 m

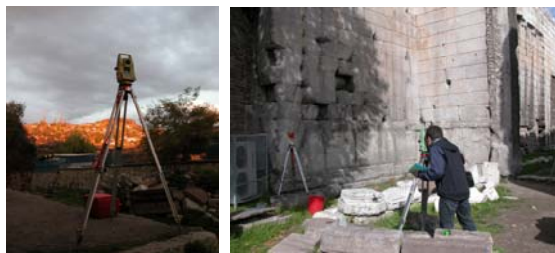
Figure 14 – The topographic measurements and the used instruments

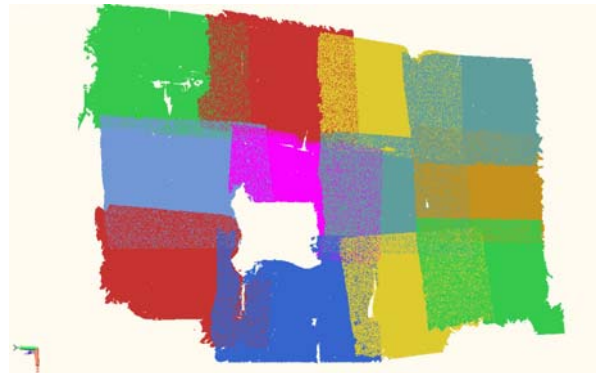
The acquired points were processed using a commercial software (Geomagic) and a scientific software developed by the Politecnico di Torino (LSR2004) in order to build a 3D model of the three inscriptions (Figs. 15-16).

All the gross errors and outliers were eliminated and a correct registration of the single acquisitions was performed using an original approach developed by our Research Group.

Figure 15 – Scans before the registration phase

As previously mentioned, the overlap between each part of the acquired sub-areas was about 10% and each portion contained some known points (approximately 20 points for each portion). A first registration of the portions was performed using the ICP approach (a well known method used in many commercial software programs to register point sets). Considering the small overlap, many systematic errors arose therefore a least square

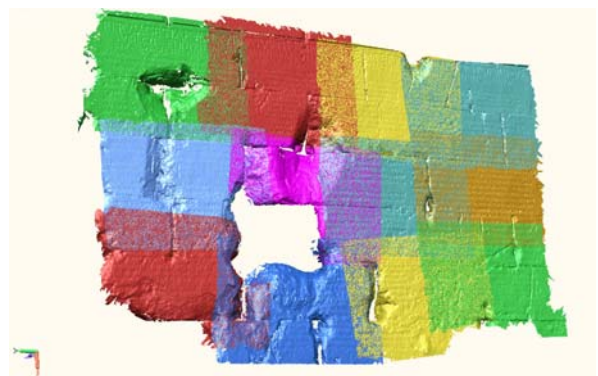
Figure 16 – 3D models of the surfaces after the complete registration phase

compensation of all the portions of a single object was computed using all the information obtained from existing known points on the surface.

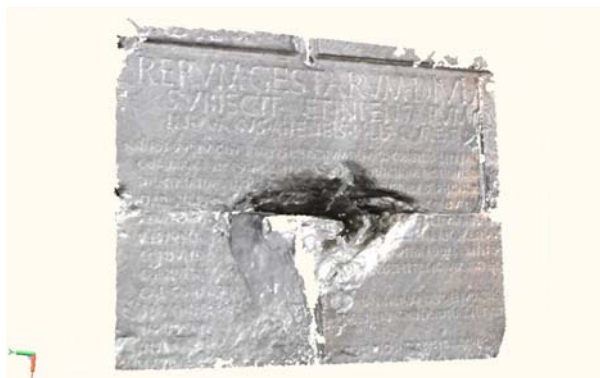
A realistic 3D model, Figure 17, of the three epigraphs was produced by mapping the oriented images onto the 3D point model after a surface generation (TIN approach). This represents the most important output of this kind of survey technique and allows a complete and exhaustive analysis of the object to be made by the specialists.

Figure 17 – 3D realistic model
