# Galvanic Corrosion Behavior of Orthodontic Archwire Alloys Coupled to Bracket Alloys

The purpose of this study was to provide a quantitative assessment of galvanic corrosion behavior of orthodontic archwire alloys coupled to orthodontic bracket alloys in 0.9% NaCl solution and to study the effect of surface area ratios. Two common bracket alloys, stainless steels and titanium, and four common wire alloys, nickel-titanium (NiTi) alloy,  $\beta$ -titanium ( $\beta$ -Ti) alloy, stainless steel, and cobalt-chromium-nickel alloy, were used. Three different area ratios, 1:1, 1:2.35, and 1:3.64, were used; two of them assumed that the multibracket appliances consists of 14 brackets and 0.016 inch of round archwire or 0.016  $\times$  0.022 inch of rectangular archwire. The galvanic current was measured for 3 successive days using zero-impedance ammeter. When the NiTi alloy was coupled with Ti (1:1, 1:2.35, and 1:3.64 of the surface area ratio) or  $\beta$ -Ti alloy was coupled with Ti (1:2.35 and 1:3.64 of the surface area ratio), Ti initially was the anode and corroded. However, the polarity reversed in 1 hour, resulting in corrosion of the NiTi or  $\beta$ -Ti. The NiTi alloy coupled

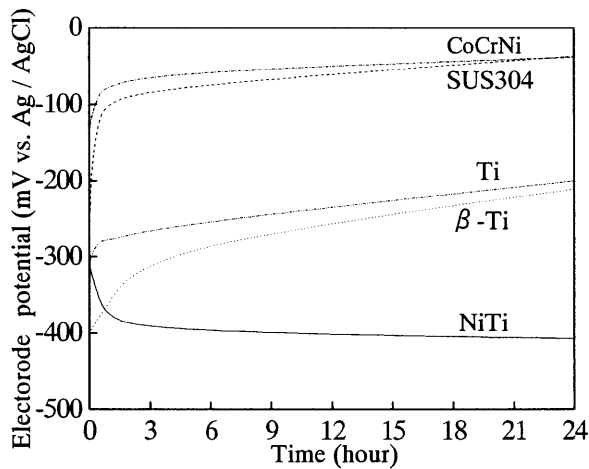
**FIGURE 1.** Representative corrosion potential of the NiTi,  $\beta$ -Ti, SUS 304, and Ti during the first 24 hours of immersion in 0.9% NaCl solution. NiTi indicates nickel-titanium;  $\beta$ -Ti,  $\beta$ -titanium.

Figure 1 shows the variations in the corrosion potentials ( $E_{\text{corr}}$ ) of representative uncoupled alloys dur-

ing the first 24 hours of immersion in 0.9% NaCl solution. The corrosion potentials ( $E_{\text{corr}}$ ) of the uncoupled  $\beta$ -Ti, CoCrNi, SUS 304, and Ti moved in the noble direction a few hours after starting immersion, whereas the corrosion potential of the NiTi moved in the less noble direction a few hours after starting immersion. Comparing the steady-state values of  $E_{\text{corr}}$ , SUS 304 and CoCrNi indicated more noble corrosion potential (approximately  $-50$  mV for both samples) than any other samples. In contrast, the corrosion potential for the NiTi (approximately  $-400$  mV) was much lower than that for any other samples. The corrosion potentials obtained from Ti and  $\beta$ -Ti (approximately  $-200$  mV) were intermediate.

than that of NiTi immediately after starting immersion and moved in the noble direction in a few hours. On the other hand, the corrosion potential of the NiTi moved in the less noble direction after the starting immersion (Figure 1).

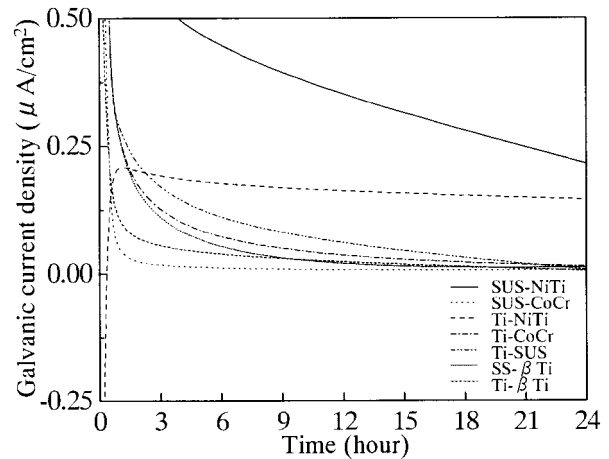
**FIGURE 2.** Representative galvanic current density of archwire alloys (NiTi,  $\beta$ -Ti, SUS 304, CoCrNi) coupled with bracket alloys (SUS 304, Ti) with area ratio of 1:1 in 0.9% NaCl solution. NiTi indicates nickel-titanium;  $\beta$ -Ti,  $\beta$ -titanium; and CoCr, cobalt-chromium.

The galvanic current density was calculated from the measured galvanic current and surface area of the alloy, which served as an anode during most of the measurement time. Figures 2 through 4 show the variation in the galvanic current density during the first 24 hours of immersion; similar results were found for second and third samples. Table 4 shows the mean values of the galvanic current density obtained from all coupled alloys at 24, 48, and 72 hours. In all coupled samples, the galvanic current density decreased with time and reached a nearly constant value after 24 hours. In NiTi alloy coupled with Ti (1:1, 1:2.35, and 1:3.64 of the surface ratio) or  $\beta$ -Ti alloy coupled with Ti (1:2.35 and 1:3.64 of the surface ratio), Ti was initially the anode and corroded. However, the polarity reversed in 1 hour, resulting in corrosion of the NiTi or  $\beta$ -Ti. The galvanic current density for NiTi alloy coupled with SUS 304 or Ti at 72 hours of immersion was 0.033 to  $0.114 \mu\text{A}/\text{cm}^2$ , which was more than one order of magnitude higher than that observed for the other couples.

In this study, the galvanic current decreased with time and reached a nearly constant value after 24 hours for all coupled samples (Figures 2 through 4). In NiTi alloy coupled with Ti (1:1, 1:2.35, and 1:3.64 of the surface ratio), Ti was initially anode and corroded; however, the polarity reversed in 1 hour, resulting in corrosion of the NiTi. This phenomenon can be explained by the time change of corrosion potential ( $E_{corr}$ ) because the corrosion potential of the Ti was lower

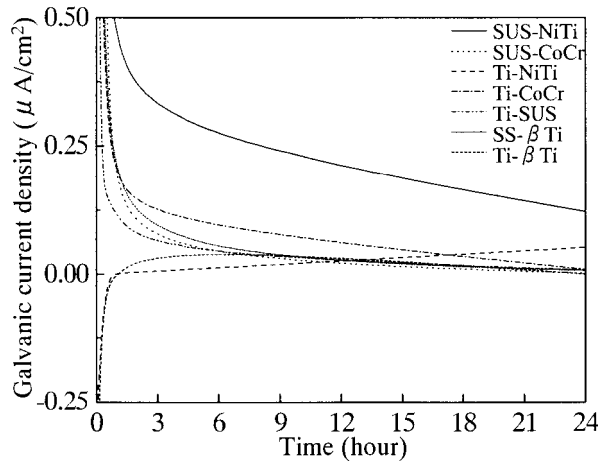
**FIGURE 3.** Representative galvanic current density of archwire alloys (NiTi, β-Ti, SUS 304, CoCrNi) coupled with bracket alloys (SUS 304, Ti) with area ratio of 1:2.35 during the first 24 hours of immersion in 0.9% NaCl solution. NiTi indicates nickel-titanium; β-Ti, β-titanium; and CoCr, cobalt-chromium.

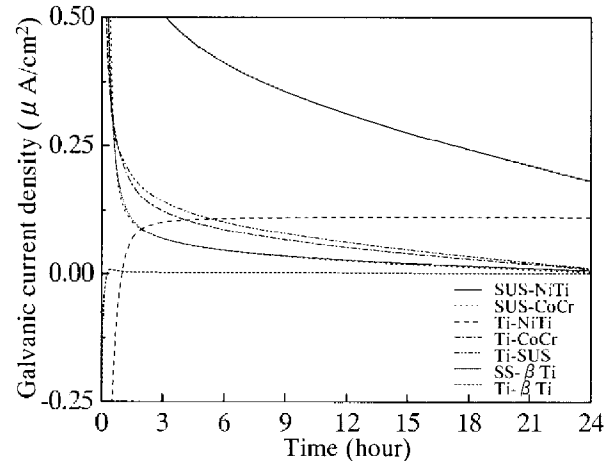
**FIGURE 4.** Representative galvanic current density of archwire alloys (NiTi, β-Ti, SUS 304, CoCrNi) coupled with bracket alloys (SUS 304, Ti) with area ratio of 1:3.64 during the first 24 hours of immersion in 0.9% NaCl solution. NiTi indicates nickel-titanium; β-Ti, β-titanium; and CoCr, cobalt-chromium.

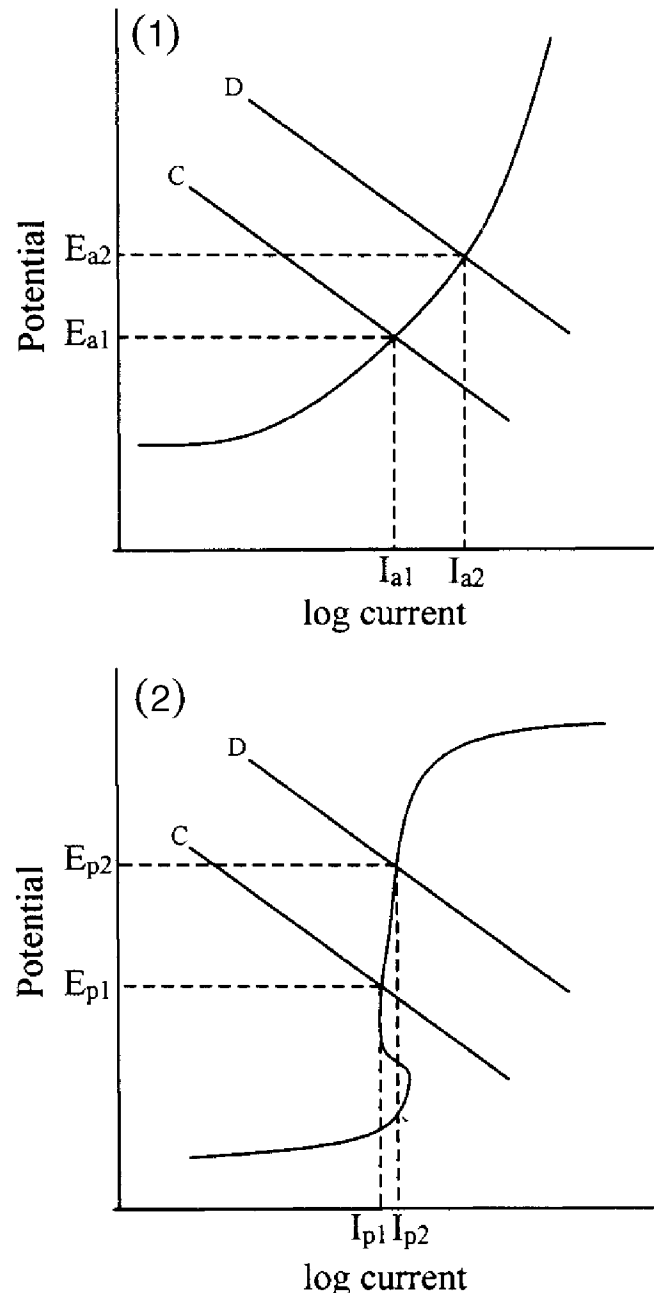
**FIGURE 5.** Effect of anode-cathode area ratio on the polarization diagram of two galvanically coupled alloys. (A) Anodic polarization curve of an active alloy with surface area of S cm<sup>2</sup>. (B) Anodic polarization curve of a passive alloy with surface area of S cm<sup>2</sup>. (C) Cathodic polarization curve when each alloy is coupled to an alloy (S cm<sup>2</sup>) with relatively noble potential. (D) Cathodic polarization curve when each alloy is coupled to an alloy (3.64 cm<sup>2</sup>) with relatively noble potential.

Figure 5 illustrates the effect of anode-cathode area ratio on the anodic and cathodic polarization curves for (1) an actively corroding alloy and (2) a passive alloy when each alloy is galvanically coupled to an alloy that has more positive potential (cathodic). When equal areas of the anodic and cathodic alloys are coupled, the corrosion rate of the active and the passive alloys are  $i_{corr, a1}$  and  $i_{corr, p1}$ , respectively. The corrosion rate of the active alloy is increased from  $i_{corr, a1}$  to  $i_{corr, a2}$  as the area of cathodic alloy is increased from S to 3.64S. In contrast to this, the corrosion current of the passive alloy is not markedly influenced by the surface area of the cathodic alloy because the anodic current of the passive alloy is almost constant, independent of potential in the passive region. Because the alloys used in this study were all passive, the surface area ratio of two dissimilar alloys had little effect on the corrosion rate, as shown in Figure 5b.
