LASER REPAIR WELDING OF MOLDS WITH VARIOUS PULSE SHAPES

Received – Prispjelo: 2008-12-22 Accepted – Prihvaćeno: 2009-03-14 Preliminary Note – Prethodno priopćenje

M. Pleterski, J. Tušek Faculty of Mechanical Engineering, Ljubljana, Slovenia, L. Kosec, Faculty of Natural Sciences and Engineering, Ljubljana, Slovenia, T. Muhič, M. Muhič, TKC d.o.o., Ljubljana, Slovenia

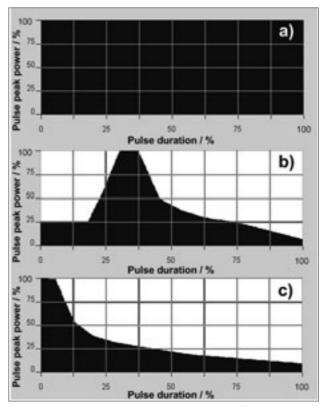
Figure 1. Investigated laser pulse shapes; a) pulse shape A, b) pulse shape B, c) pulse shape C

explanation of the influence of laser beam pulse shape on the repair welding is demonstrated with three laser pulse shapes (Figure 1).

Type A laser pulse shape is a classical rectangular pulse shape with the constant power distribution during its duration time, which varies in the case of shapes B and C. Laser parameters for the investigated pulse shapes are presented in Table 2.

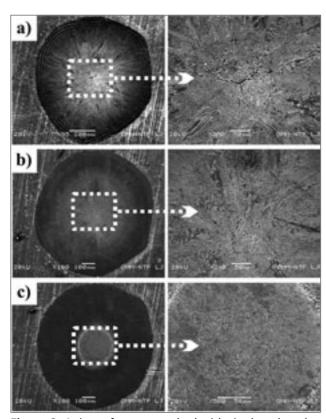
Figure 2. Apices of spots remelted with single pulse; a) type A pulse, b) type B pulse, c) type C pulse.

The analysis of spot apices made with single pulse remelting reveals the major problem in welding of cold-work tool steels i.e. shrinkage cracking, as a consequence of rapid solidification. Rectangular laser pulse (type A) is commonly used pulse for welding of mild steels, stainless steels and low alloyed tool steels. From the Figure 2a, it can be inferred that this type of pulse is inappropriate for welding of the investigated material, due to major cracking in the spot. The cracks originate from the centre and propagate towards the periphery of the remelted spot in the length of $200~\mu m$.

Fewer issues arise from remelting with the type B pulse shape, shown in Figure 2b. There is still some noticeable cracking with the crack length of approx. 100 μm. Influence of type C pulse shape and process parameters on solidification behavior of molten spot is depicted in Figure 1c. The long ramped-down pulse is superior to pulses A and B. In this case no deficiencies on the apex of remelted spot can be perceived. This type of pulse shape and parameters are beneficial because of its relatively long lasting annealing effect. Essential is the last 90 % of the pulse, i.e. 50 ms, that make solidification process run slower and the stresses not exceeding the tensile strength of material with the newly formed structure. The distinctive round area in the center of the spot is also characteristic for this type of laser pulse. This is due to a different microstructure in this area, which is the consequence of specific pulse action.

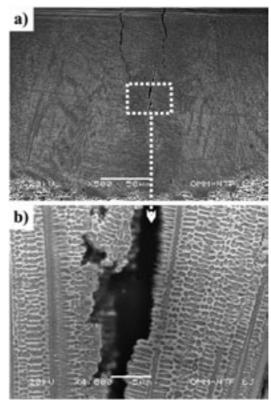
Figure 3. Cross section of the spot, remelted with type A laser pulse; a) macro section, b) higher magnification image of microstructure by the crack.

Microstructures formed in the molten pool under type A and B conditions are basically the same. As shown in Figures 3a and 3b, the microstructure consists of fine columnar dendrites with very narrow dendrite arm spacing. The dendrites are perpendicular to the fusion line and grow towards the spot surface center. Columnar dendrite solidification occurs in a case of low temperature gradient and when the most under-cooled area of the melt is distant from the solidification line. This kind of solidification depends on under-cooling range, which is significantly larger than the grain diameter. Large distance of the solidus-liquidus region enables lower actual temperature compared to the effective temperature of the melt [12]. Laser, due to localized high energy input, causes rapid melting and also very quick solidification. This causes great distance between the S-L phase, but the time for growth is very short, therefore only primary dendrite arms can develop. Because of fast solidification, cracking occurs as a consequence of high tensile stresses, due to solidification contraction. Consequently cracks form as a tearing between dendrites in the central region of the spot. The cracks are not uniform, they occur in a great number, and extend from the apex to the root of remelted spot.

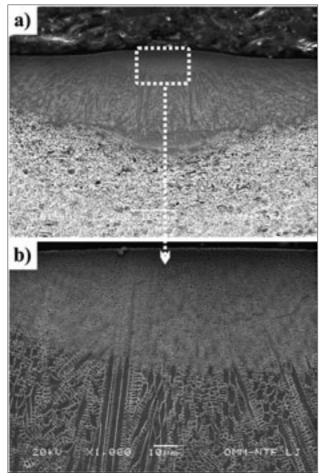
Figure 4. Cross section of the spot, remelted with type C laser pulse; a) macro section, b) detailed picture of distinctive microstructures

Figures 4a and 4b show the macro section and the detailed image of characteristic microstructure performed under pulse C shape and parameters. The majority of microstructure is basically similar to the one mentioned above, with the exception of central surface area and a few very elongated columnar dendrites, extending from

the fusion line on the root side of the bead, through complete remelted region, to the apex. As mentioned above, the distinctive circle inside the spot surface originates in a specific microstructure, which is different from that in the remaining molten volume. As depicted in Figure 4b, this surface area consists of microstructure, based on columnar dendrites, but the long pulse duration time ensures more time for solidification and formation of secondary dendrite arms. This results in a fine dendritic microstructure with very narrow dendrite arm spacing (less than $1~\mu m$).
