Comparison of the technological and building situation of Estonian cowsheds in 1999 and 2004

R. Miljan¹, J. Miljan² and A. Leola³

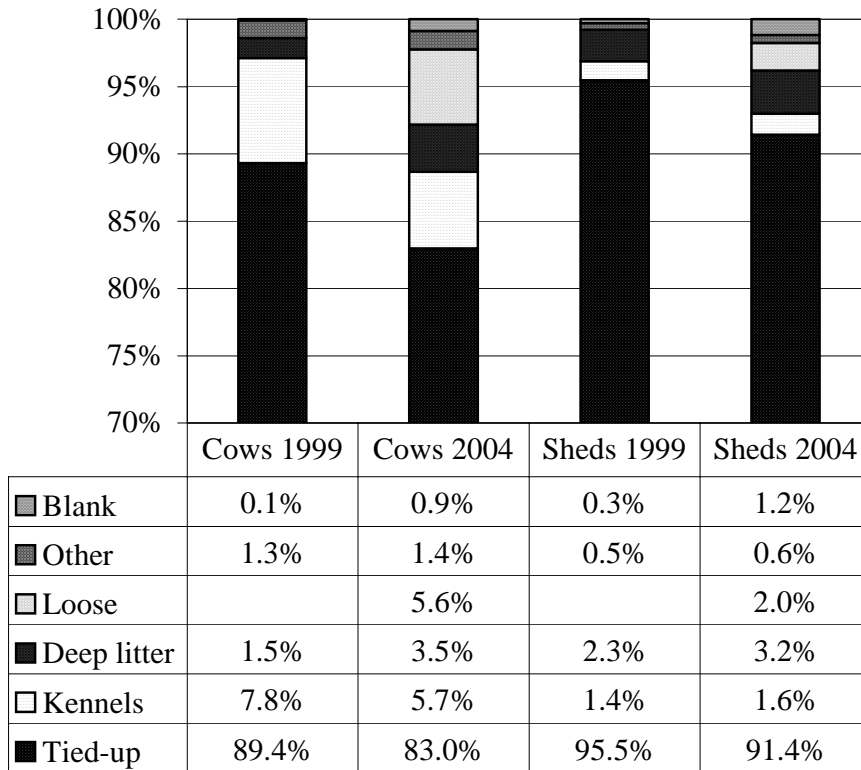
Fig. 2. Change of systems of housing from the total number of cows in percents and from the total number of cowsheds in percents.

During the past five years, the housing systems of cows in Estonia have changed somewhat. There has been a shift from tied-up to loose housing but the change has been only 5–6% in the number of cows and 4% in the number of cowsheds (Fig. 2). Loose housing means housing in kennels, housing on deep litter and loose housing summarised.

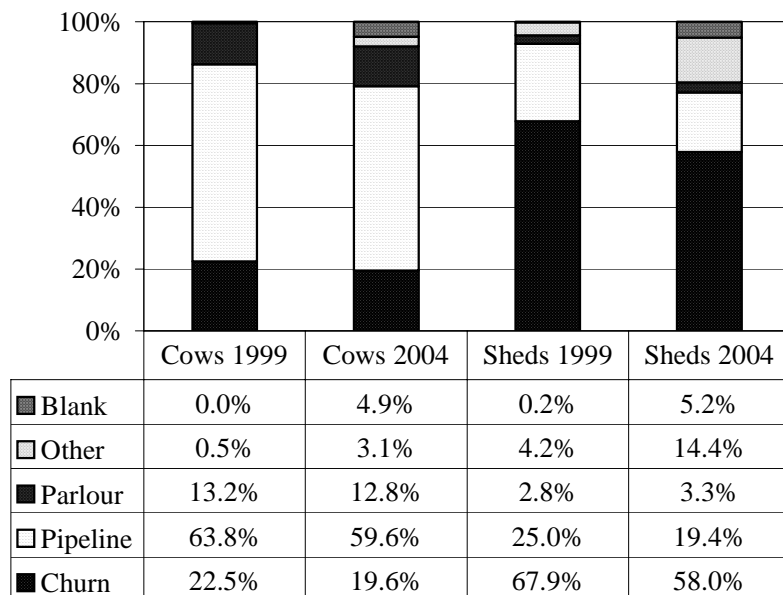
Fig. 3. Change of systems of milking from the total number of cows in percents and from the total number of cowsheds in percents.

Considering the efficiency of the milker, it is important that the number of cows and cowsheds where milking is performed on a parlour has increased. Analysing the data from the questionnaire from the aspect of milking methods, it appears that the number of cows milked into a pipeline or on a parlour (Fig. 3) has almost not changed. The number of cows milked into a churn has decreased and the number of cows whose owners could not specify the milking method has increased.

In the number of cowsheds separated by the milking method (Fig. 3), pipeline milking has decreased by 5.6% and parlour milking has increased by 0.5%. The number of cowsheds where cows are milked into a churn has decreased and the number of cowsheds whose owners could not specify the milking method has increased.

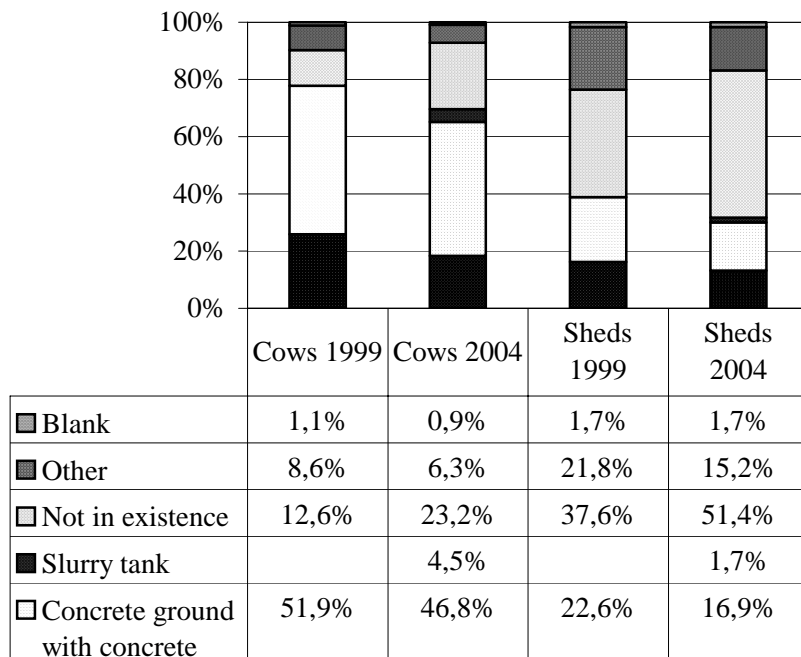
Fig. 4. Manure storage from the total number of cows in percents and from the total number of cowsheds in percents.

From the environmental point of view, the method of manure storage is relevant (Fig. 4). The greatest role in manure storage is played by reinforced concrete storages and concrete grounds. This applies to both the number of cows and the number of cowsheds. Surprisingly, the relative importance of concrete storages and -grounds has significantly diminished during the past five years. The frequency of manure storage without proper facilities has increased by both the number of cows (almost two times) and the number of cowsheds (over 1.5 times). This can be caused by the fact that numerous cowsheds with storages in a poor condition were listed as 'without storage'. This was possibly caused by a non-refundable aid project launched at the end of 2004 for improvement of manure processing. The point that in 2004 the manure of almost 5% of the cows was stored in slurry tanks should be considered a positive trend.

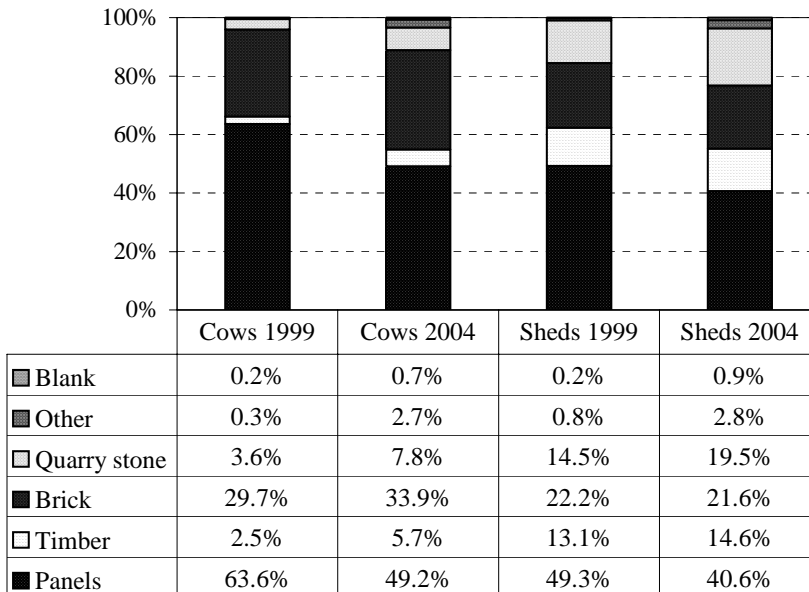
Fig. 5. Material of walls from the total number of cowsheds and from the total number of cows in percents.

In 2004, 40.6% of Estonian cowsheds housing more than five animals had wall-structures of gas-concrete (Fig. 5). In five years their significance fell by over 9%. By the number of cows, over 50% were still in buildings made of panels but here also a decrease of the relative importance is considerable – over 15%. The number of cowsheds with wooden walls has risen, but mainly among the smaller cowsheds.

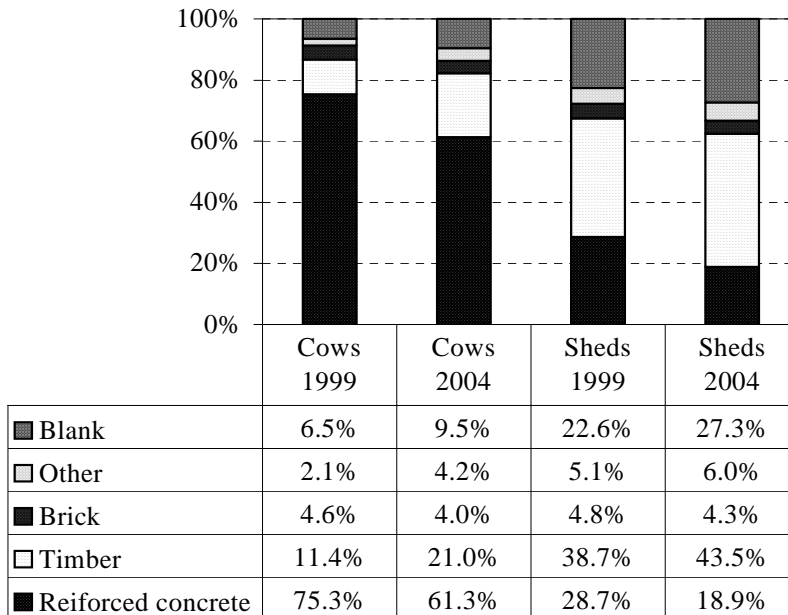
Fig. 6. Material of columns (from the total number of cowsheds and from the total number of cows in percents).

In regard to bearing structures, cowsheds with reinforced concrete columns have lost their significance (Fig. 6). By the number of animals, however, most cows (61.3%) are still housed in buildings with reinforced concrete columns. The importance of cowsheds with wooden columns has risen, but primarily among smaller cowsheds as 43.5% of the cowsheds have wooden columns but they all house only 21% of the cows.

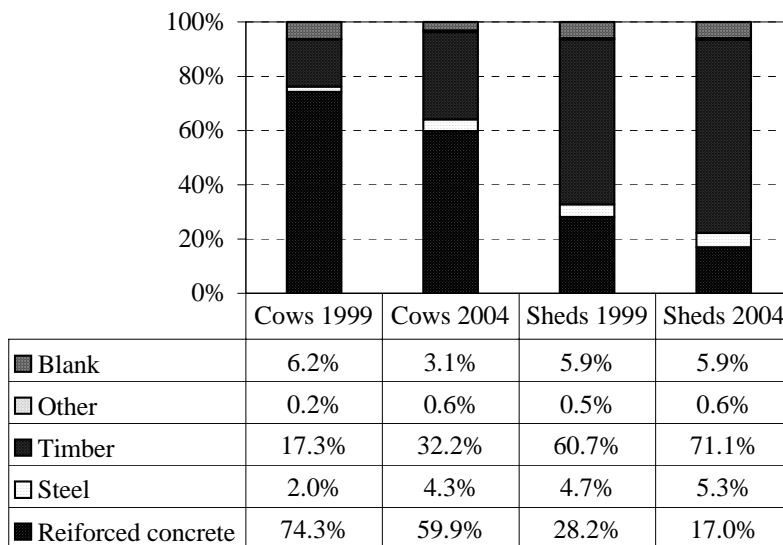
Fig. 7. Material of beams (from the total number of cowsheds and from the total number of cows in percents).

By the number of cowsheds, buildings with wooden beams have achieved a clear majority and, by the end of 2004, they included 71.1% of the cowsheds with five or more animals (Fig. 7). By the number of animals, however, most cows (59.91%) resided in cowsheds with reinforced concrete beams. Here also, a decrease of over 14% has taken place during the past five years. About one third (32.2%) of the cows are still held in cowsheds with wooden beams. An important trend to be noticed is an increase of cowsheds with steel beams and also an increase in the number of cows housed in cowsheds with steel beams.
